INSPECTION REPORT

PANTHER POND DAM
MEMA No. 122

**Department of Inland Fisheries and Wildlife
Augusta, Maine**

March 2020

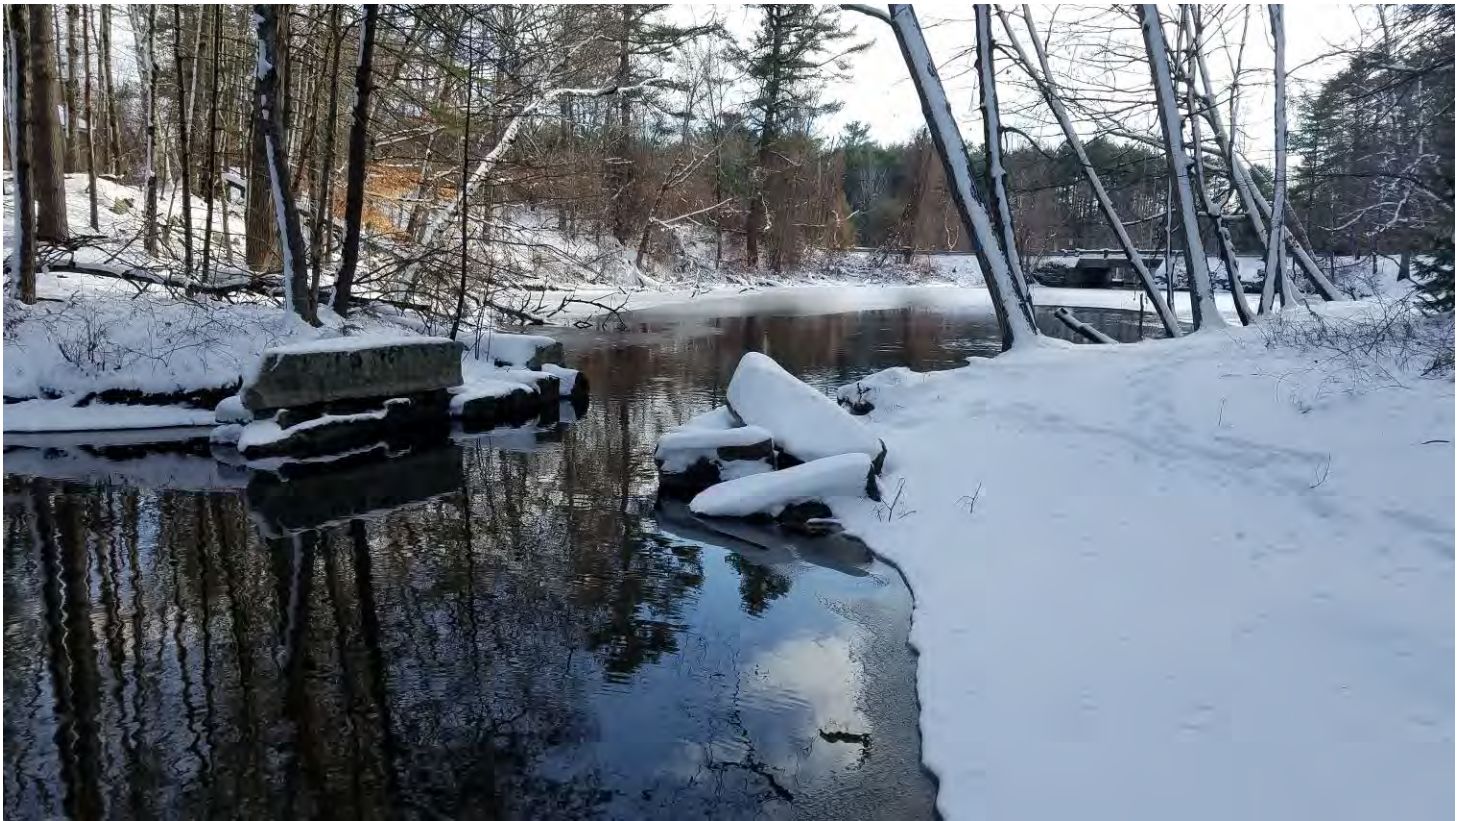
The reservoir immediately upstream of the dam is a meandering channel that passes through a natural constriction and remnants of a concrete block structure (Photos 1 and 2) approximately 450 feet upstream of the dam and Mill Street Bridge (Photos 3 and 4) immediately upstream of the dam. The upstream constriction and bridge offer potential locations for cofferdam installation in the event dewatering of the dam is necessary for repair or replacement of the dam. The short spans and depths of water in the two locations would reduce cofferdam costs if water control or other construction techniques at the dam are not sufficient.

PHOTO 1: CONCRETE BLOCK STRUCTURE LOOKING BACK TOWARDS DAM.

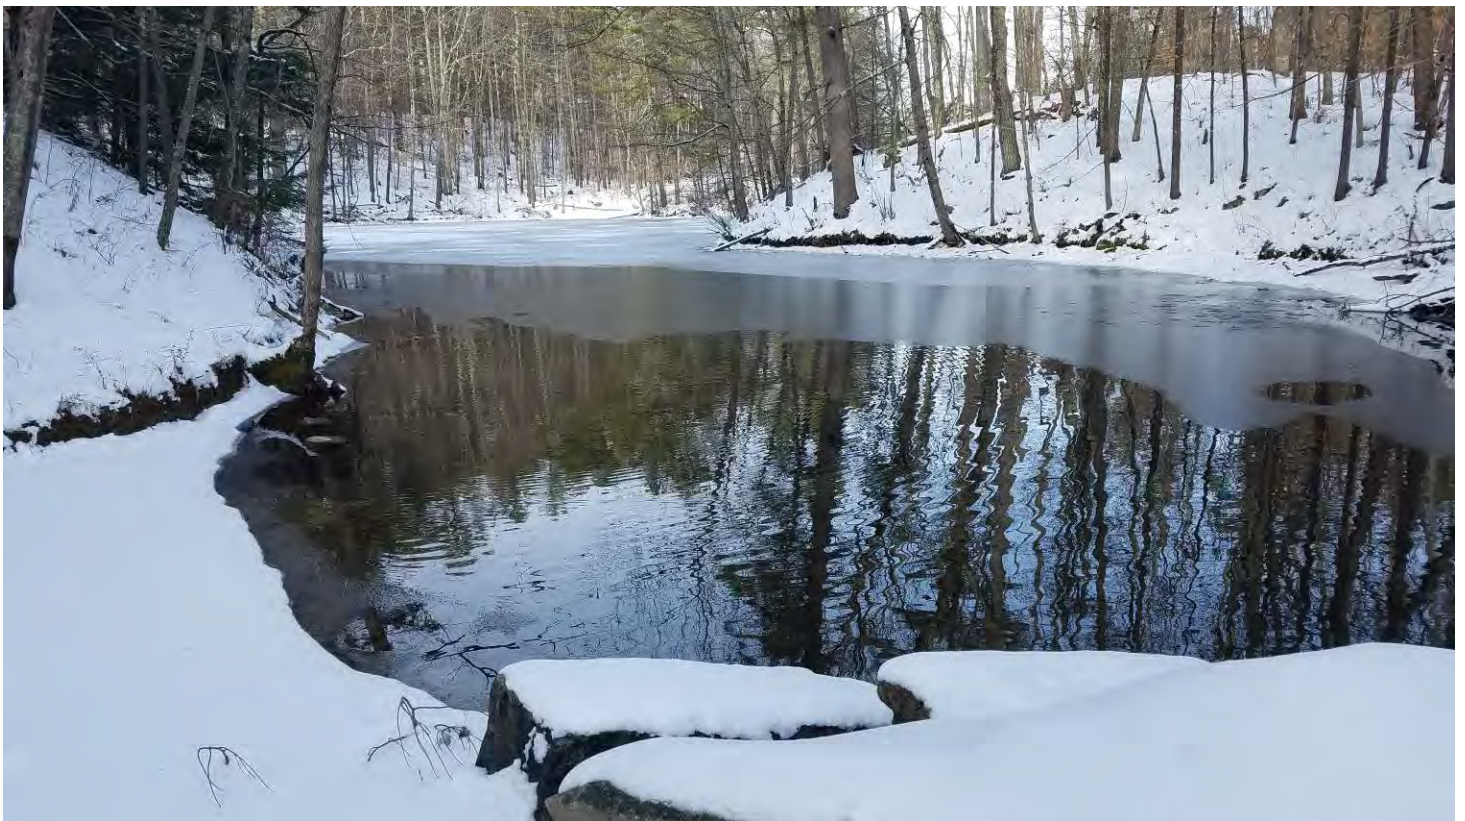
PHOTO 2: RESERVOIR UPSTREAM OF CONCRETE BLOCK STRUCTURE.

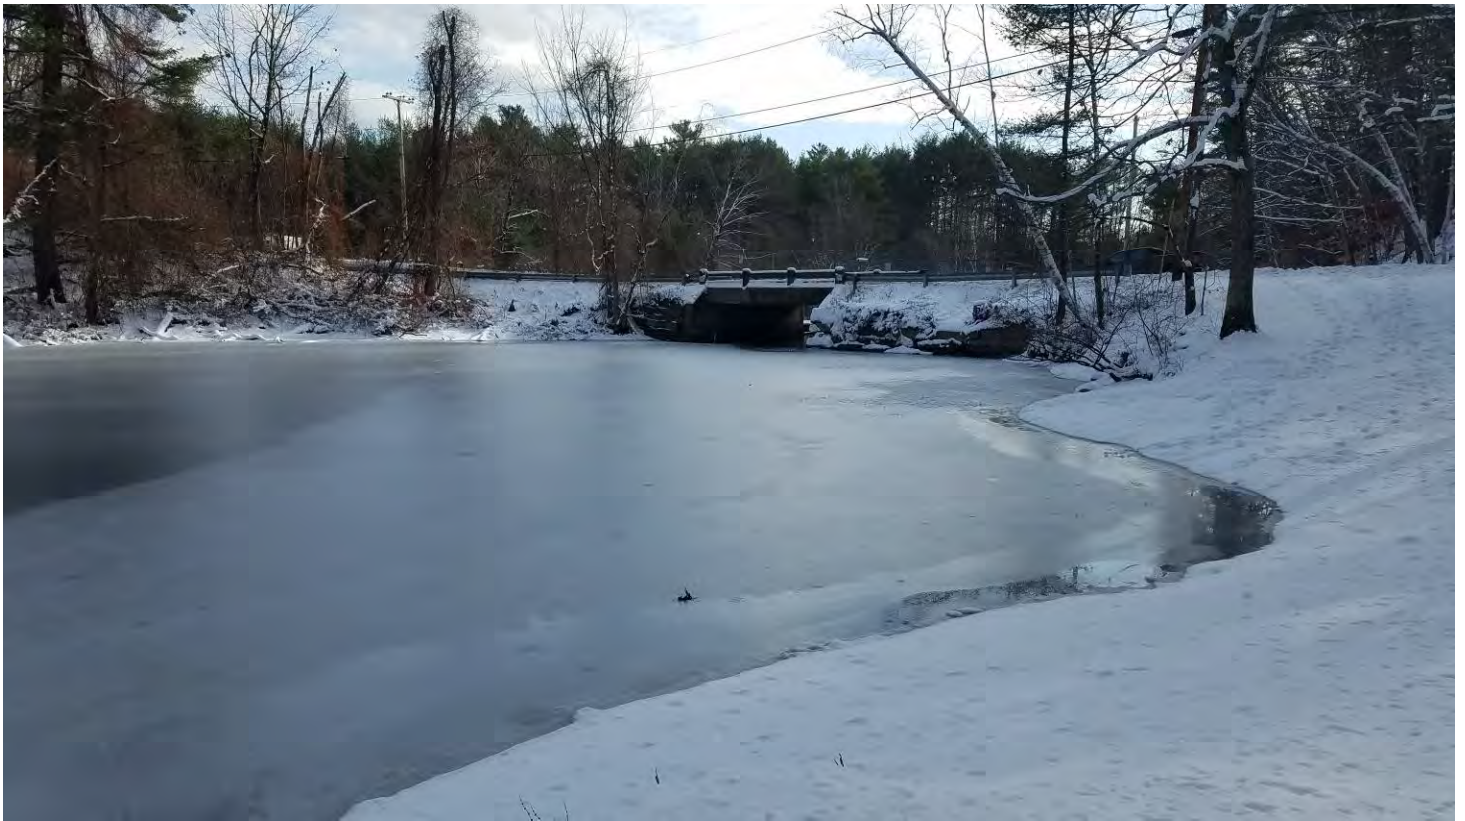
PHOTO 3: MILL STREET BRIDGE UPSTREAM OF DAM.

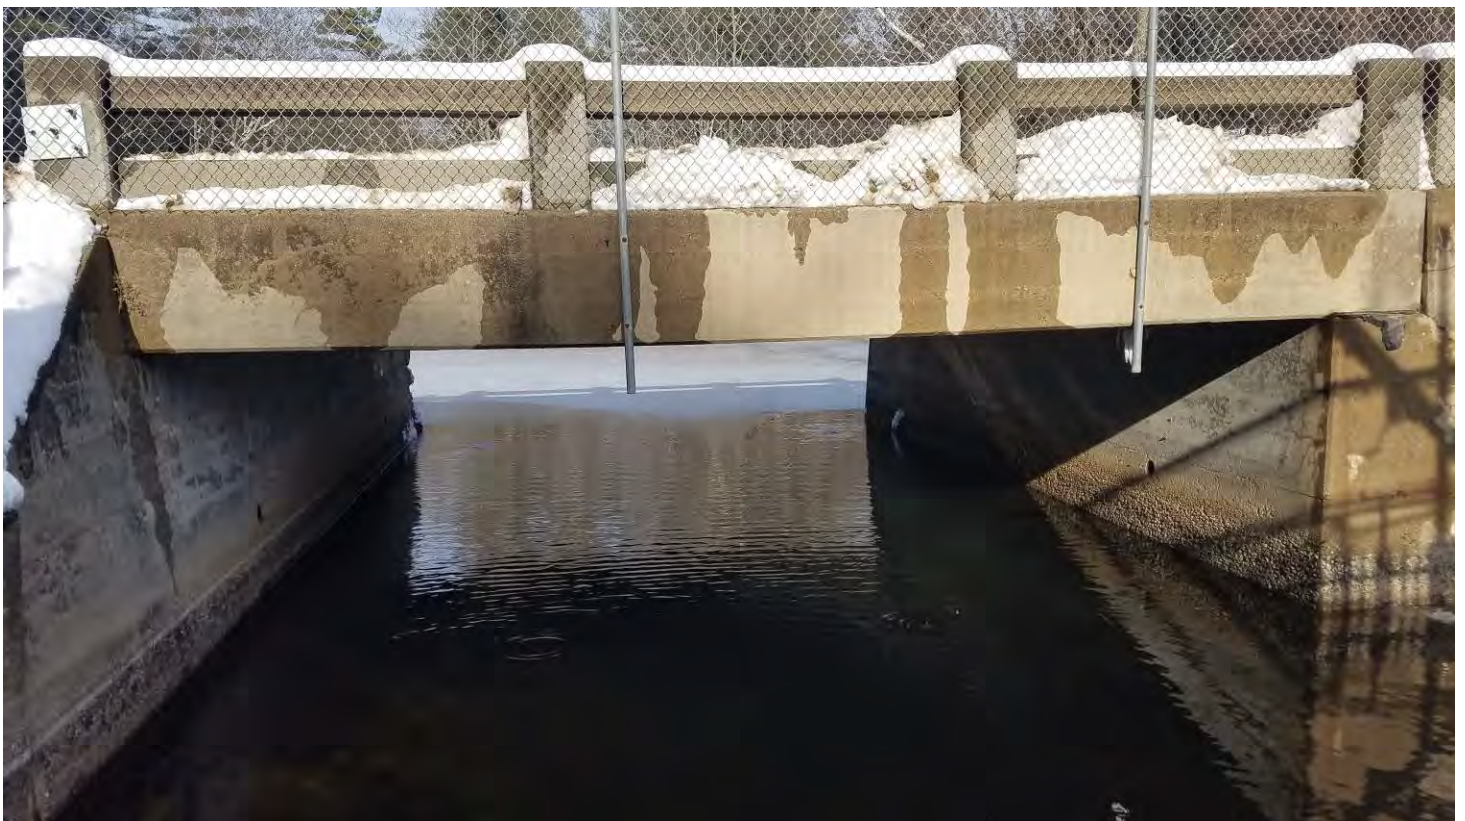
PHOTO 4: DOWNSTREAM SIDE OF MILL STREET BRIDGE.

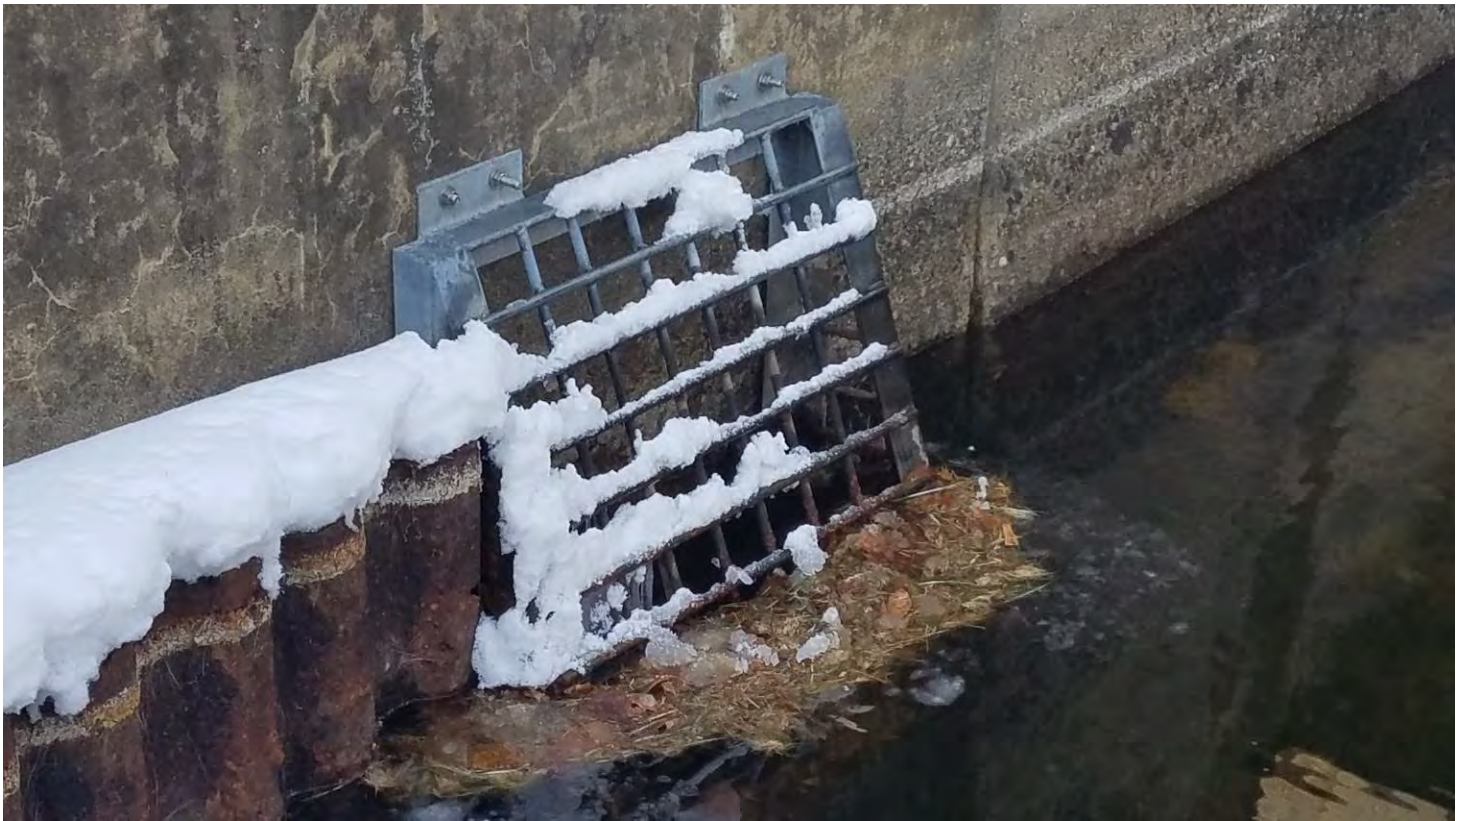
The Mill Street Bridge abutments tie into the left and right dam abutments, as well as the fish hatchery intake (Photo 5). The fish hatchery intake is protected by a steel grate to prevent large debris from entering the pipe. Photo 6 shows the fishway intake during repairs in 2011. The inspection noted that the pipe intake is located just below the normal water surface elevation, and therefore, the inspection team was not able to verify the condition of the intake. Above water portions of the steel grate and concrete surrounding the intake appear to be in satisfactory condition and do not require repair or replacement at this time.

PHOTO 5: FISHWAY INTAKE GRATE.

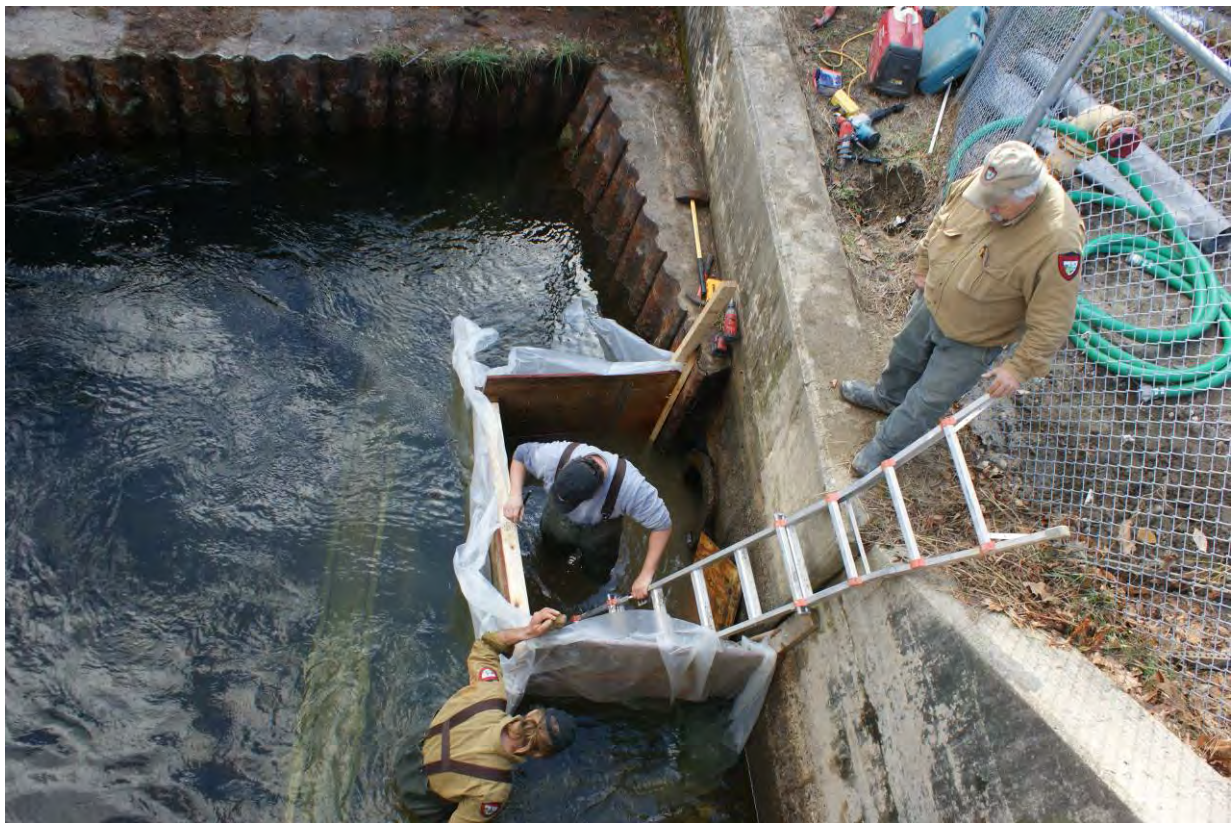
PHOTO 6: FISHWAY INTAKE DURING REPAIRS IN 2011.

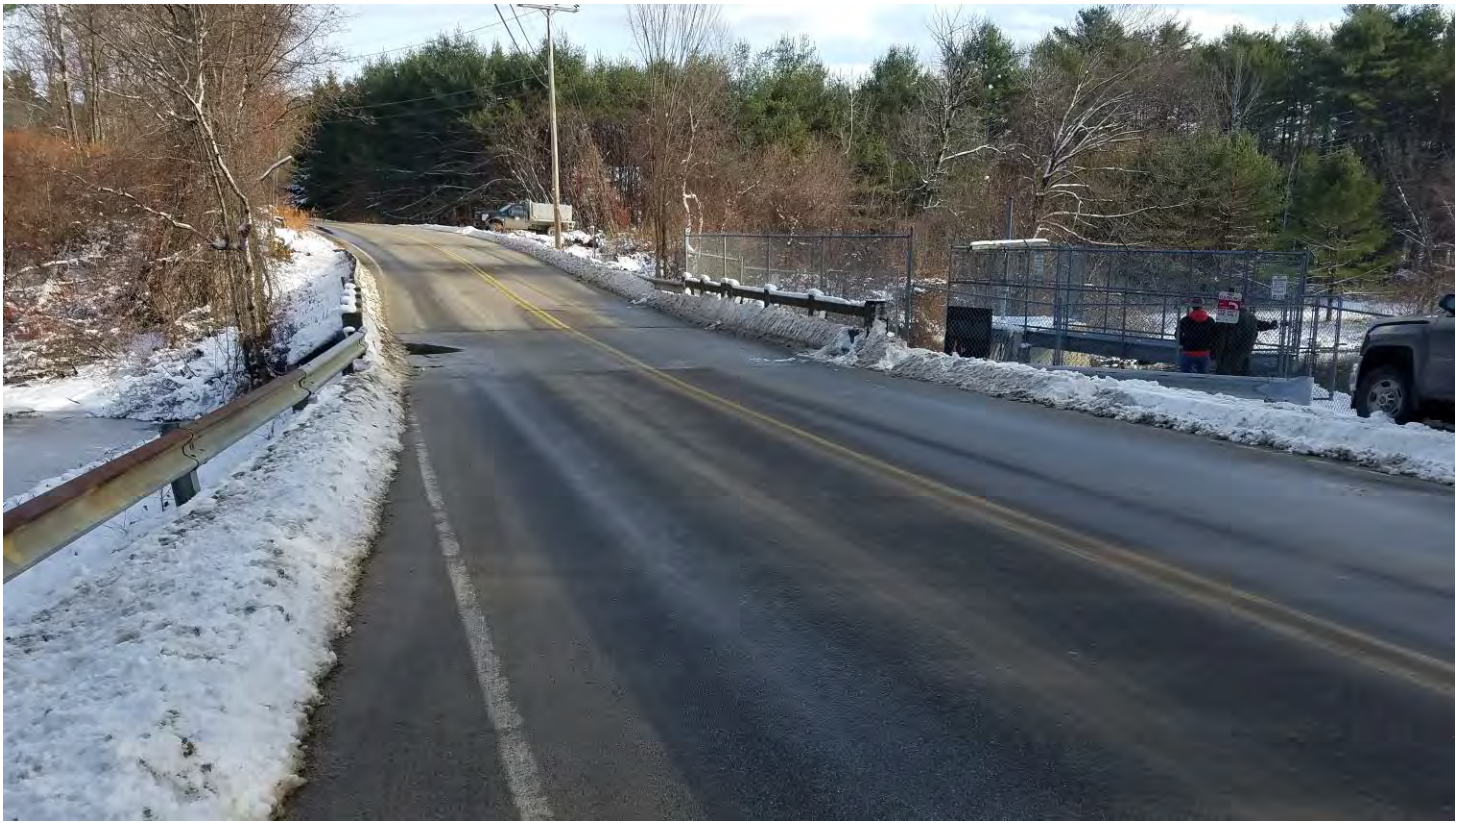
The Dam's left abutment consists of an earthen embankment that appears to be natural grade and built-up embankment for the Mill Street roadway (Photos 7 and 8). The earthen section of the abutment appears to be in satisfactory overall condition. The inspection did not note any signs of instability, settlement, wet spots or seepage. The embankment does have low lying and mid-sized brush that can make access and visual inspection difficult. It is recommended that vegetation on water retaining structures and within 20 feet of the toe be cleared. If left uncleared, visual inspection of the embankment can be difficult and leave deficiencies unnoticed. Large root systems can penetrate the embankment, creating paths of least resistance for seepage or blow over and loss of section width due to the root ball.

PHOTO 7: MILL STREET BRIDGE AND LEFT ABUTMENT.

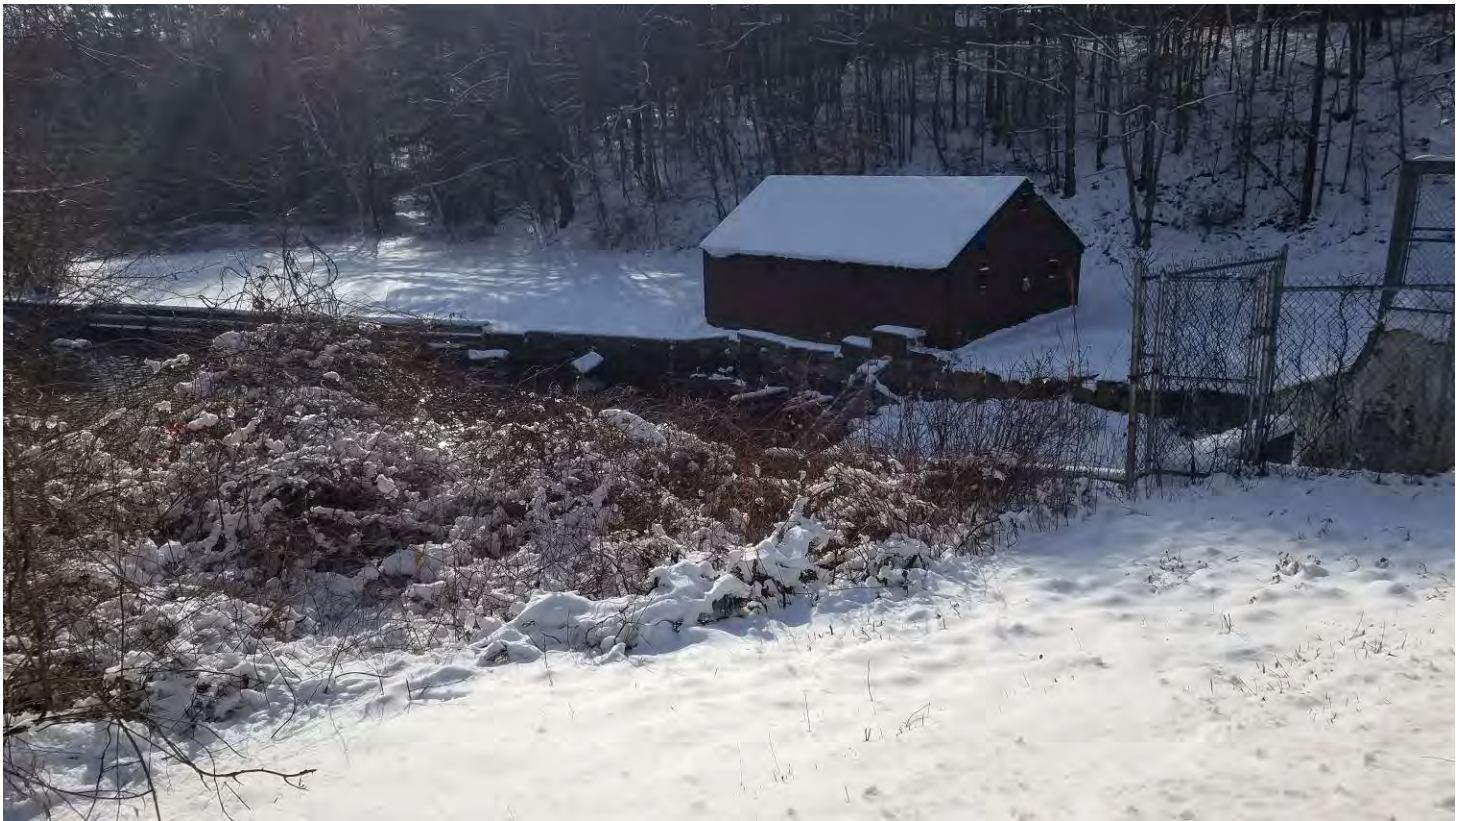
PHOTO 8: LEFT ABUTMENT EMBANKMENT DOWNSTREAM FACE.

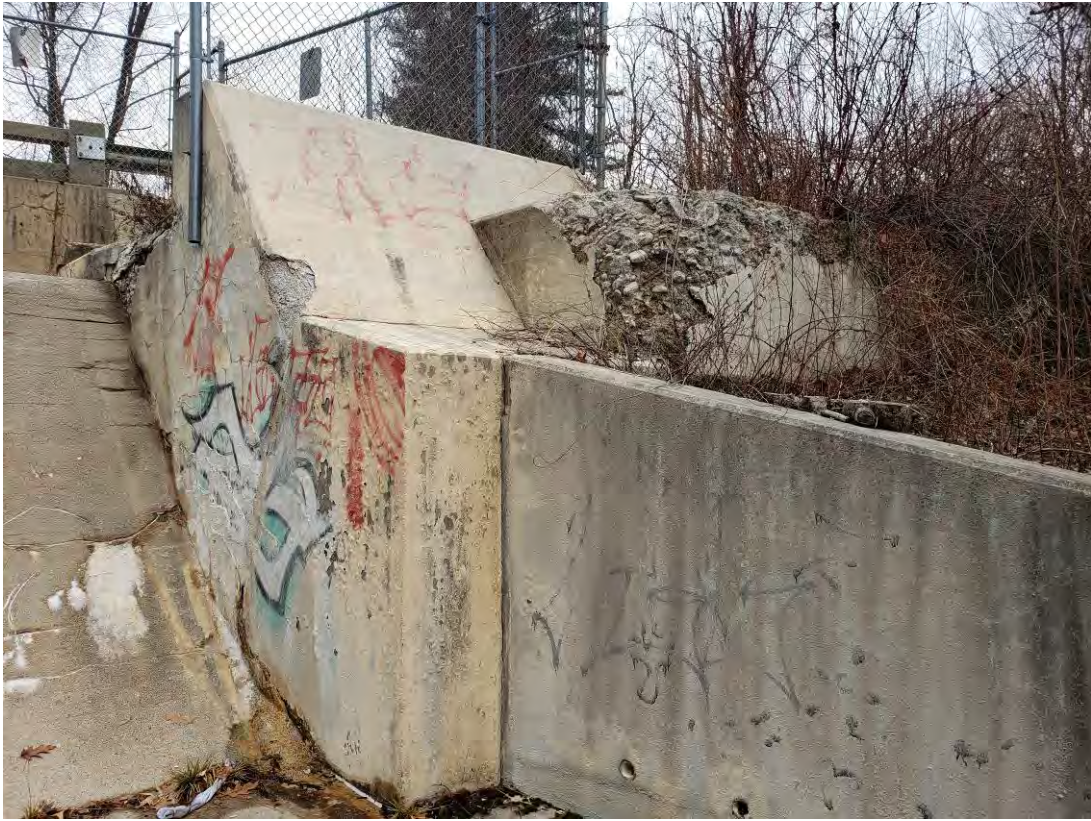
The embankment at the left overflow spillway interface is retained by concrete retaining walls at the Mill Street Bridge, Dam, and downstream apron (Photos 9 and 10). The left abutment at the interface with the downstream side of the left overflow spillway section's crest has significant loss of concrete and exposed aggregate. It is recommended that the concrete wall in this location be repaired by returning the wall to its original condition to prevent further loss of the retaining wall. If left in current condition, overtopping flows over the left spillway section could eventually erode through the wall and provide a concentrated flow path and eventual erosion of the downstream face of the left embankment.

PHOTO 9: LEFT ABUTMENT CONCRETE RETAINING WALL.

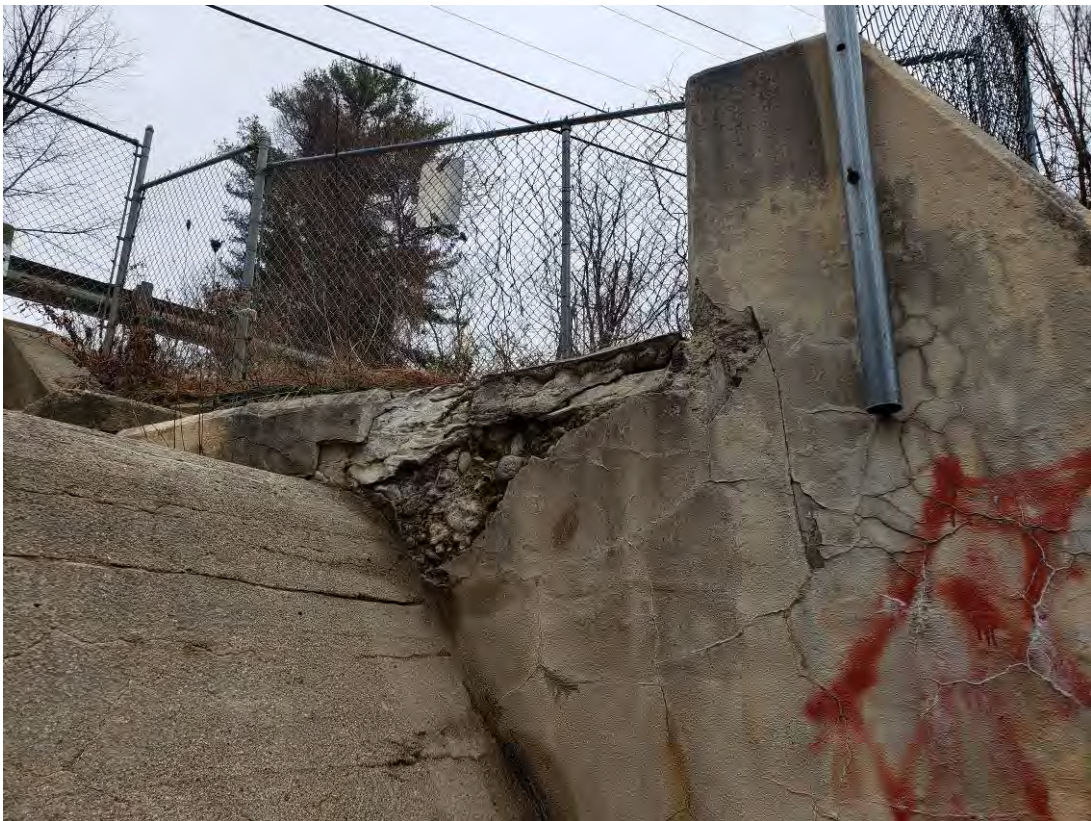
PHOTO 10: CONCRETE DEGRADATION TO LEFT ABUTMENT RETAINING WALL.

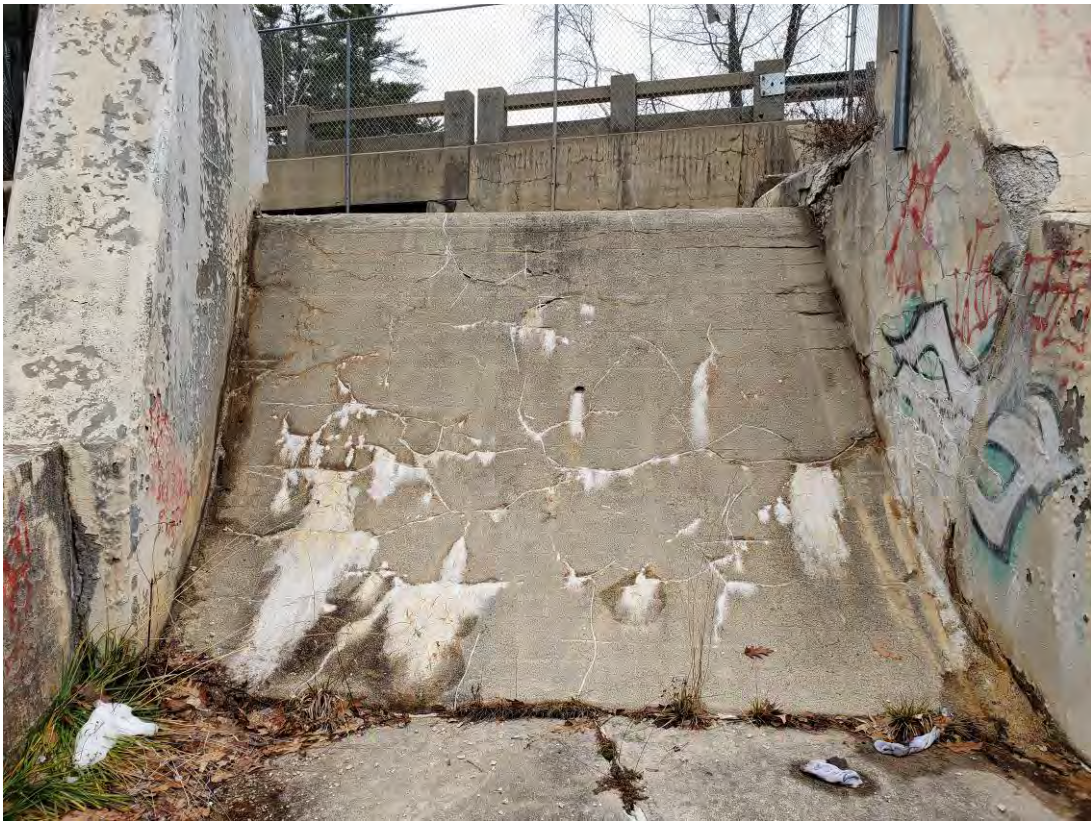
The left and right overflow spillways were found to be in poor overall condition. The actual overflow and downstream face of the gravity spillway structure was found to be in satisfactory condition, with only minor spalling and cracking of surface concrete (Photos 11 and 12). The sides of each spillway section where they abut the sluiceway structure have areas of concentrated concrete degradation due to flows impacting the sluiceway walls at the joints (Photos 13 and 14). Concrete at the intersection between left and right sluiceway walls and left and right spillway sections should be repaired by returning the walls to their original dimensions to prevent further loss of sound concrete. Additional concrete loss could expose embedded steel in the concrete, if present, or result in significant section loss that could result in loss of structural integrity of the concrete.

PHOTO 11: DOWNSTREAM FACE OF THE LEFT OVERFLOW SPILLWAY.

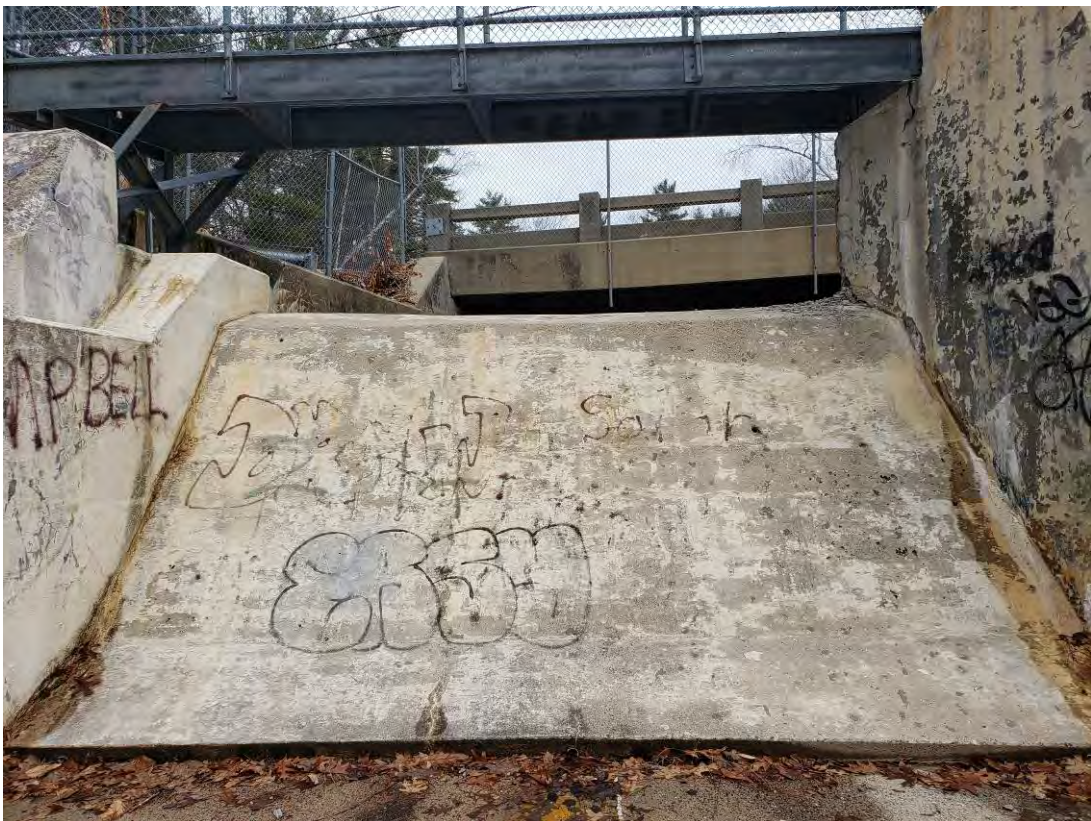
PHOTO 12: DOWNSTREAM FACE OF THE RIGHT OVERFLOW SPILLWAY.

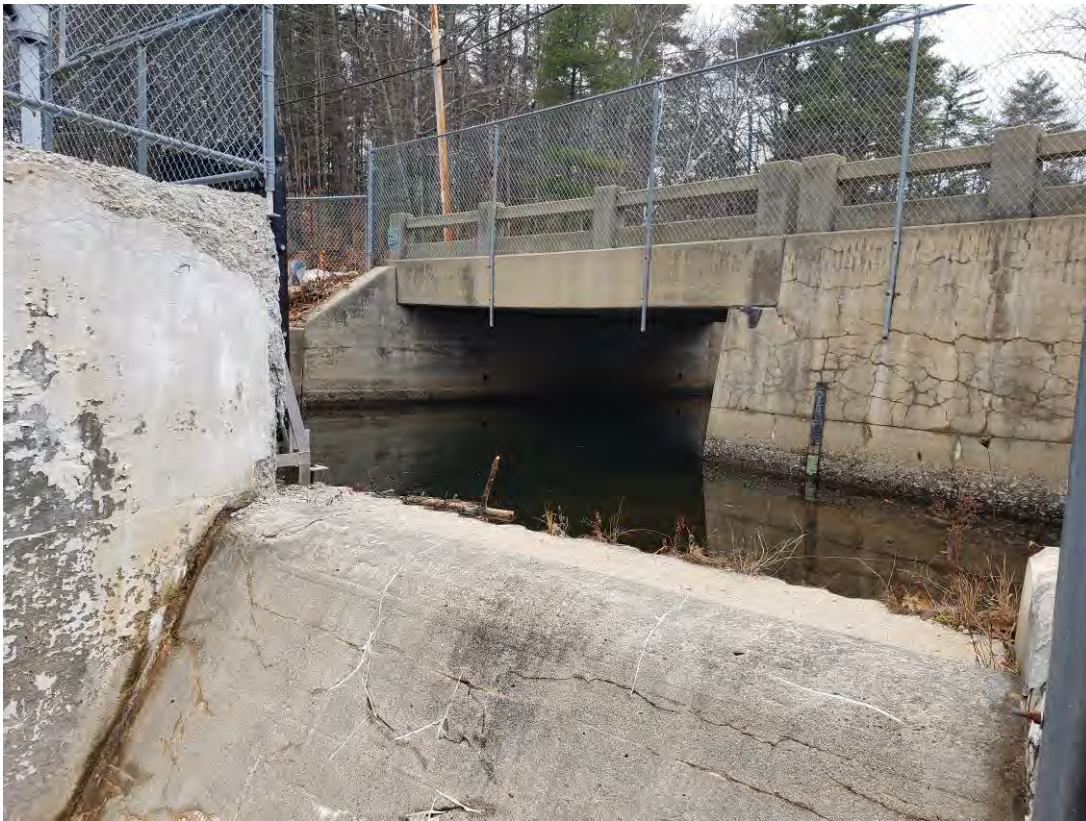
PHOTO 13: CONCRETE DEGRADATION ALONG LEFT SPILLWAY AND SLUICEWAY INTERFACE.

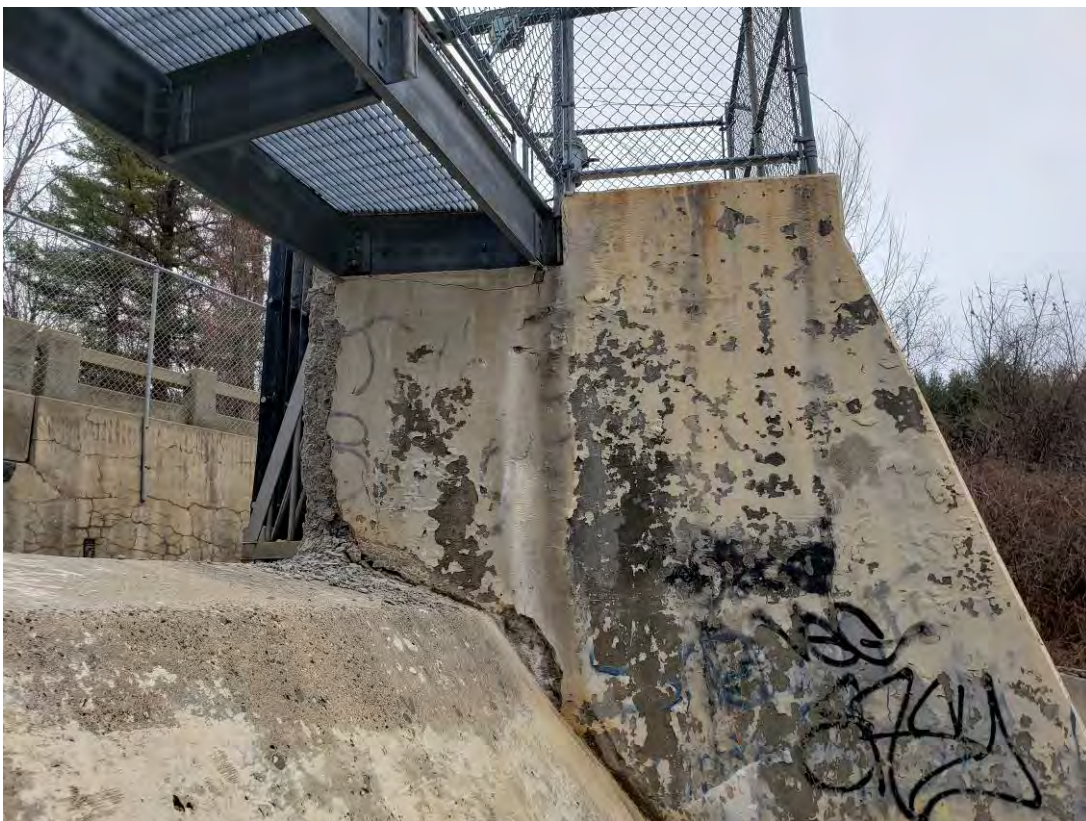
PHOTO 14: CONCRETE DEGRADATION ALONG RIGHT SPILLWAY AND SLUICEWAY INTERFACE.

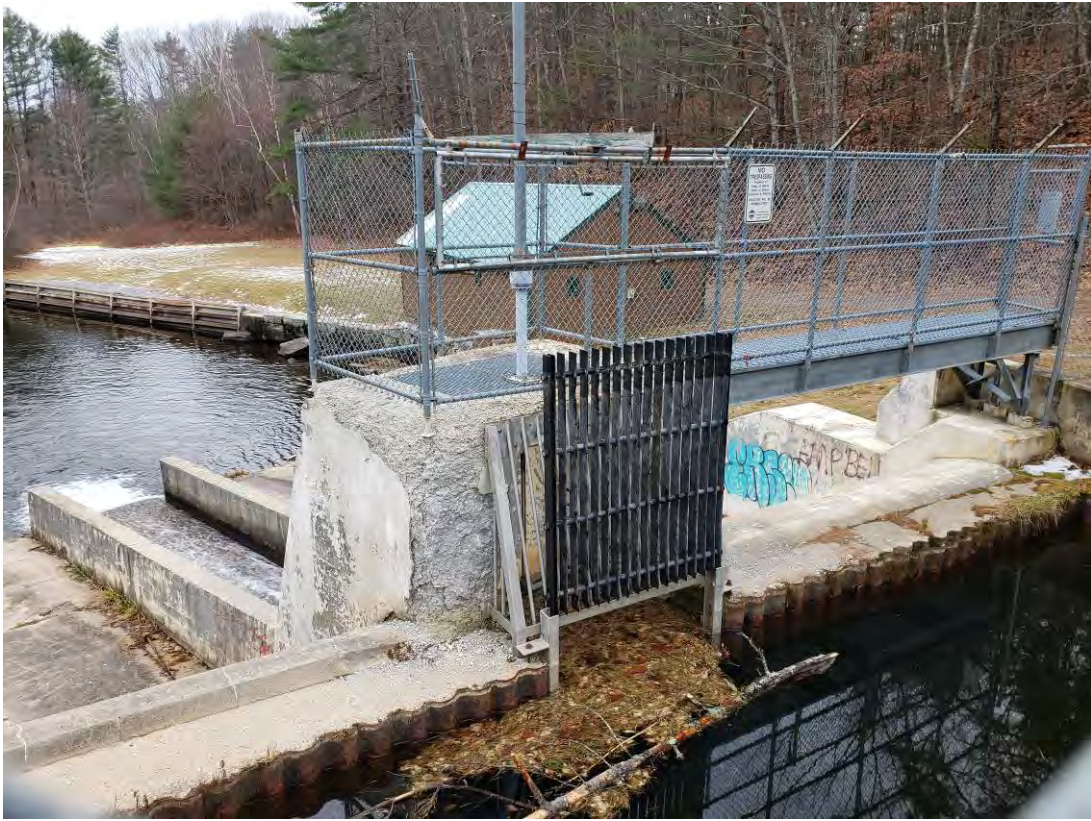
The crest of the spillways and upstream 2-foot-thick concrete added to the project in 1982 appears to be in good overall condition (Photo 15). However, the upstream sheet piling installed in 1982 with the concrete is in poor condition with significant corrosion through the sheet piling near the normal water line and separation from the 2-foot-thick concrete sections (Photo 16). The steel sheet piling condition below the water surface elevation is not known at this time and may still provide protection to the downstream concrete and act as a cut-off wall for seepage below the concrete dam. It is recommended before any repairs or modifications are design or made to the dam, that an assessment of the steel sheet piling be made. The findings from the assessment will allow for an informed approach to returning the sheet piling to an acceptable condition.

PHOTO 15: 2 FT THICK CONCRETE AND STEEL PILING.

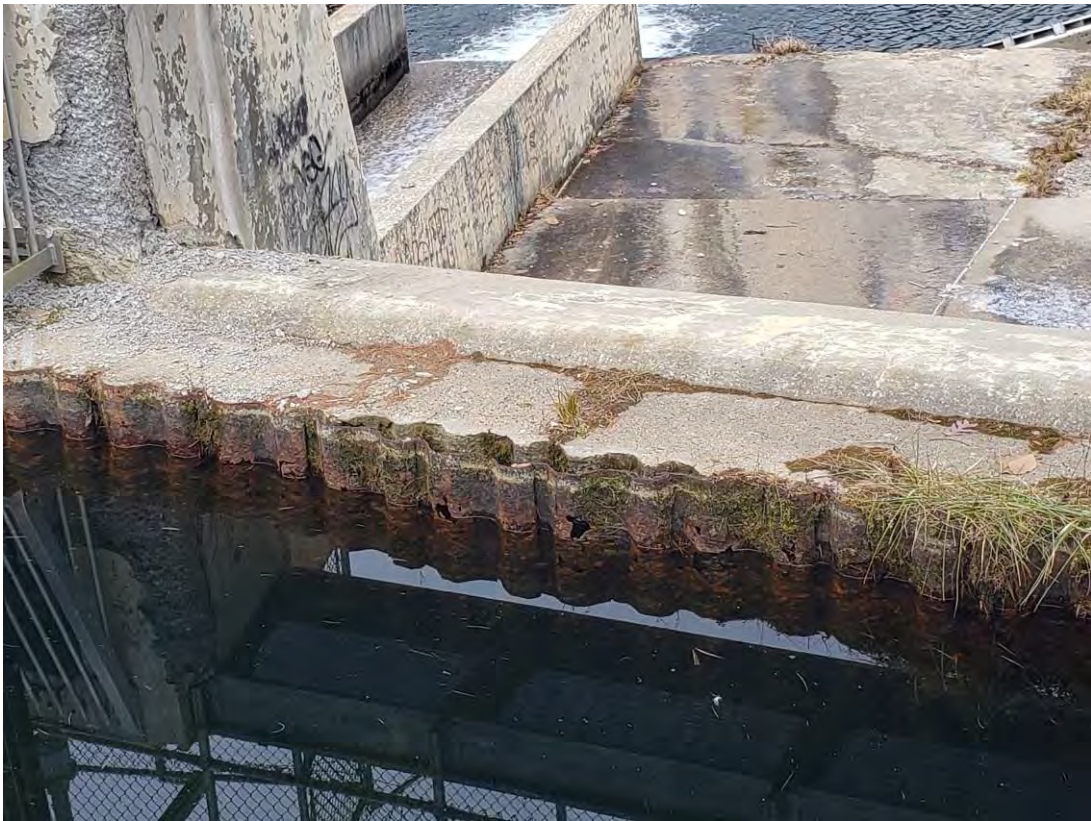
PHOTO 16: STEEL PILING CORROSION AND SEPARATION.

If the assessment of the steel sheet piling finds the submerged portions of the steel are in satisfactory condition, consideration should be given to repairing or replacing the steel sheet piling above and at the waterline. This repair will not only provide protection to spillway concrete from debris impact and freeze/thaw cycles, but also help to prevent any seepage between the existing sheet piling along the concrete interface that could then travel below the dam. It is not known whether the existing separated portion of the sheet piling upstream of the right overflow spillway has rotated or not, but this area could currently allow reservoir water to bypass the seepage cut-off the piling is providing. Kleinschmidt recommends at a minimum that the sheet piling at and above the waterline be either replaced or reinforced with new sheet piling and re-anchored as necessary to the existing concrete.

1. At a minimum, repair the steel sheet pile cut-off wall along the upstream face of the dam.
 - a. This would include either replacing or repairing the damaged, corroded, and displaced sections of the sheet piling at and above the normal water line.

- b. The new sheet piling will protect the existing concrete from damage from debris and exposure to normal weather cycles, potentially prevent seepage from bypassing the cut-off wall, and extend the lifespan of the project.

- c. The extent of the repair below the normal water line will be determined based on the assessment made in Priority 1 Recommendation #3.
2. Demolition of the overflow spillway crests down to the desired maximum water surface elevation.

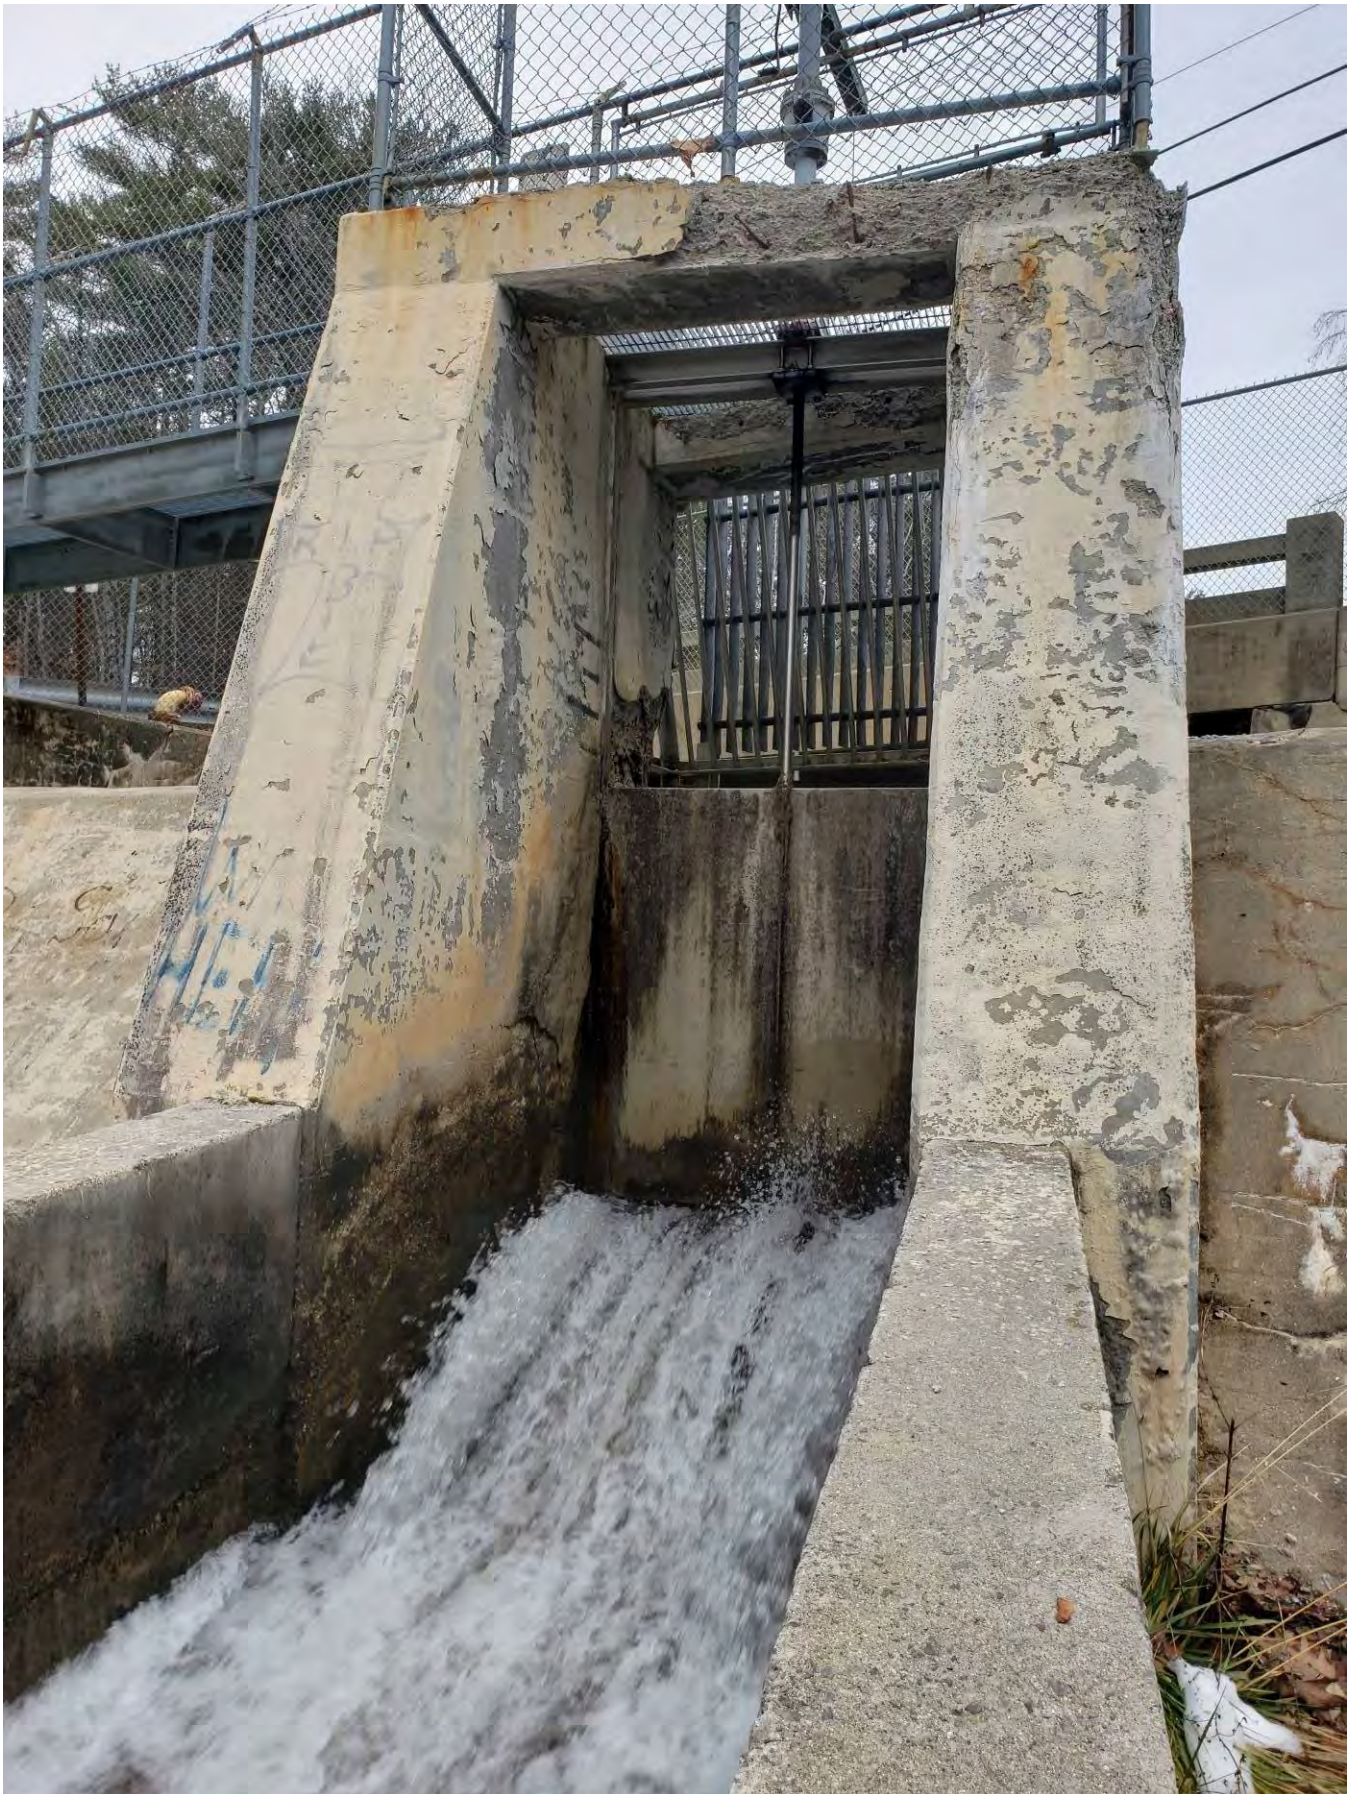
The sluiceway was found to be in unsatisfactory overall condition. The vertical lift gate controlling the flows at the Dam and upstream trashrack and grates were found to be in good condition (Photo 17). As discussed in Section 3.3 above, the upstream faces of the sluiceway's concrete piers are in poor condition, as well as the sluiceway operator's concrete slab (Photos 17, 18, and 19). Additionally, the interior portions of both piers near the reservoir water line have deteriorated to the point that steel reinforcing has been exposed (Photos 20 and 21). The sluiceway gate's concrete side slots have significant concrete deterioration from typical flows, leakage flows around the gate, and normal gate operation. It is recommended that the interior portions of the sluiceway piers be resurfaced to the original condition to prevent further loss of sound concrete and negative impacts to operation of the sluice gate.

PHOTO 17: SLUICEWAY VERTICAL LIFT GATE AND CONCRETE DEGRADATION.

In addition to modifying the fixed spillway crest elevation to reduce operational needs, consideration should be given to demolishing the existing sluiceway gate structure. The current gate structure requires repairs to ensure future operation. In lieu of repairs, costs could be diverted to reconstructing the demolished sluiceway structure to act as a stoplog controlled structure. The stoplogs could be set and adjusted to allow desired flows and pond elevations, with minimal operator intervention throughout the year and lower maintenance costs compared to the sluiceway structure.
