INSPECTION REPORT

PANTHER POND DAM
MEMA No. 122

**Department of Inland Fisheries and Wildlife
Augusta, Maine**

March 2020

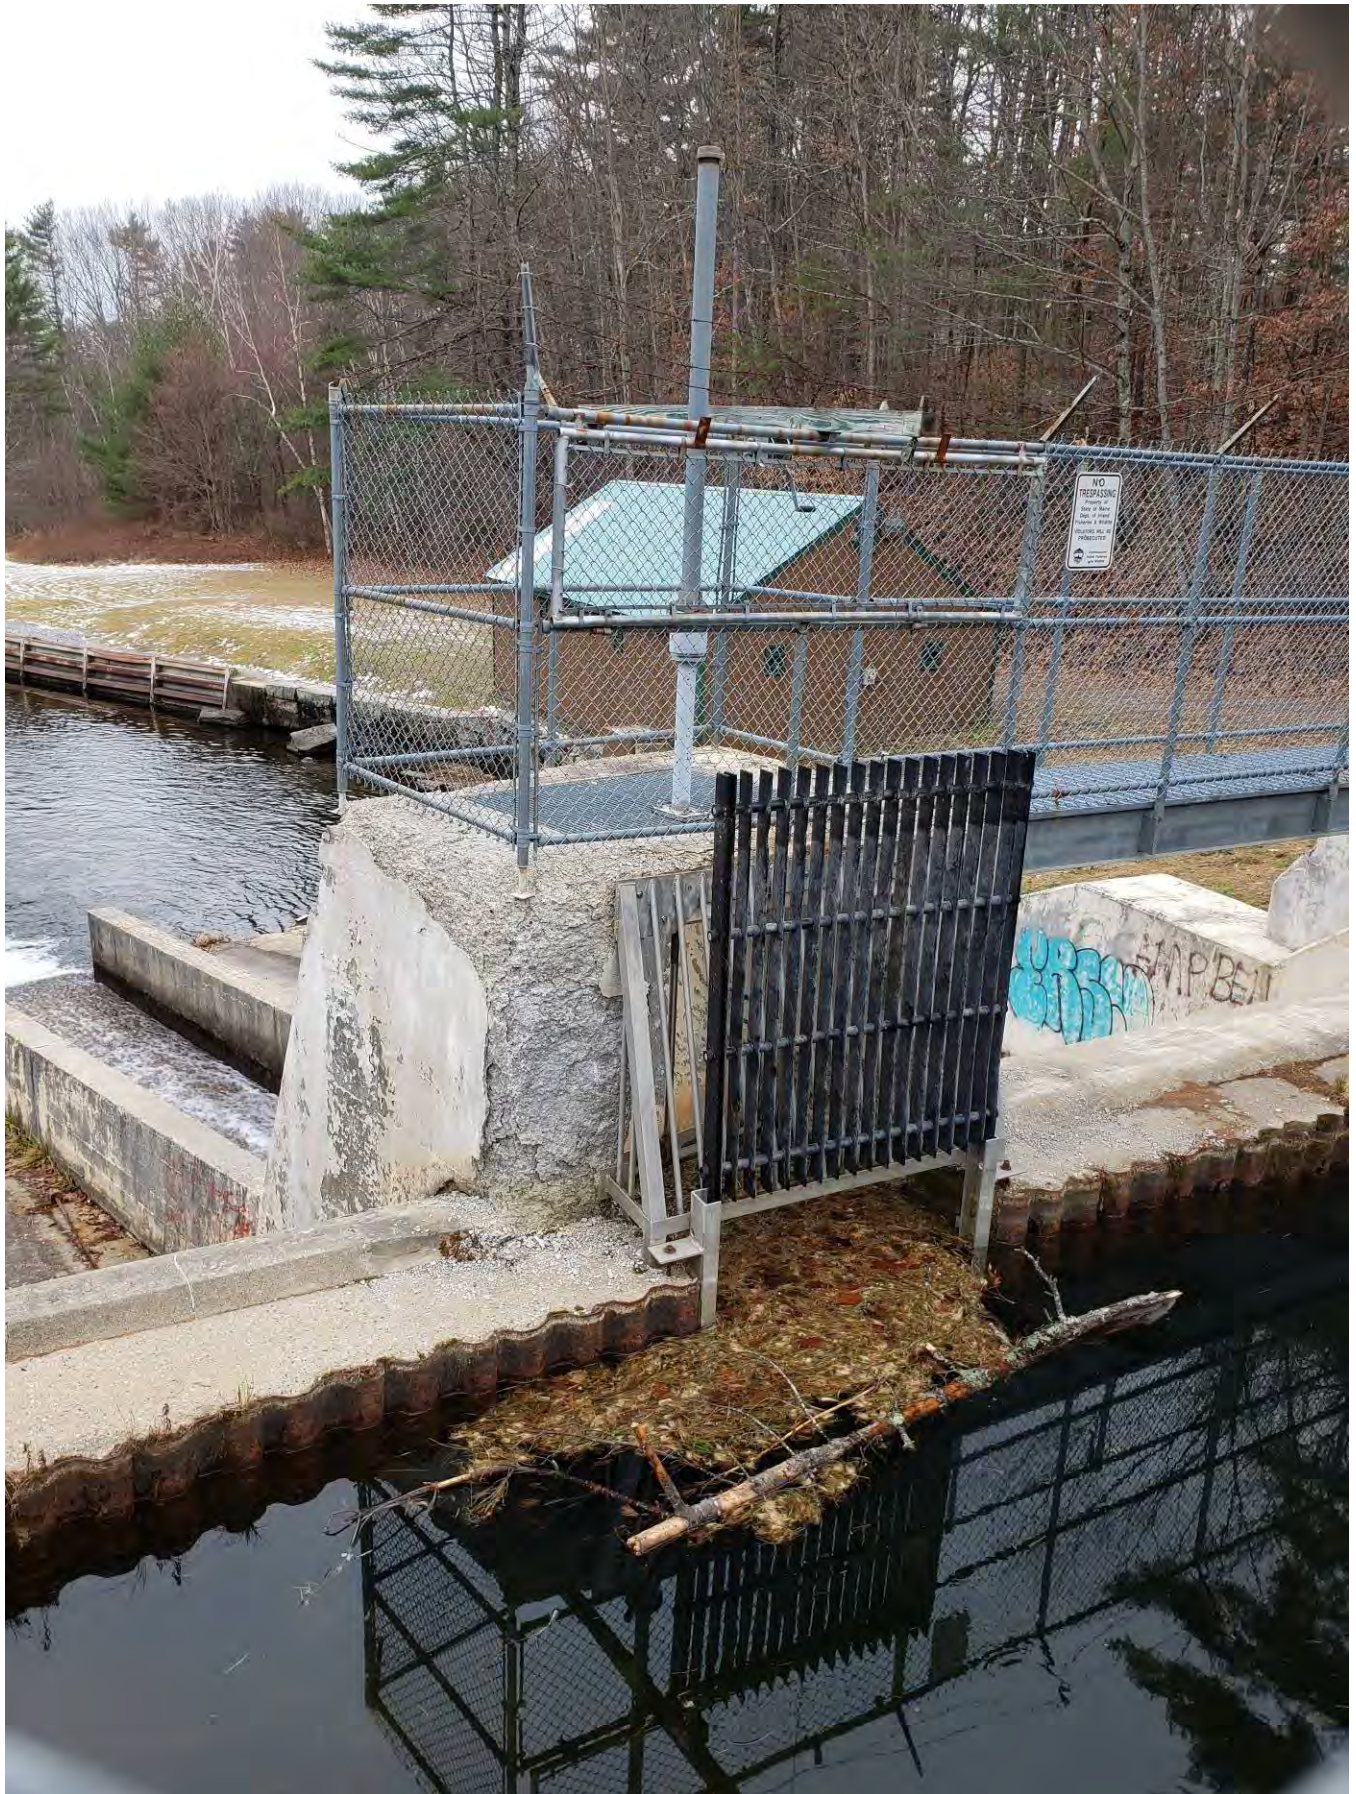
PHOTO 18: CONCRETE DEGRADATION TO LEFT SLUICWAY WALL.

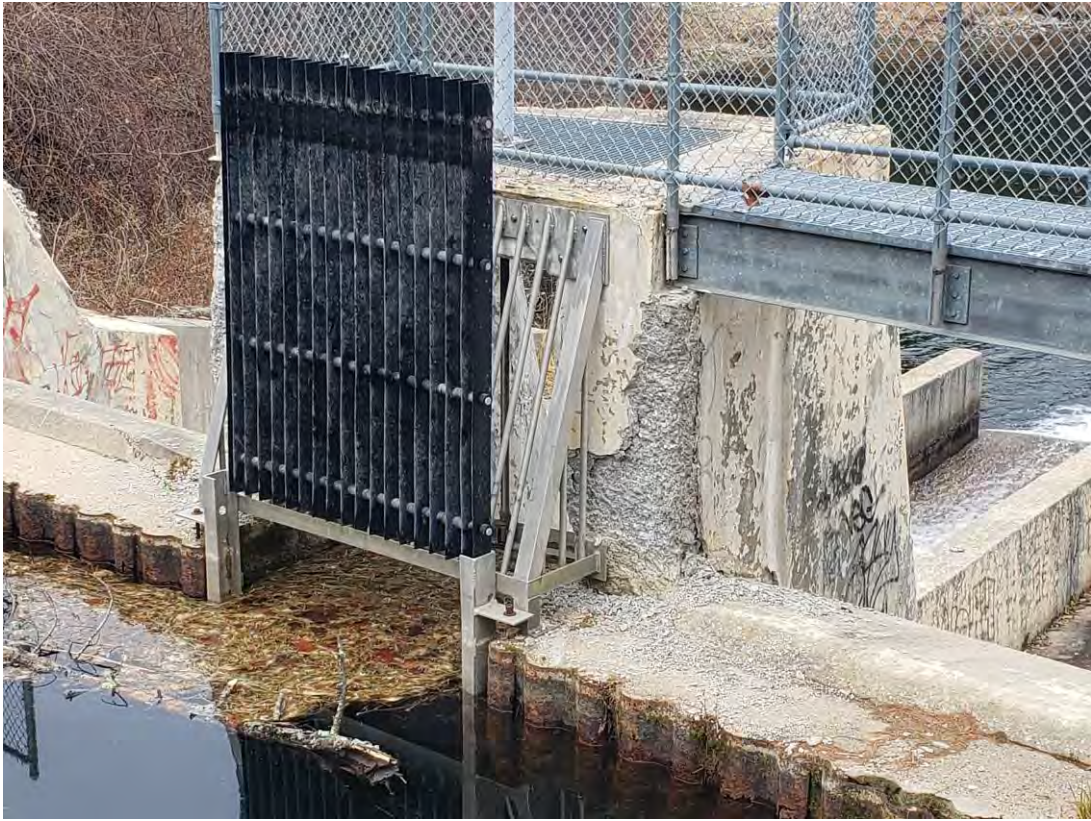
PHOTO 19: CONCRETE DEGRADATION TO RIGHT SLUCEWAY WALL.

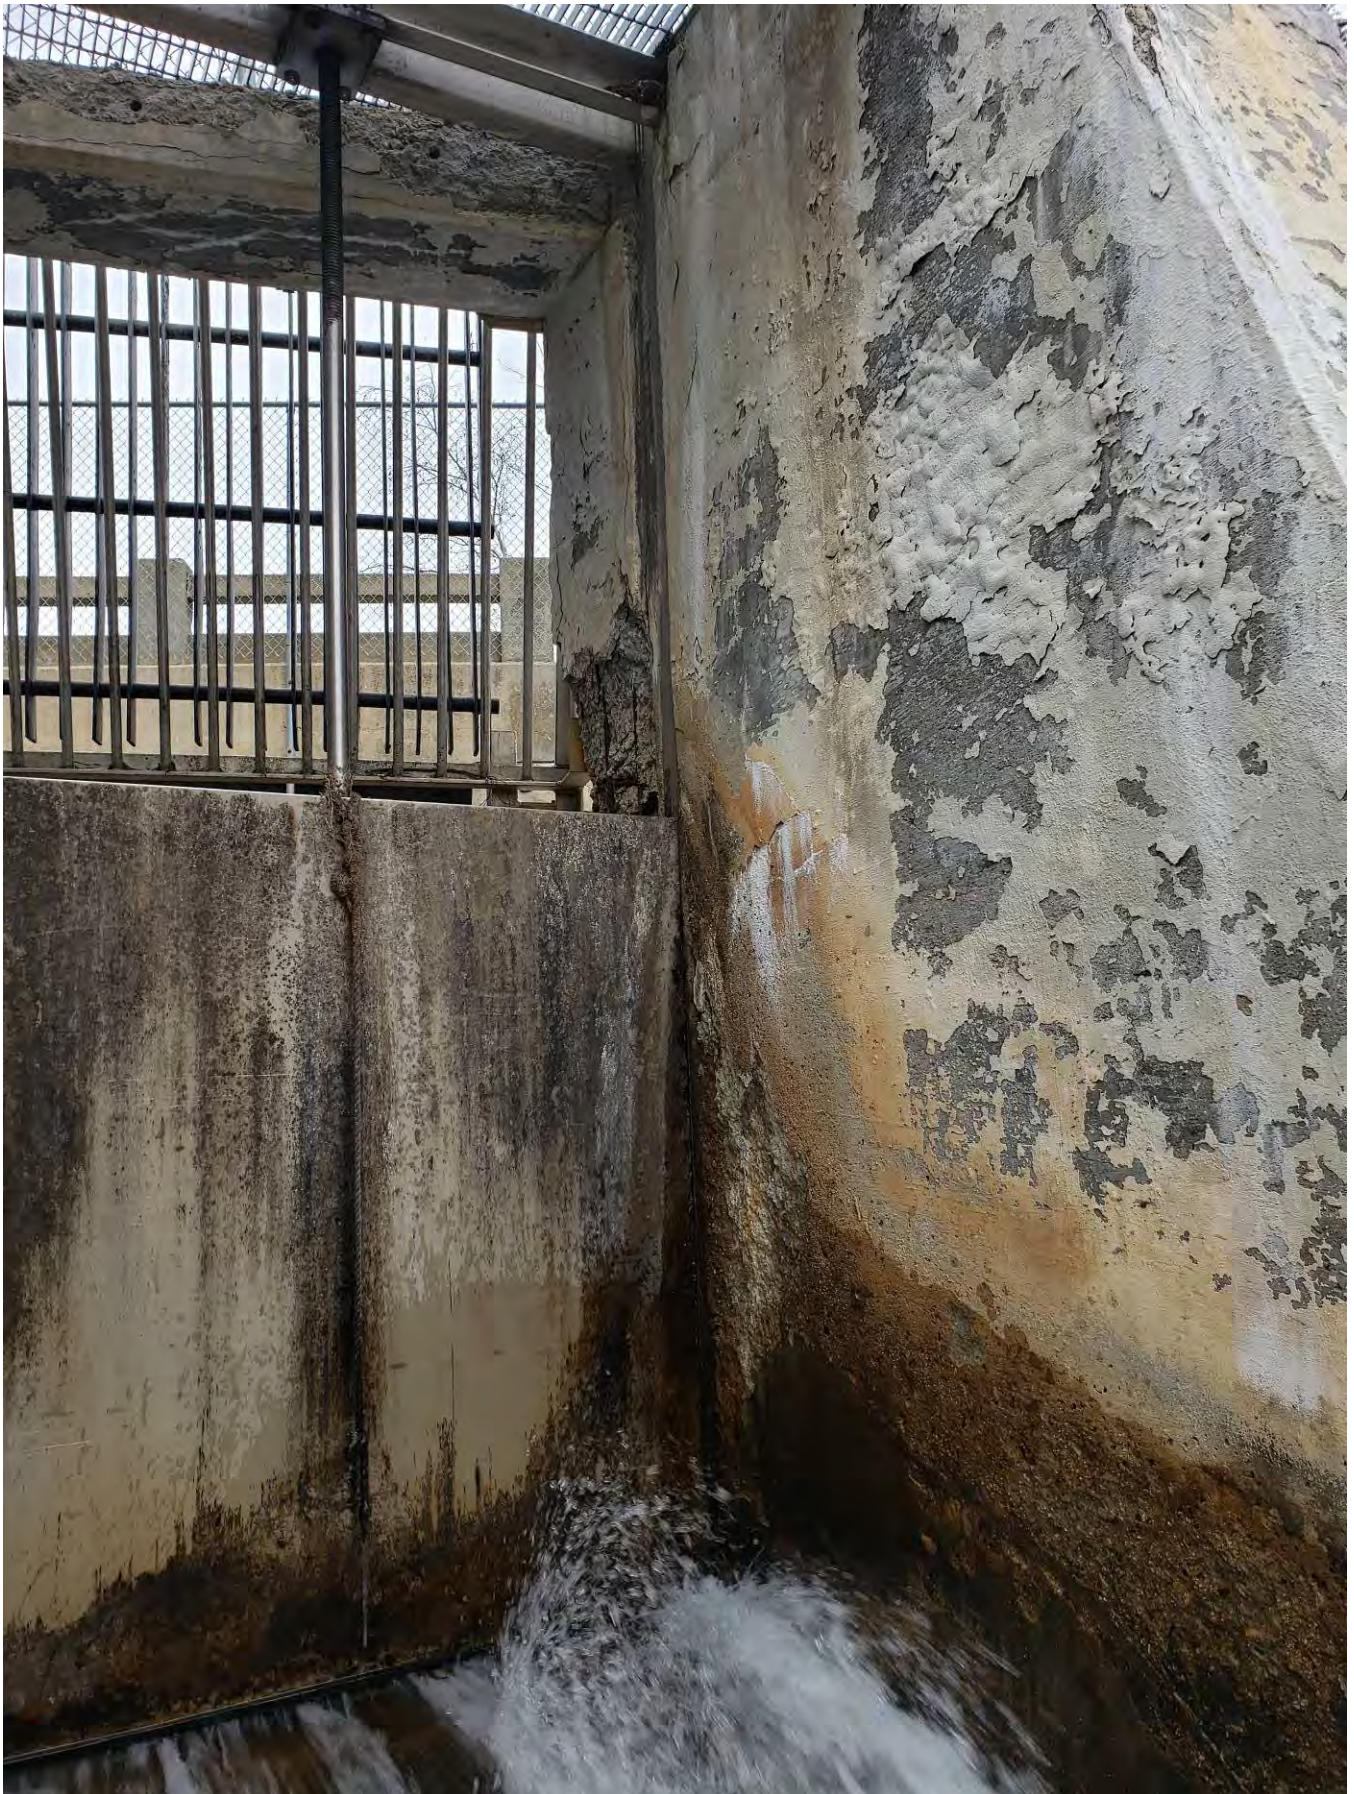
PHOTO 20: EXPOSED REINFORCING STEEL IN LEFT SLUICEWAY WALL.

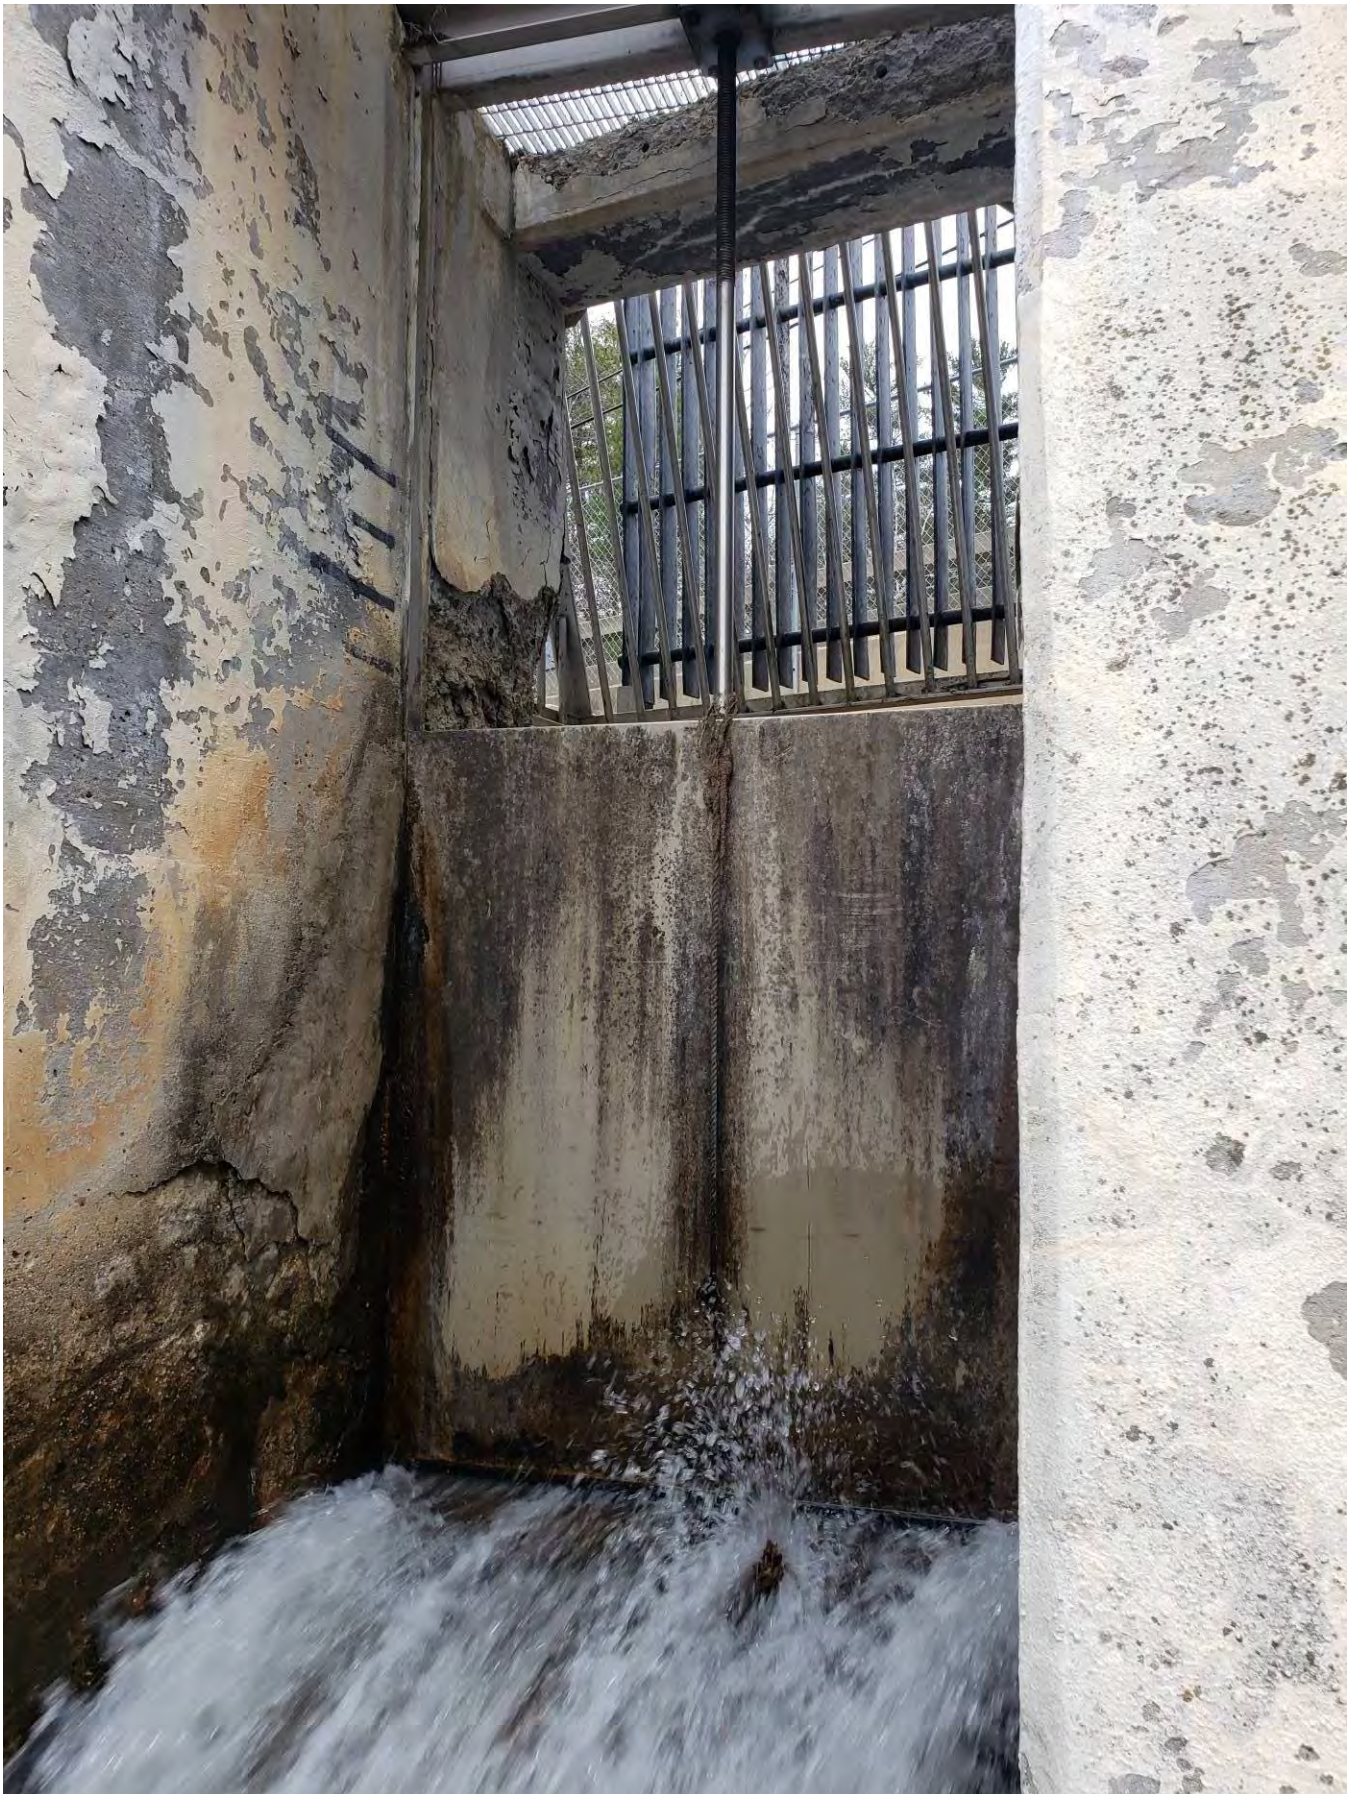
PHOTO 21: EXPOSED REINFORCING STEEL IN RIGHT SLUICWAY WALL.

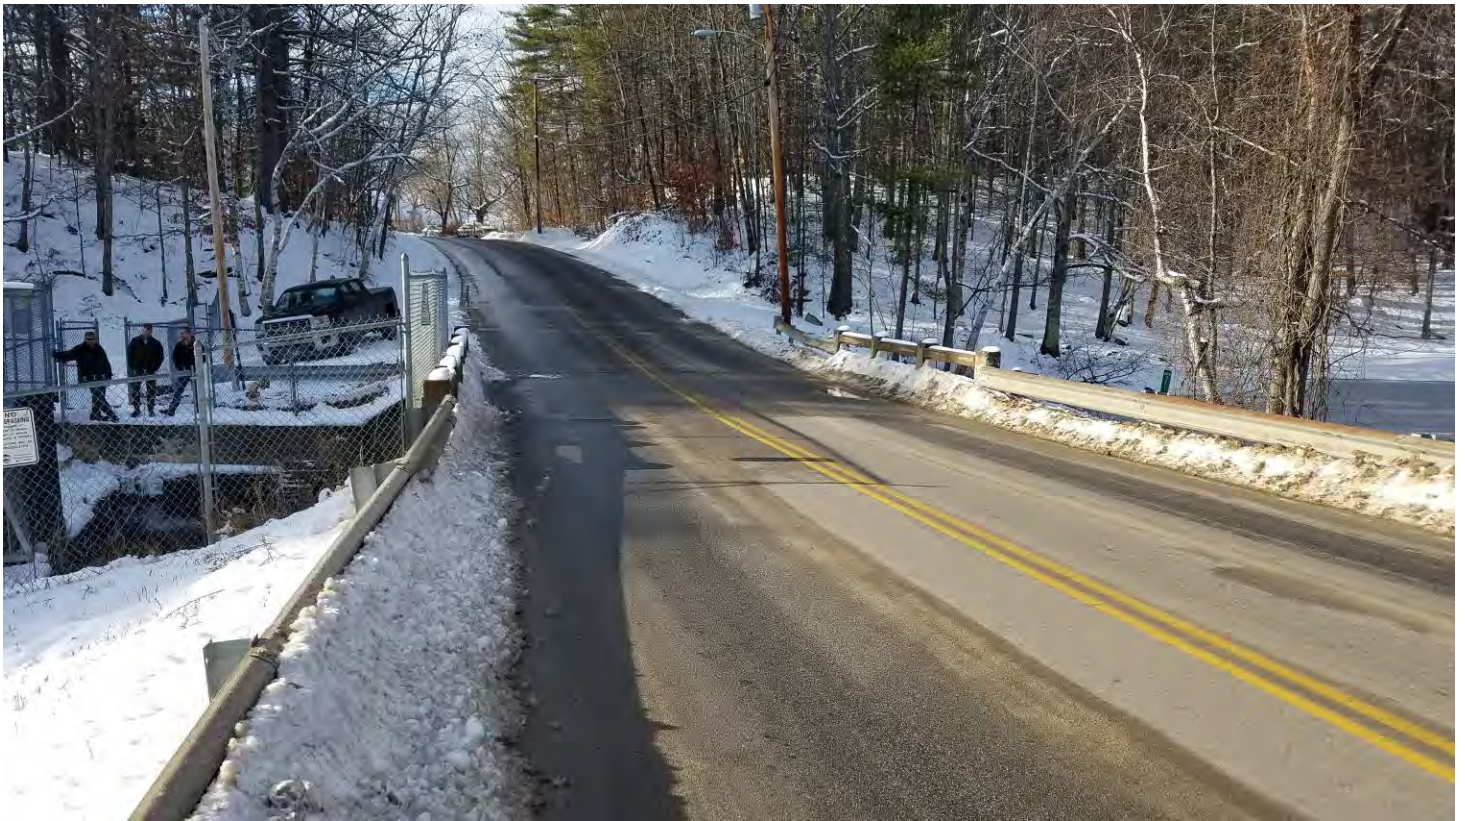
The right abutment consists of an earthen embankment that appears to be natural grade and built-up embankment for the Mill Street roadway, similar to the left abutment (Photo 22). The embankment portion of the right abutment is in good overall condition. The inspection did not note any signs of instability, settlement, wet spots or seepage. The right abutment embankment is also the location of the fishway building's access road, which is maintained and kept free of vegetation (Photo 23).

PHOTO 22: MILL STREET BRIDGE AND RIGHT ABUTMENT EMBANKMENT.

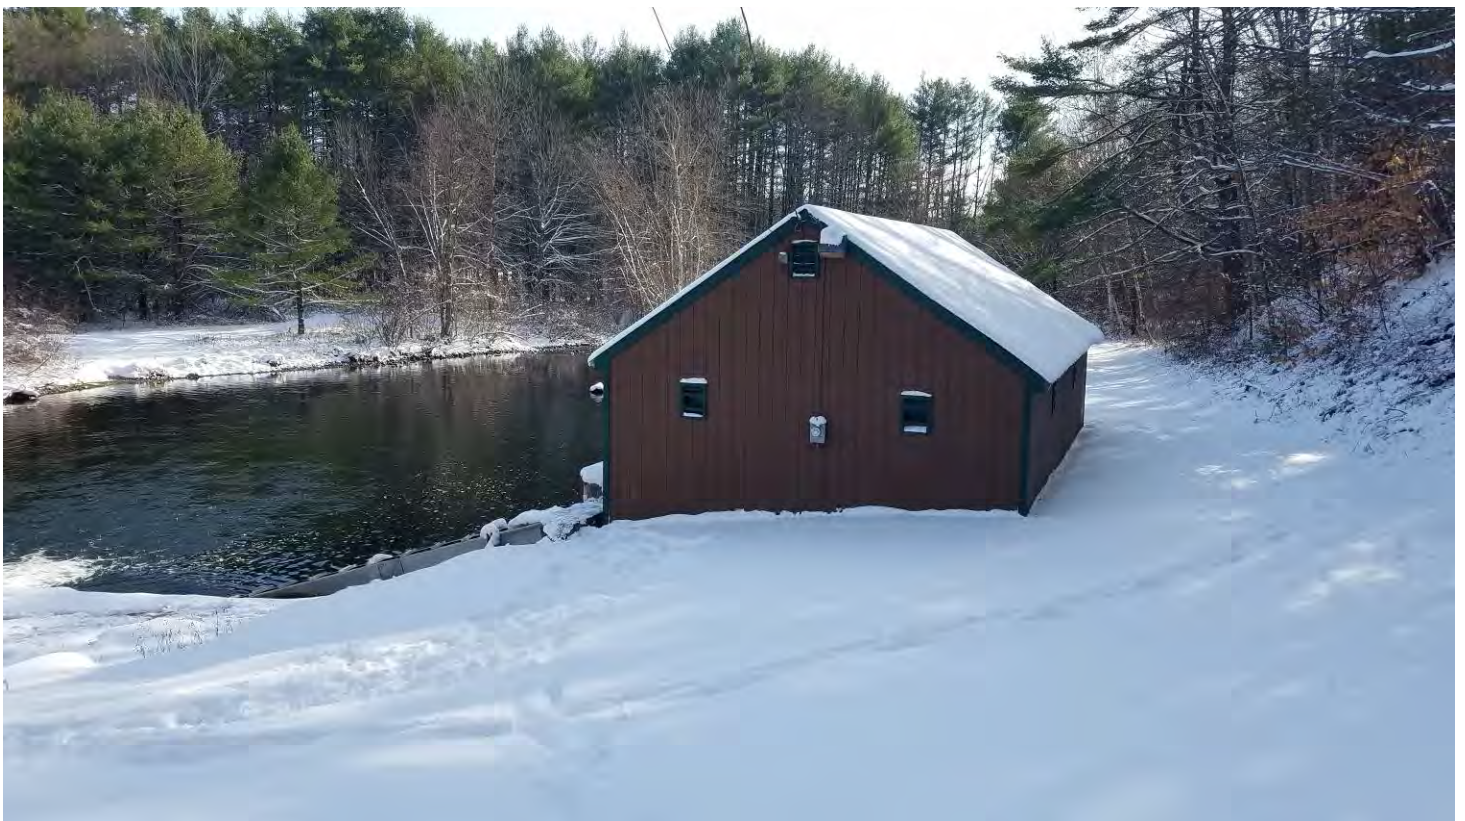
PHOTO 23: FISHWAY BUILDING AND ACCESS ROAD (UNDER SNOW COVER).

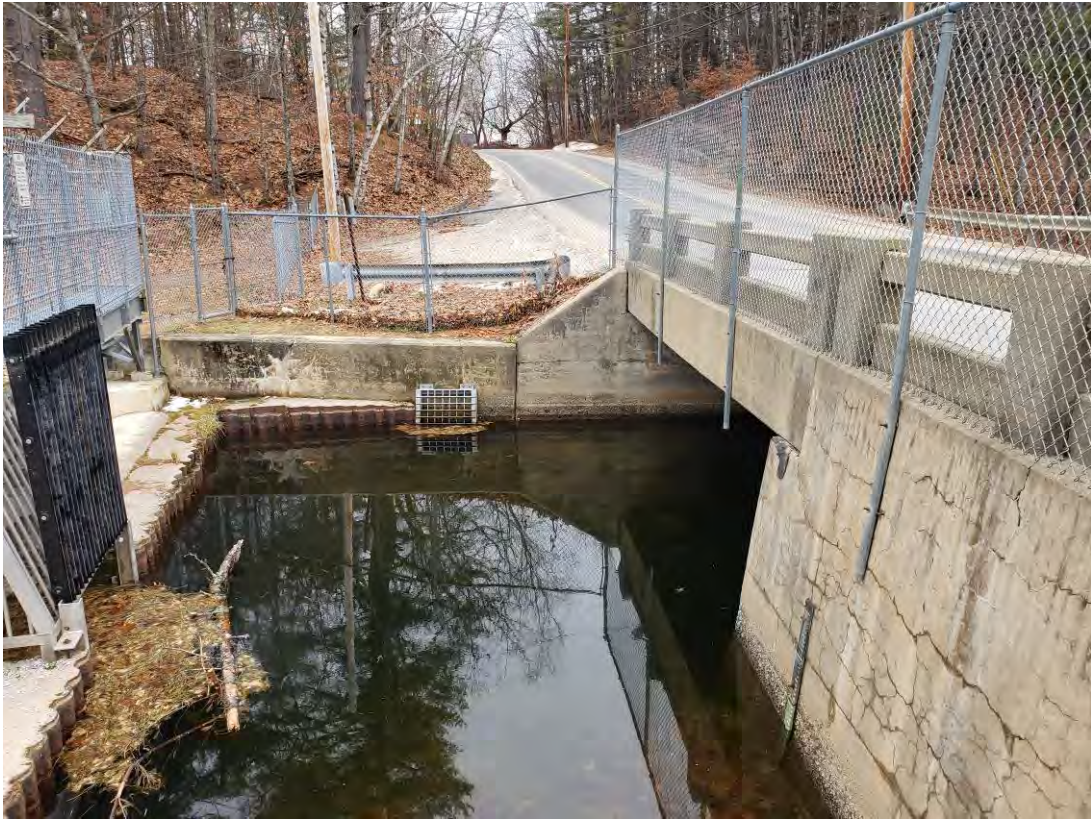
The embankment at the right overflow spillway interface is retained by concrete retaining walls at the Mill Street Bridge, Dam, and downstream apron (Photos 24 and 25). The concrete retaining wall between the bridge and dam is in good overall condition. A concrete cutoff wall extending off the Dam and into the right abutment embankment was observed to have a small sinkhole formed just upstream of the wall (Photo 26). The sinkhole reportedly has been

PHOTO 24: RIGHT ABUTMENT RETAINING WALL UPSTREAM OF DAM.

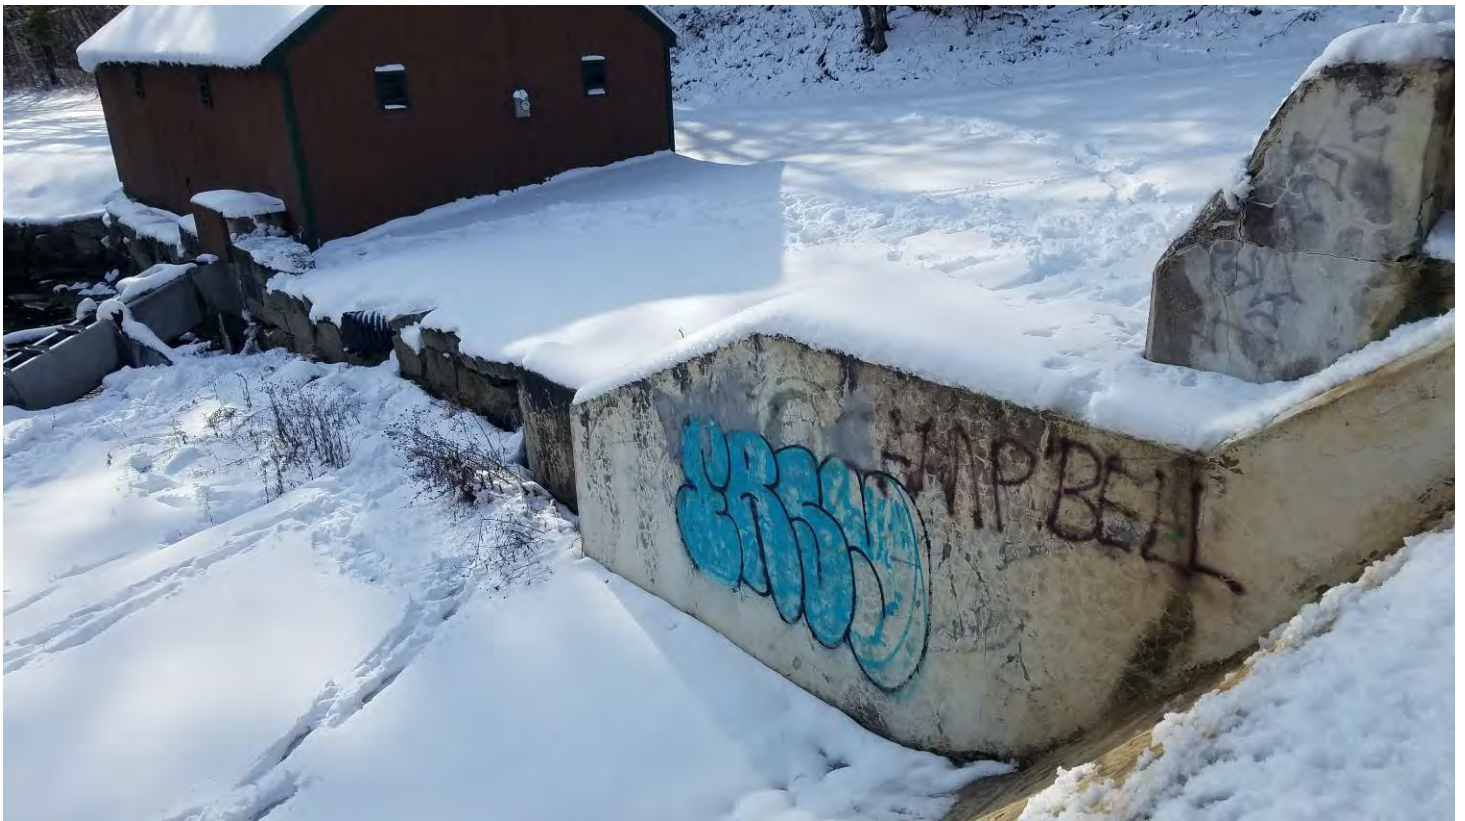
PHOTO 25: RIGHT ABUTMENT RETAINING WALL DOWNSTREAM OF DAM.

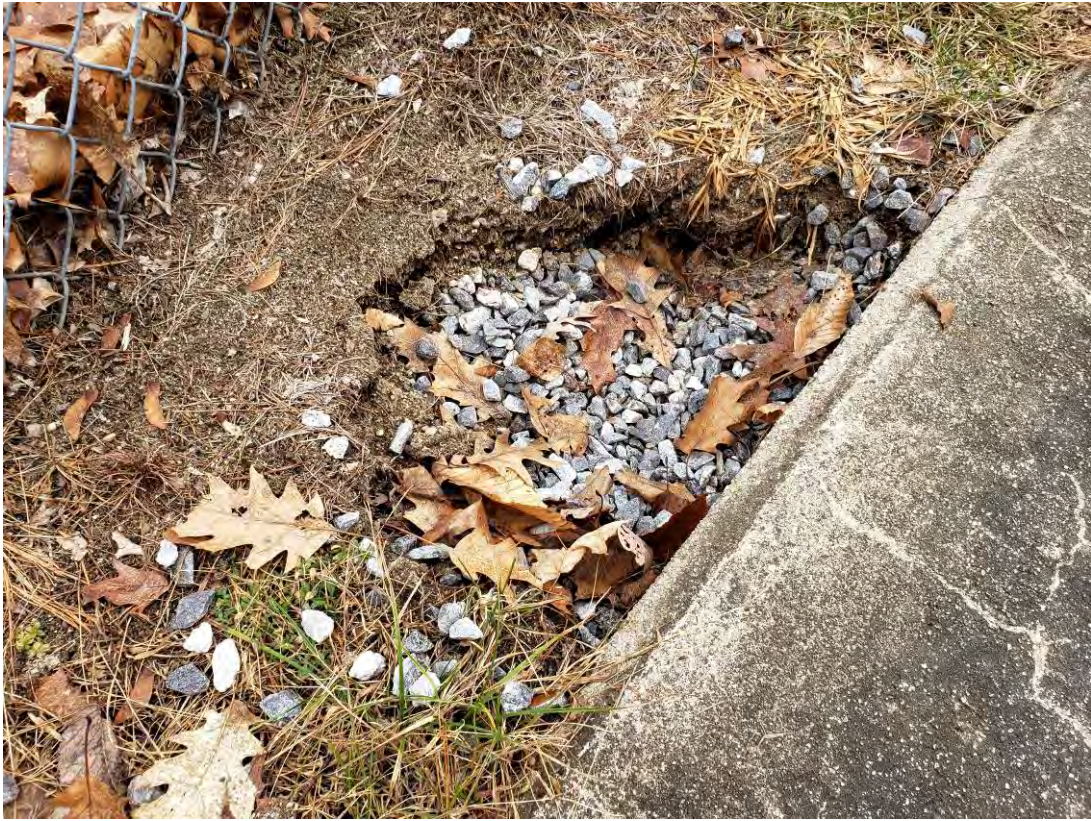
PHOTO 26: SINKHOLE UPSTREAM OF RIGHT ABUTMENT CUTOFF WALL.

The significant seepage issues through the right abutment requires additional information in order to properly diagnose any on-going issues that could threaten the integrity or service life of the Dam. If left unchecked, a soil pipe could form over time, increasing in size as soil is transported by seepage from within the abutment to the downstream tailrace. Without intervention, this could lead to an eventual collapse of the right abutment embankment, structural failure of the right abutment concrete retaining walls due to loss of soil support, and potential loss of the reservoir. As repairs in 2011 downstream of the right abutment cutoff wall did not perform as intended, consideration should be given to addressing issues at the source of seepage entering the Dam's embankment.

It is recommended, during periods of low flow and normal reservoir elevations, that dye testing upstream of the dam within the reservoir be completed. The area of focus should be between the bridge and dam along the right abutment, as well as upstream of the right overflow spillway. Dye testing is a low-cost approach to determine the location of seepage entering the right abutment embankment from the reservoir. Mapping the location of seepage into the abutment would provide locations for sealing off the upstream end of seepage paths to reduce or eliminate the current seepage issues.

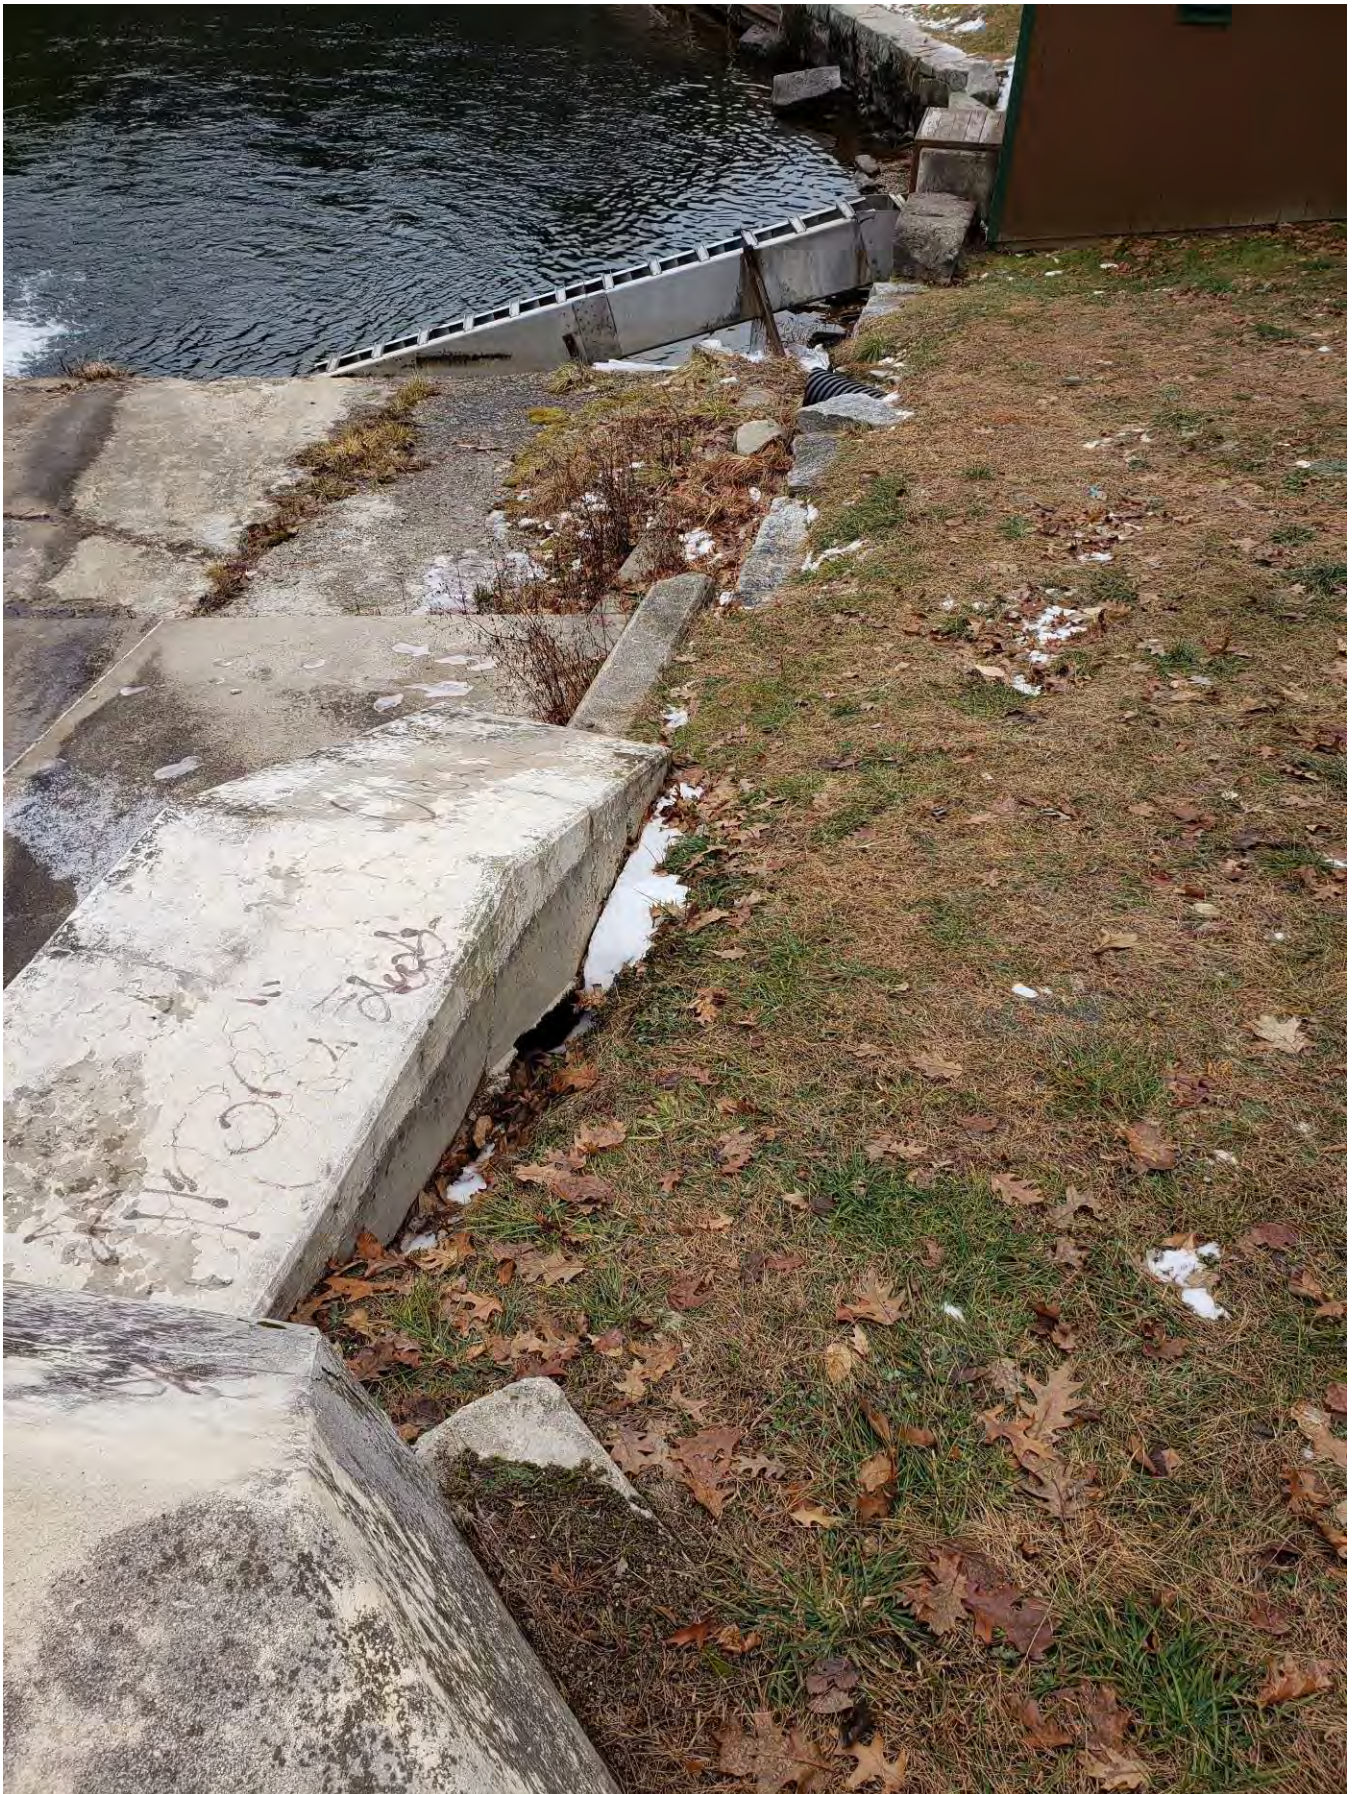
PHOTO 27: SEEPAGE AND LOSS OF SOIL ALONG RIGHT ABUTMENT DOWNSTREAM RETAINING WALL (1).

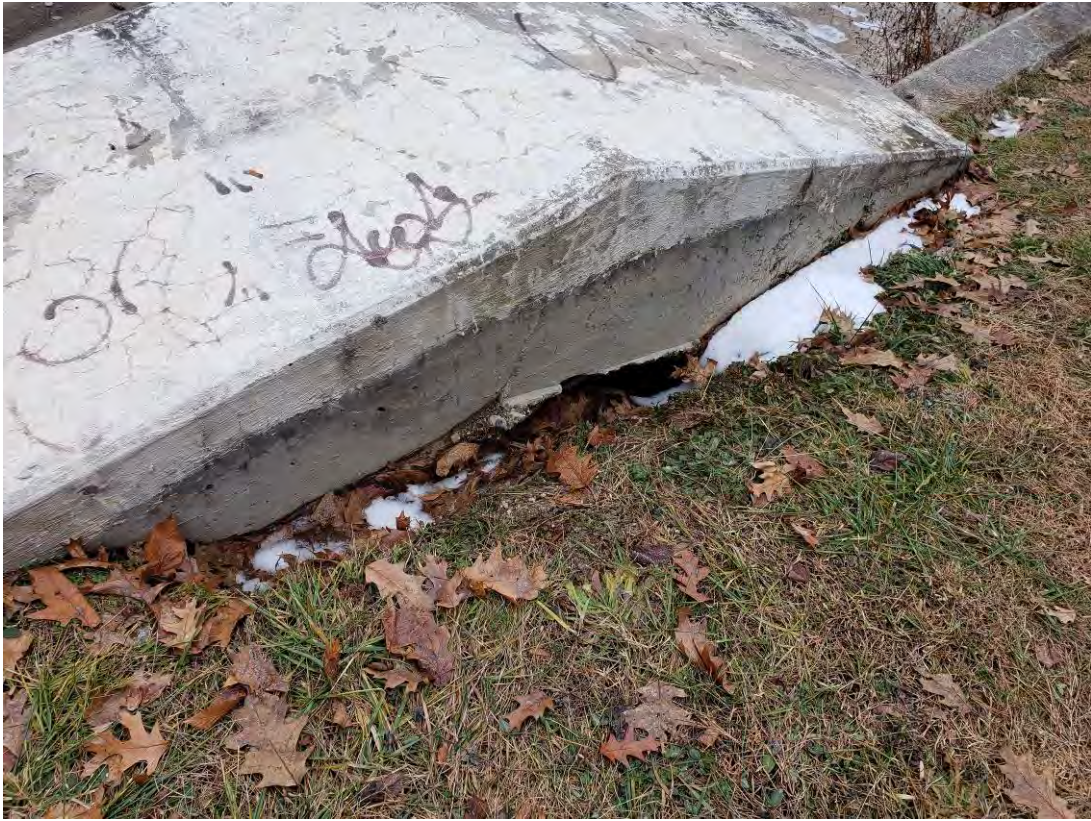
PHOTO 28: SEEPAGE AND LOSS OF SOIL ALONG RIGHT ABUTMENT DOWNSTREAM RETAINING WALL (2).

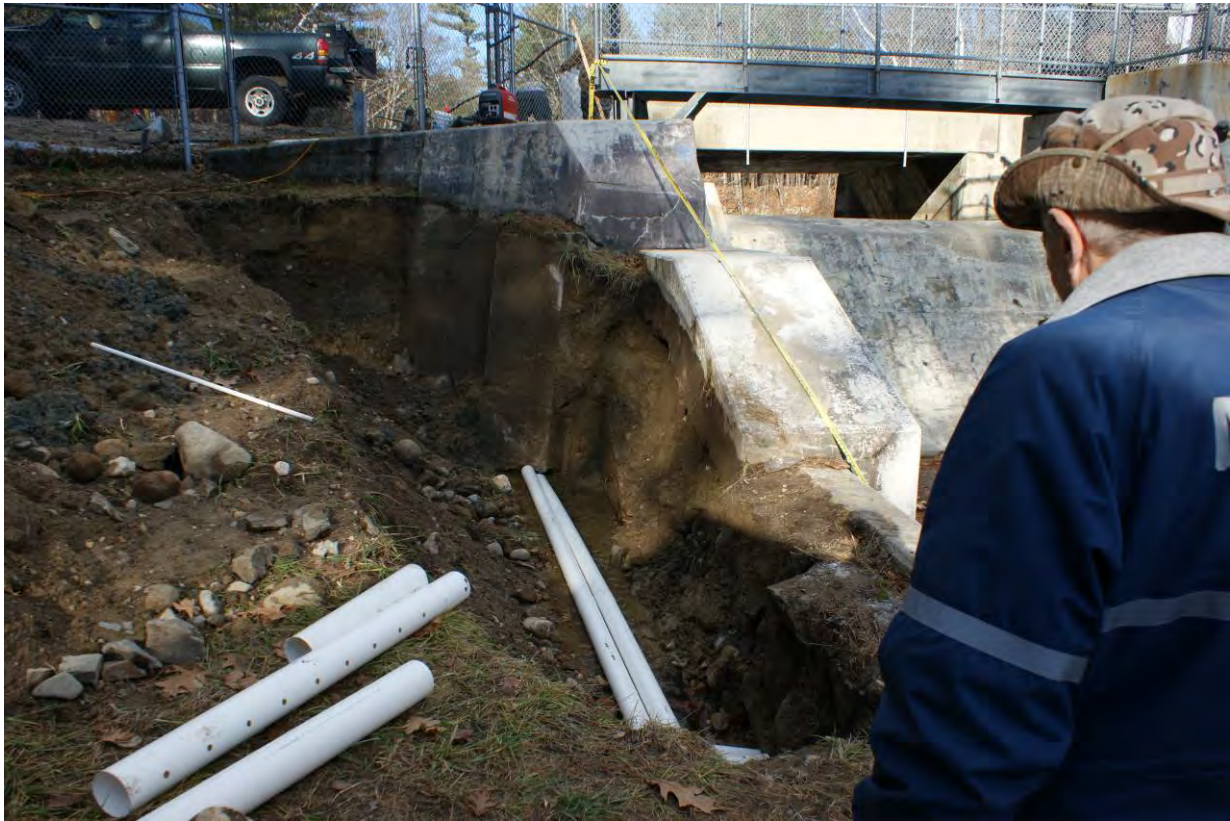
PHOTO 29: REPAIR IN 2011 DOWNSTREAM OF RIGHT ABUTMENT CUTOFF WALL.

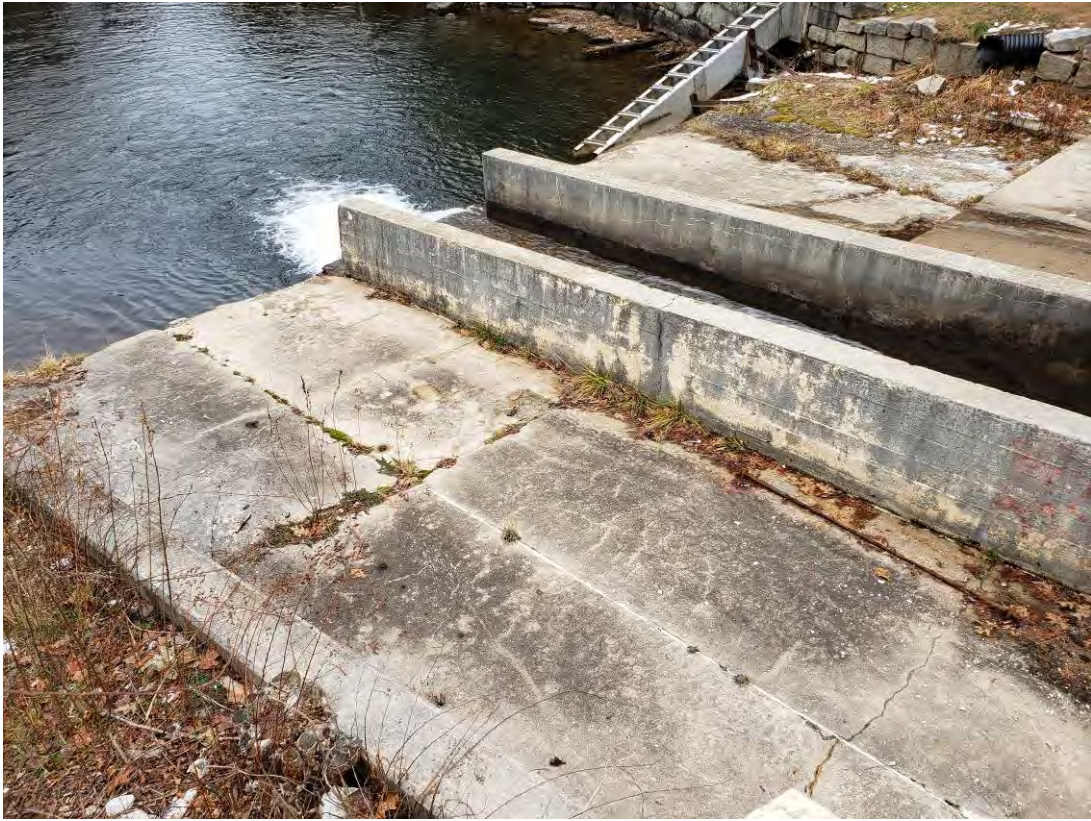
The spillway apron for the Dam was found to be in good overall condition. The inspection team did not note significant cracking or settlement along the entire length of the unreinforced concrete slab. Some minor cracking and surface erosion, specifically along the sluiceway bottom channel where flows pass most frequent, was noted (Photos 30, 31, and 32). These minor items

PHOTO 30: APRON DOWNSTREAM OF LEFT OVERFLOW SPILLWAY.

do not require attention at this time. Some vegetation was noted in slab construction joints and cracks. Though not an issue at this time, consideration should be given to managing the vegetation so medium to large sized brush do not begin to establish themselves. The root systems of medium to large vegetation could separate joints or worsen cracks if left unmaintained.

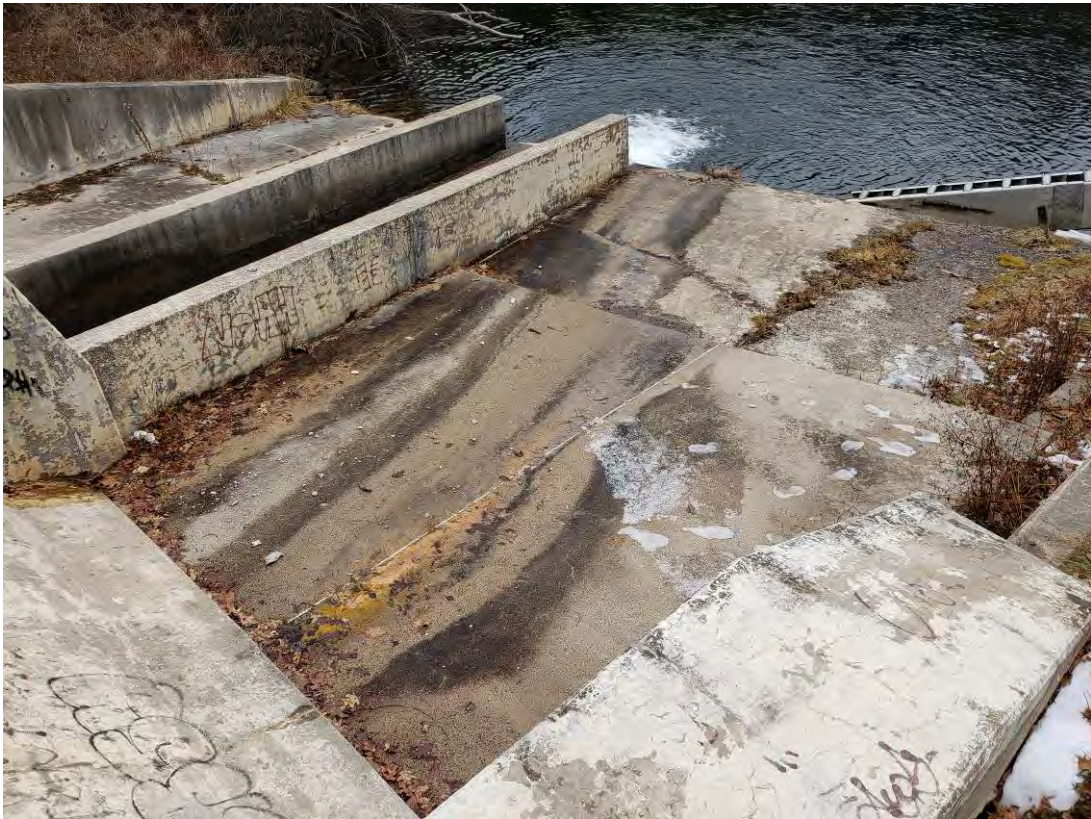
PHOTO 31: APRON DOWNSTREAM OF RIGHT OVERFLOW SPILLWAY.
