INSPECTION REPORT

PANTHER POND DAM
MEMA No. 122

**Department of Inland Fisheries and Wildlife
Augusta, Maine**

March 2020

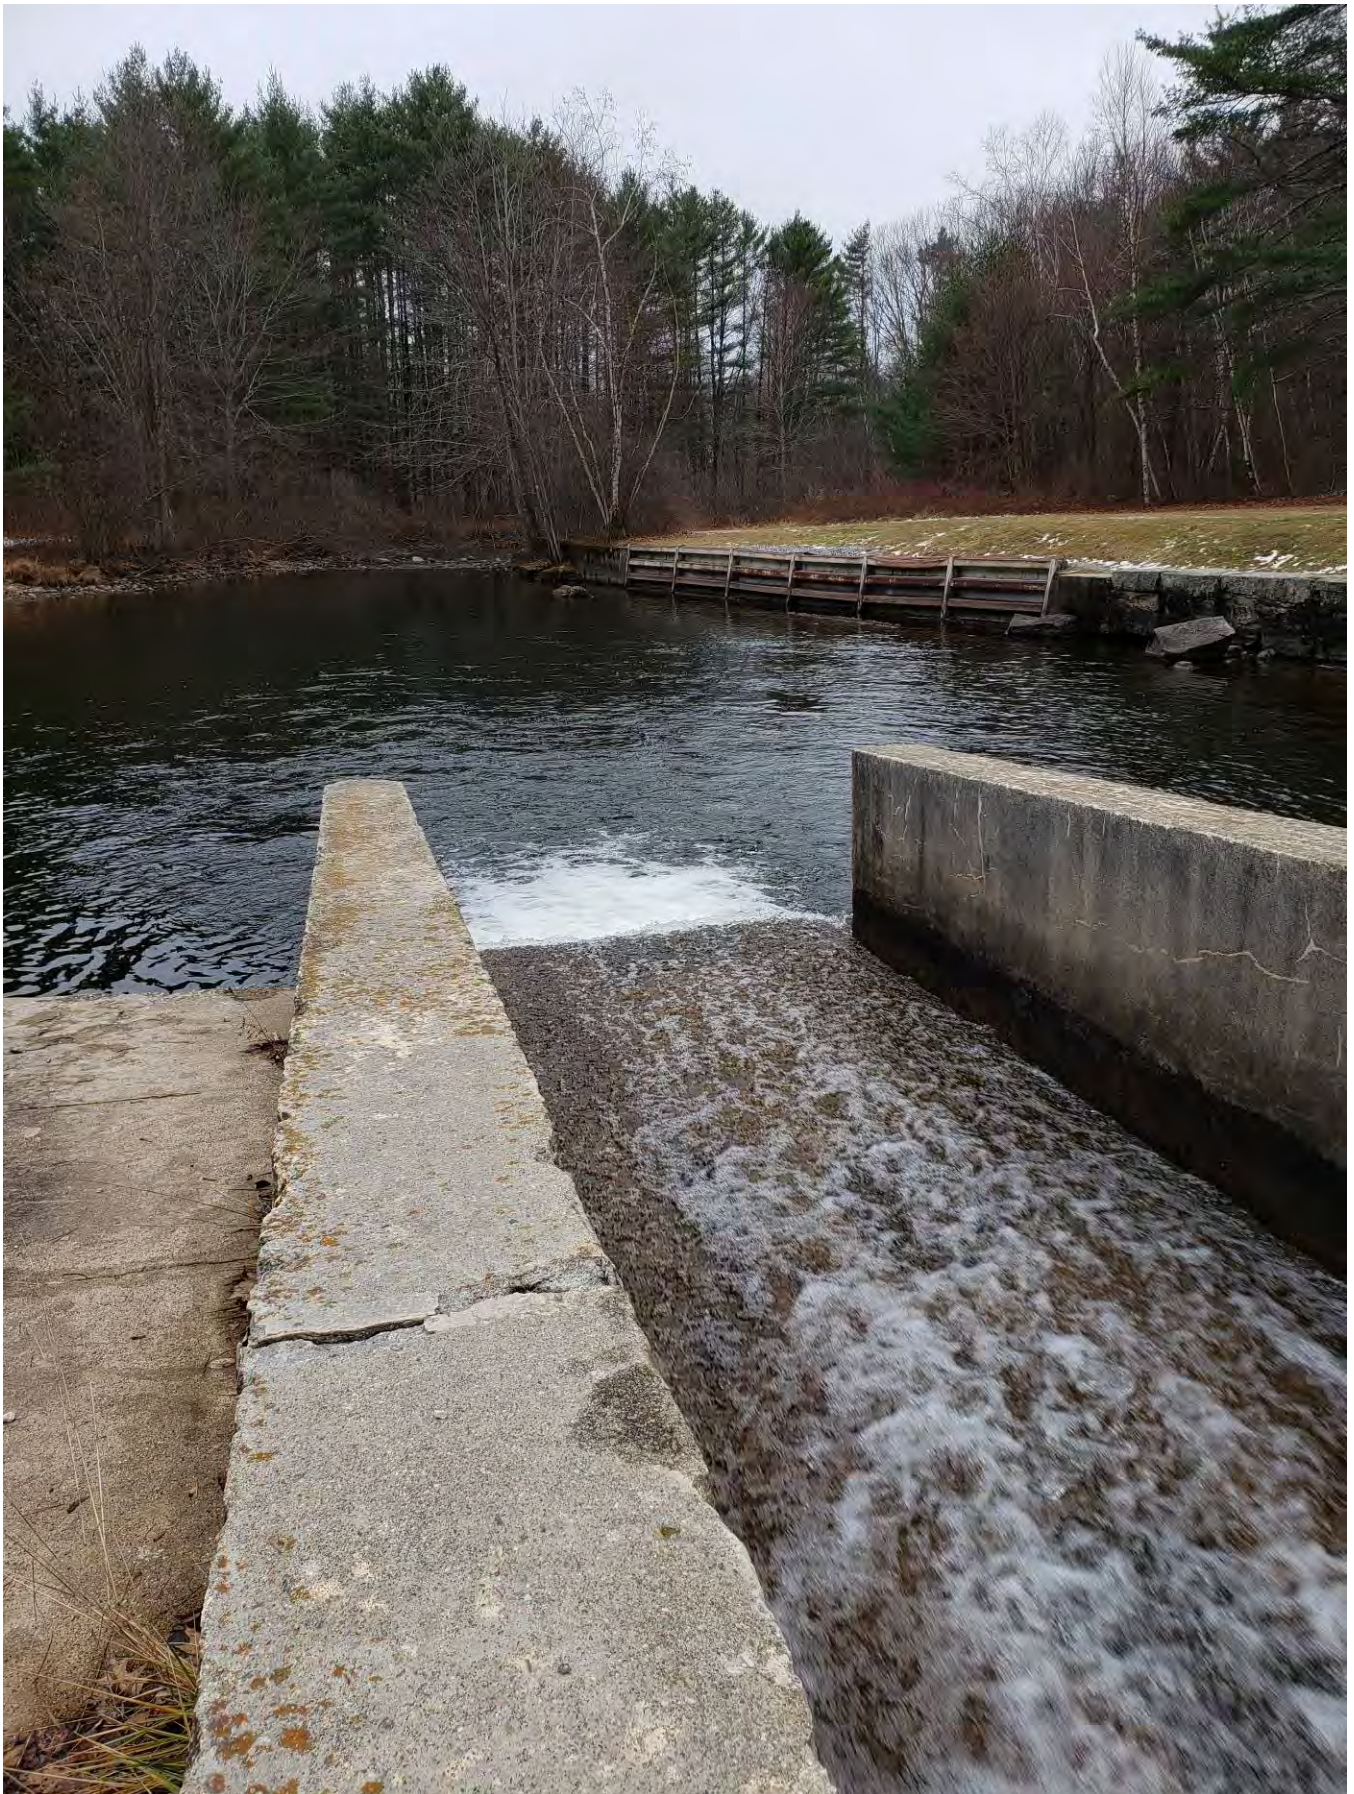
The spillway apron for the Dam was found to be in good overall condition. The inspection team did not note significant cracking or settlement along the entire length of the unreinforced concrete slab. Some minor cracking and surface erosion, specifically along the sluiceway bottom channel where flows pass most frequent, was noted (Photos 30, 31, and 32). These minor items

PHOTO 32: SLUICEWAY CHANNEL DOWNSTREAM OF GATE.

do not require attention at this time. Some vegetation was noted in slab construction joints and cracks. Though not an issue at this time, consideration should be given to managing the vegetation so medium to large sized brush do not begin to establish themselves. The root systems of medium to large vegetation could separate joints or worsen cracks if left unmaintained.

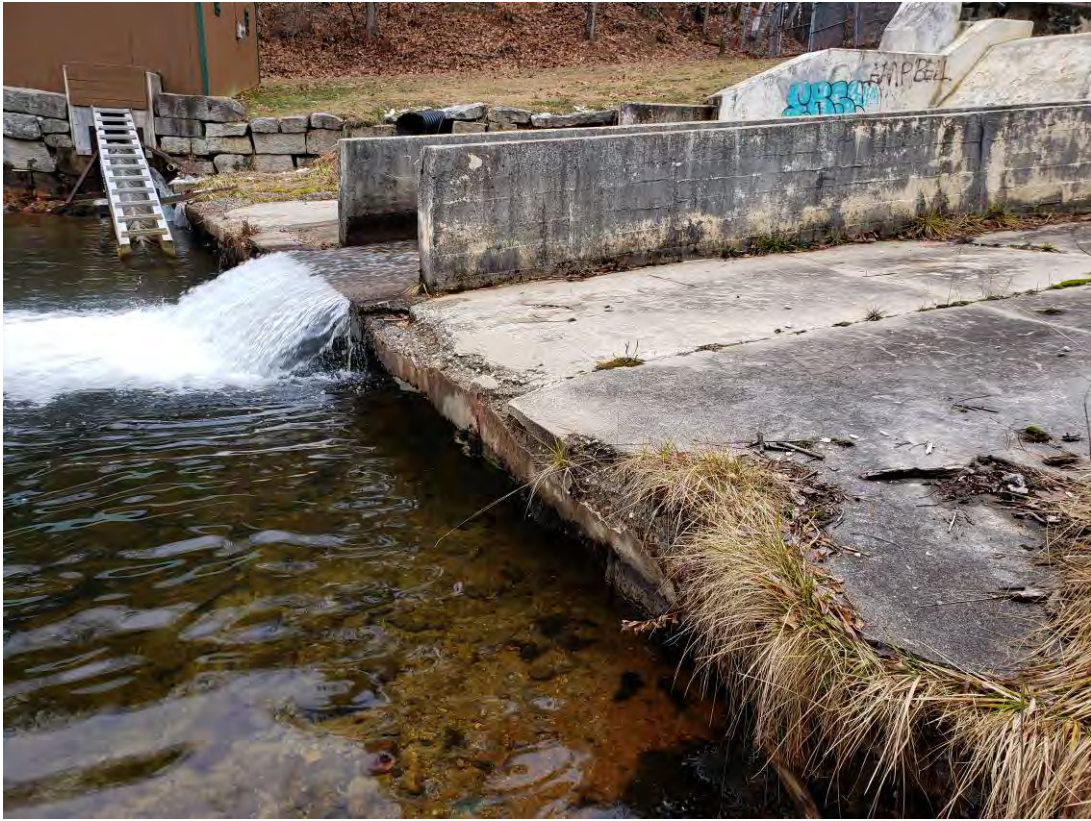
The downstream end of the apron has experienced concrete loss and appears rough; however, it remains in good overall condition and continues to perform its original design intent of preventing downstream toe scour (Photo 33). The downstream toe area consists of what appears to be a sandy gravel mix that is susceptible to scour; however, the apron and steel piling cut-off wall below the apron and the toe appear to be performing as intended (Photo 34). There are no signs of detrimental scour actively occurring at the toe, nor need for repairs to the Dam's toe at this time.

PHOTO 33: DOWNSTREAM TOE OF SPILLWAY APRON.

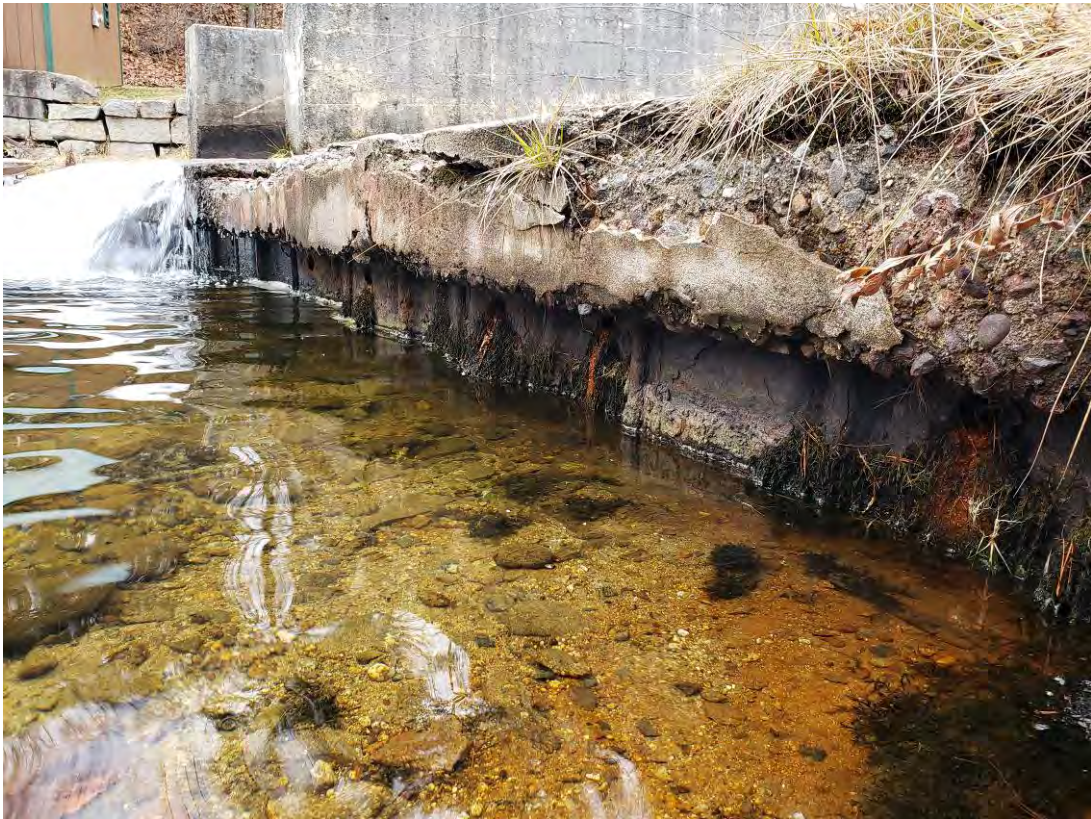
PHOTO 34: STEEL PILING BELOW END OF SPILLWAY APRON.
