# Crescent Lake Watershed Survey

Prepared by:  
Crescent Lake Watershed Steering Committee  
Raymond Conservation Commission  
April 2000

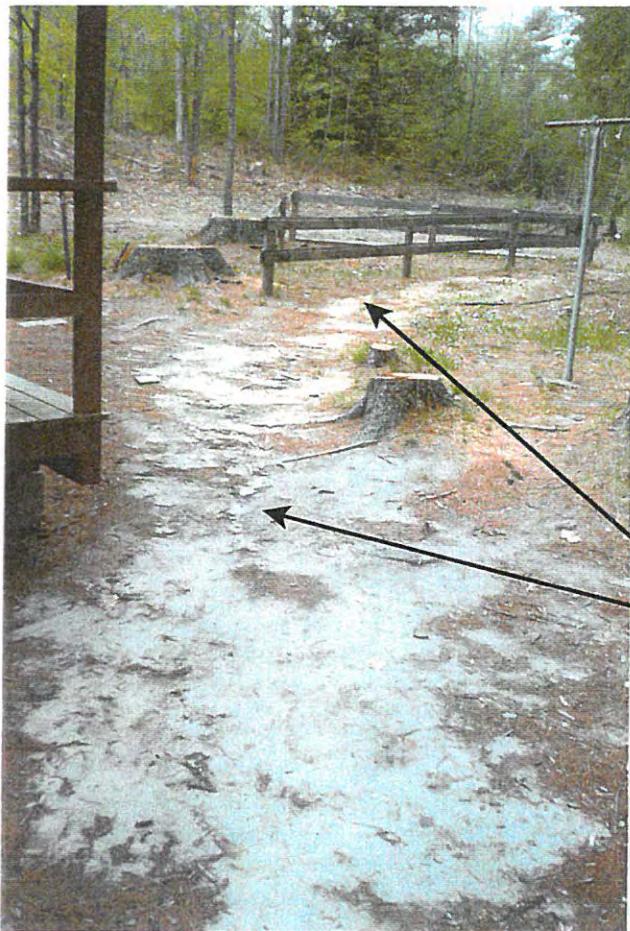
### Example Residential Site

#### Problems:

- Soil in foot path is bare and compacted; runoff velocity increased
- Path is straight, resulting in greater runoff velocity with direct flow to lake
- Trees (protective canopy) have been removed

#### Solutions:

- Limit foot traffic damage with bark mulch or pea stone on path
- Create meanders in foot path, to slow and interrupt runoff
- Terrace and/or install timbers across path to divert runoff into buffer
- Establish ground cover adjacent to path to slow down and soak up precipitation (a diverse mix of trees, shrubs and ground cover plants will stabilize this property better than wild grass)

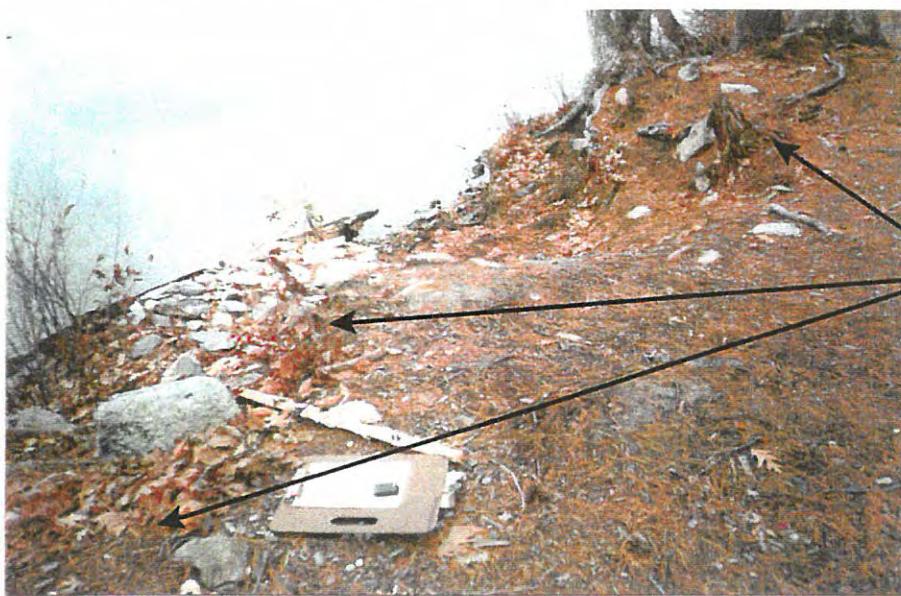
**Example Shore Access Site**

**Problems:**

- Bare soil eroding to lake
- Lack of vegetated buffer

**Solutions:**

- Establish a buffer (shrubs and groundcover) along shore front
- Plant and mulch bare soil areas
- Install steps to direct foot traffic over bank and protect bank from further erosion

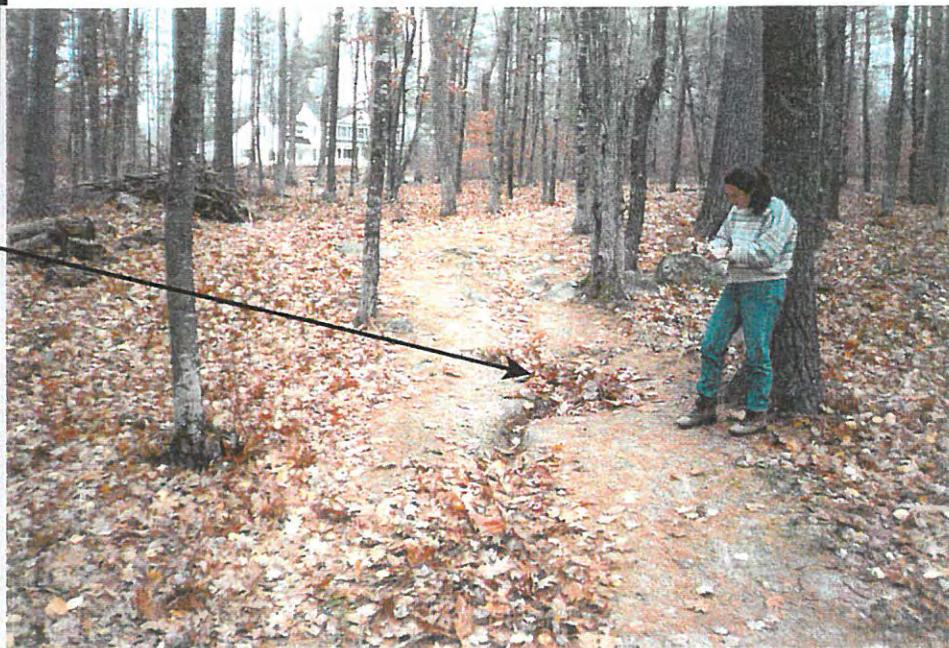
**Example Footpath Site**

**Problems:**

- Soil in footpath is bare and easily eroded;
- Path is too steep, straight and long. Storm water gains volume and velocity and ‘blows out’ trail bed.

**Solutions:**

- Terrace and meander trail to break up slope
- Resurface trail with consolidated (e.g., peastone) material or mulch path surface
- Install timbers (*waterbars*) across path to divert runoff to buffer

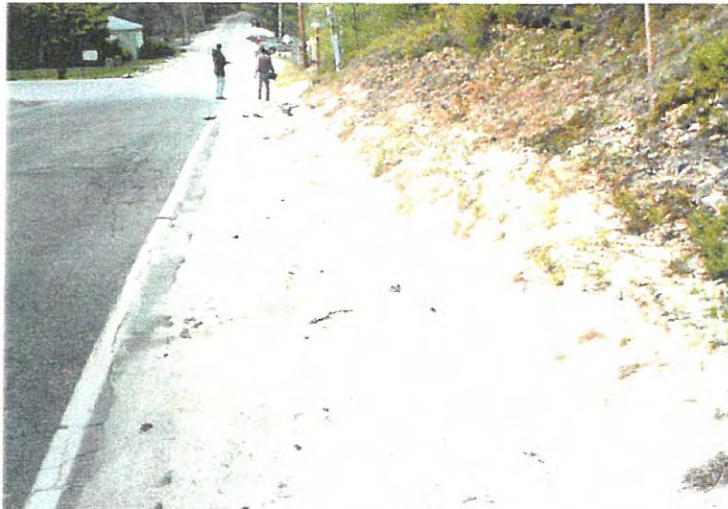
### **Problems:**

- Winter sand build-up
- Lack of ditch, road runoff carries sand to beach and phosphorous to lake

### **Solutions:**

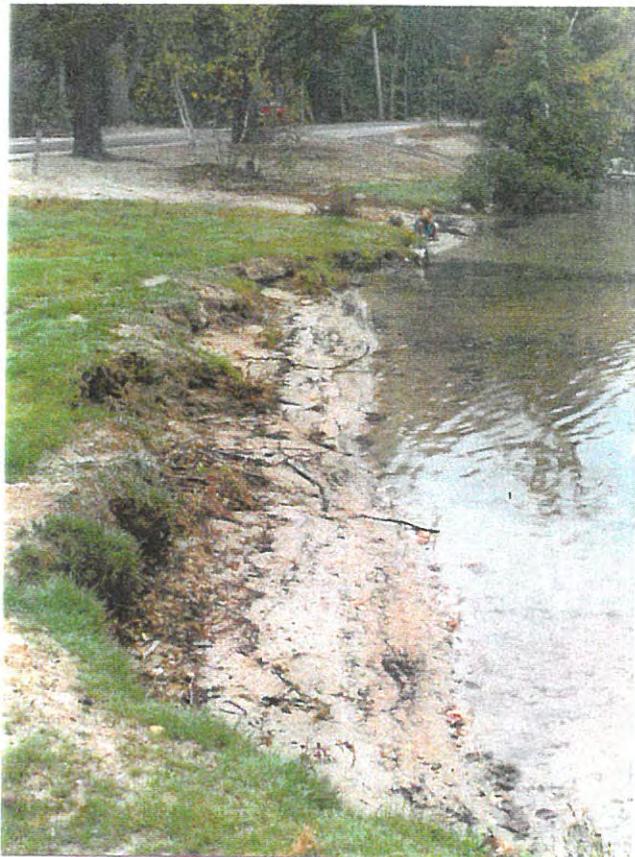
**Crescent Beach in Raymond**

Seven distinct erosion problems were identified on Raymond's and Casco's town beaches. Both beaches are used heavily and suffer from soil compaction and serious slope and shoreline erosion. The high visibility and use of these beaches make them excellent candidates for demonstrating repair and maintenance practices. Problems and solutions noted for these beaches also apply to private beaches and shorefronts.

- Re-seed, mulch, or sod high-use sunbathing areas, grassy terraces
- Divert road runoff away from beach to buffers
- Stabilize banks with rip rap or buffer vegetation to prevent further erosion of shore and banks
- Establish pathways to control beach access and reduce soil compaction
