# *Crescent Lake*

## *NPS Watershed Protection Project*

### *2011 - 2013*

Report Prepared by Patrick Marass, FB Environmental Associates

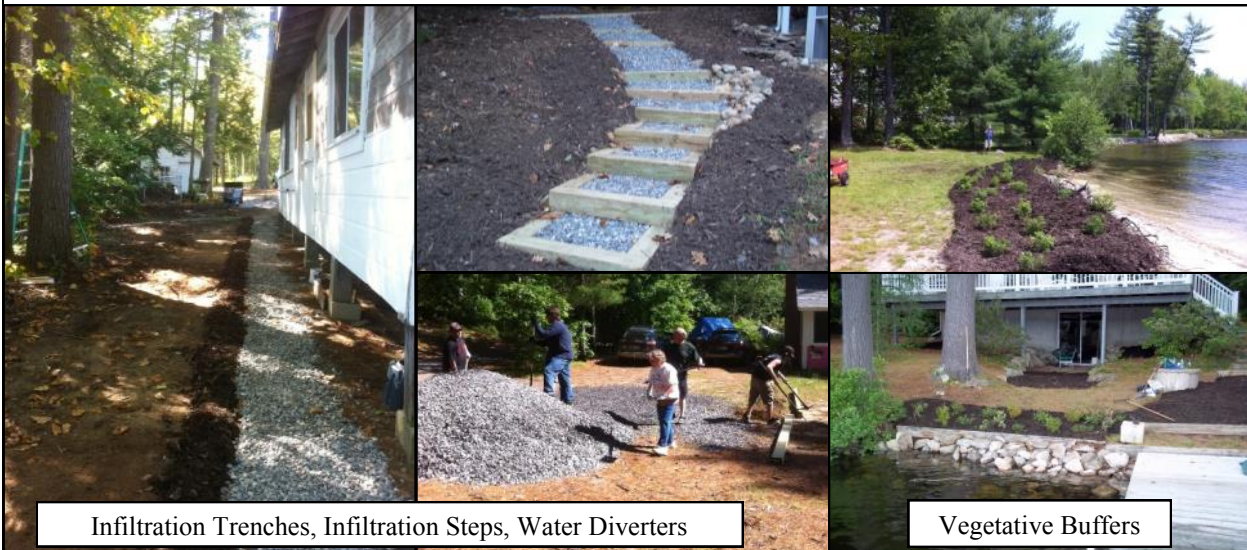
Infiltration Trenches, Infiltration Steps, Water Diverters

Vegetative Buffers

These workshops provided an opportunity for local residents and volunteers to learn where and how to install BMPs, such as infiltration trenches, vegetative buffers, drywells, and water diverters. Over the course of the project, three workshops were organized and completed.

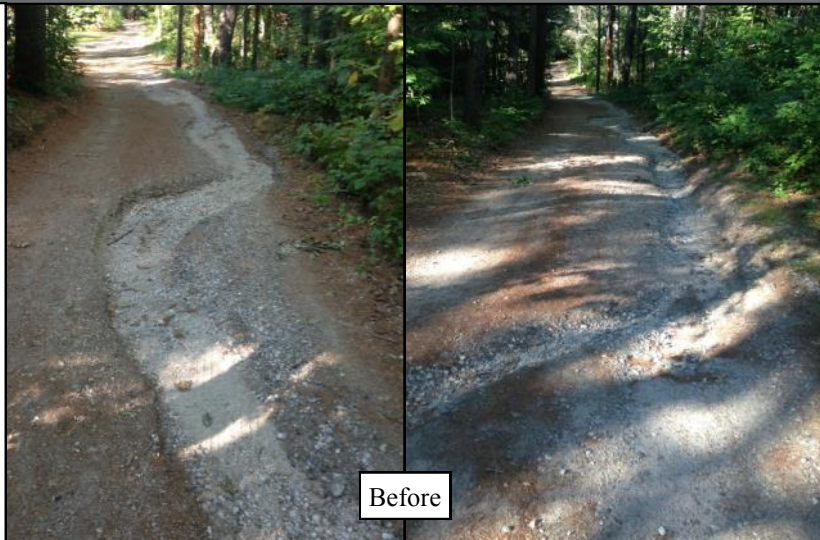
Before photo (above) show a section of Haskell Avenue that had severe erosion issues. The road used too wash out and the sediment laden stormwater would travel down a right of way and into Crescent Lake. The photos below show the road after construction. The road was re-graded, new surface material was brought in and turnouts were installed to encourage the stormwater to run into existing vegetation, which greatly reduced the sediment and phosphorus transport into Crescent Lake from the site.

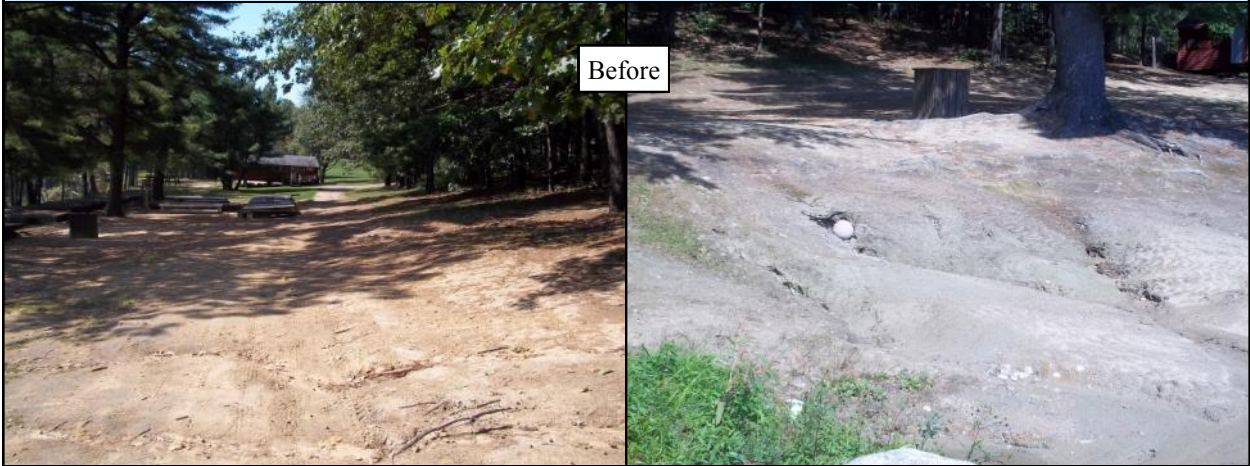
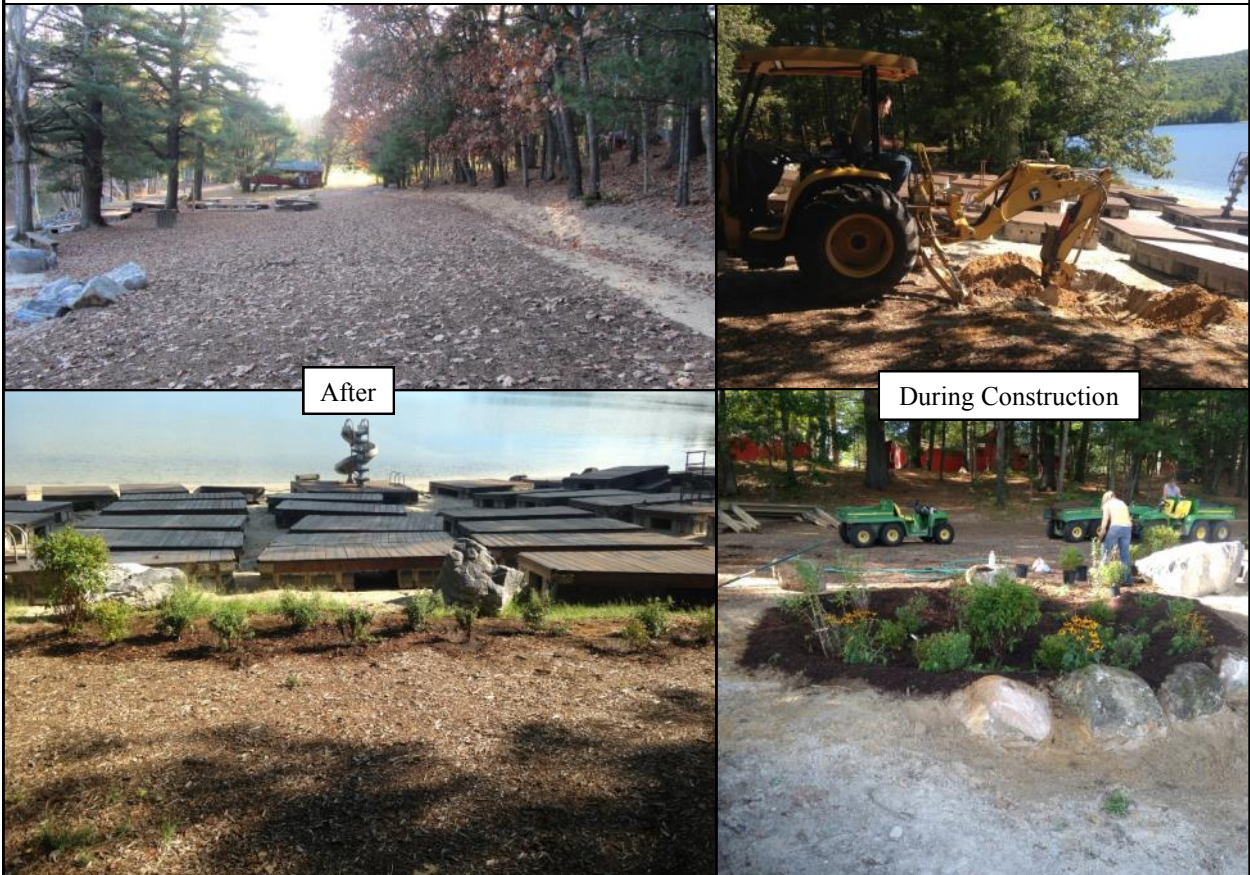
## Laurel - 1 & 2 - Photos

Before photos (above) shows the eroding swimming beach area at Camp Laurel South. Water would flow from the hill behind the beach, across bare soil, and erode the beach area carrying sediment and phosphorus directly into Crescent Lake. Construction and after photos (below) display the work that was completed to address the erosion at these sites. A large drainage swale was constructed at the bottom of the hill to carry water away from the beach area and into existing vegetation and large boulders were placed in gullies on the beach area. Erosion control mulch (ECM) was spread over the bare soil areas. Finally, plantings were installed along the top of the beach area and a large rain garden was constructed to reduce erosion and infiltrate the stormwater runoff from the site.

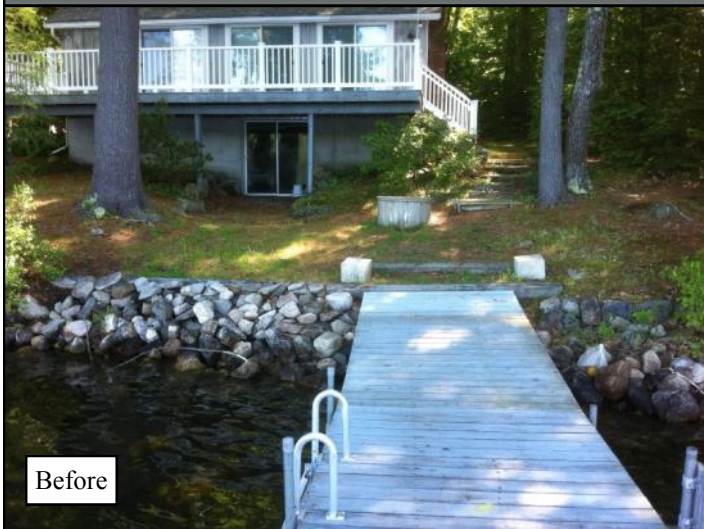
Before

This property on Hancock Road was lacking a buffer (above) and had erosion issues at the shoreline and underneath the deck. The landowner and volunteers planted over 20 shrubs along the shoreline (below left), installed several water diverters, and spread ECM underneath the deck (below right). Following this work and other landowner improvements, the property was recommended for a LakeSmart certification!

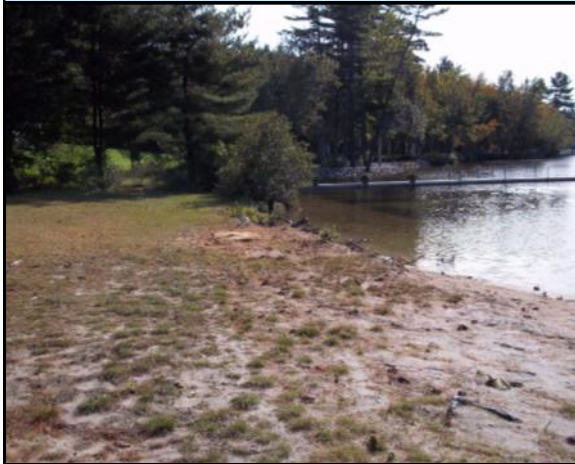
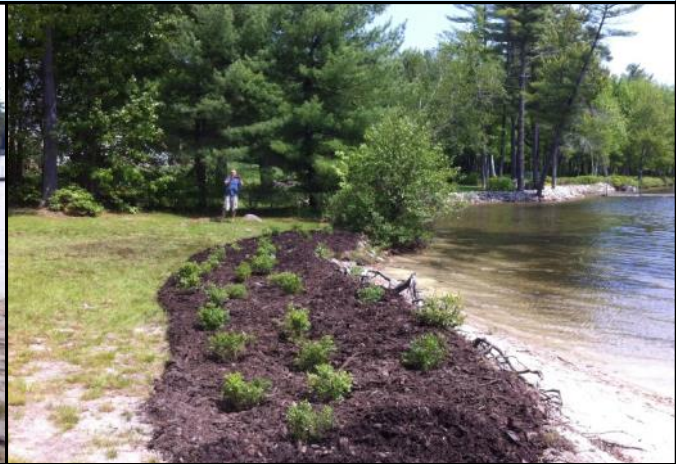
This property off Edwards Road in Casco had a large lawn leading to a bare shoreline (above left). The lack of vegetation along the shoreline was leading to some shoreline erosion over time. The landowner, along with volunteers, installed over 30 blueberry bushes and spread ECM along the shoreline to enhance the buffer and protect the shoreline and the landowner's property (above right).

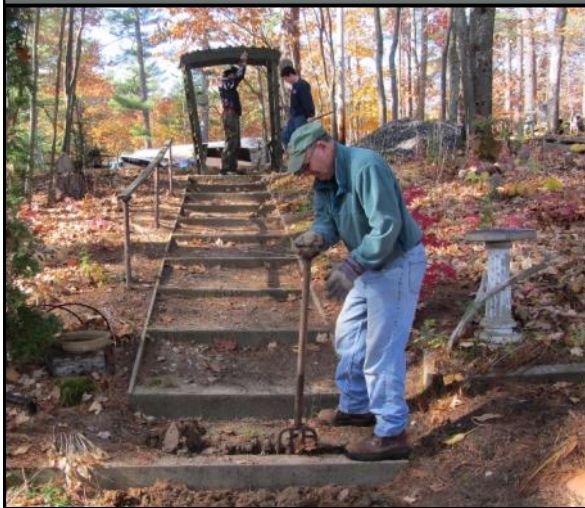
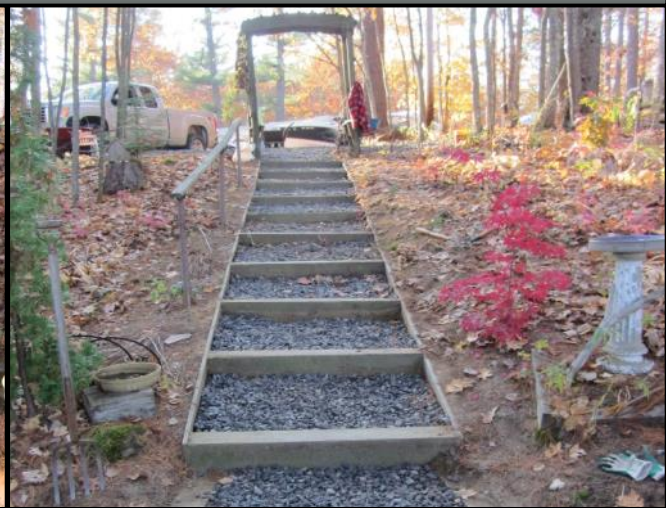
This property off Haskell Avenue had stormwater from the road flowing across their parking area, down their steps, and across their property to Crescent Lake (above left). The landowners, along with several volunteers retrofit the existing steps into infiltration steps, installed a dripline trench, spread crushed stone in the parking area and installed a water diverter to send the road runoff into existing vegetation.

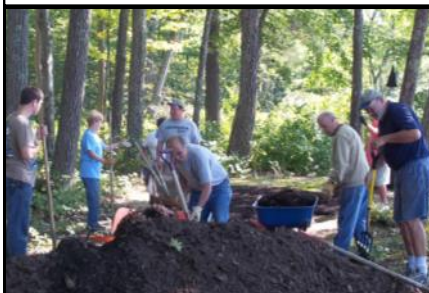
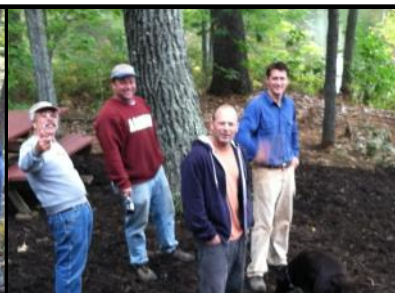
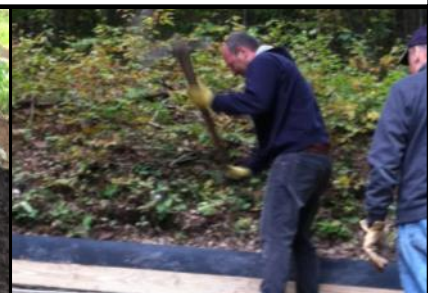
Photos of the landowners and volunteers installing the conservation practices at various residential properties
