Crescent Lake Watershed- Based Protection Plan

2025- 2035

Crescent Lake Watershed Association

WATERSHED SURVEY RESULTS | MEMORANDUM

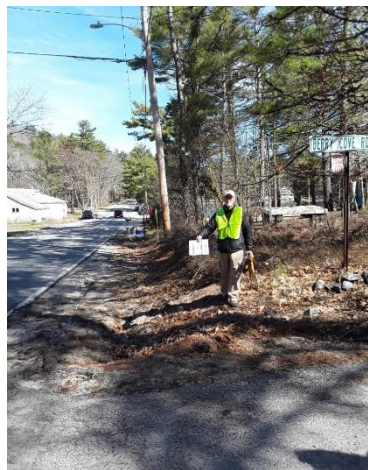
(Left) View of the northern corner where Berry Cove Road intersects with Route 85. Erosion within the gully ditch is evident. (Right) View up Berry Cove Road from Route 85. Signs of gully erosion on the lakeside of the road are present.

Recommendations: A ditch should be installed on the side of Berry Cove Road. To address erosion from runoff on Route 85, the existing ditch should be reshaped and armored with riprap. The culvert should also be cleared of debris and sediment.

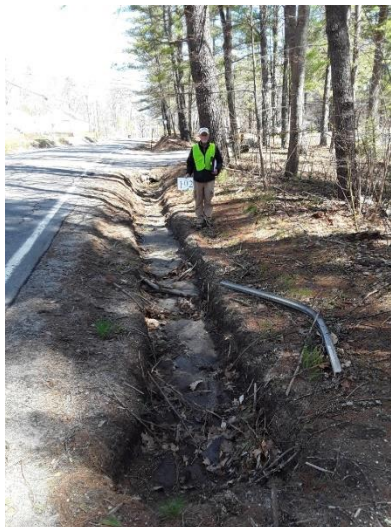
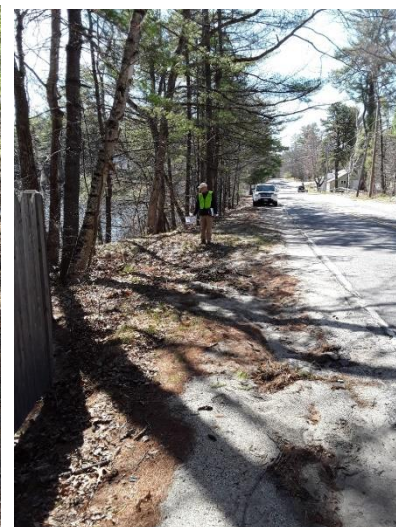
(Left) View of the start of the gully on the lakeside of Route 85, just south of Haskell Ave. Steep banks indicate severe gully ditch erosion. (Right) View of where the gully overtops onto the paved road shoulder, before veering towards an old detention basin above the lake.

Recommendations: The ditch should be enlarged so that its banks are less steep, making them less vulnerable to erosion in high rainfall events. Riprap or seed (grass or low-growing ground cover) should be planted to stabilize the soil in these ditches. Additionally, plunge pools should be established at culvert outlets within the ditch, except where the ledge makes this impossible.

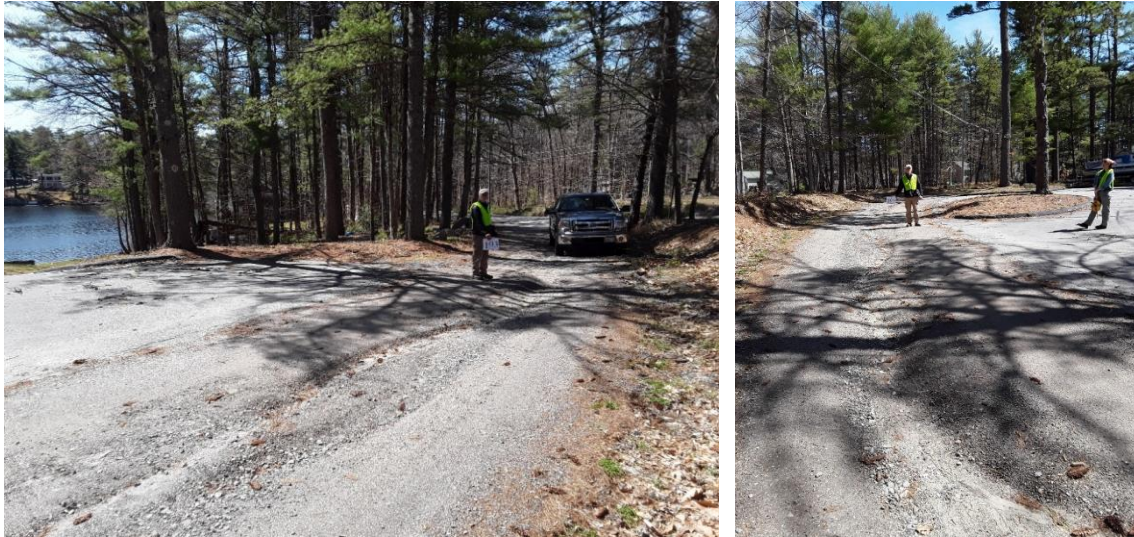
(Left) View down Haskell Ave, where a rill has formed within the unpaved road surface. (Right) View upslope of the rill.

Recommendations: Resurface, re-crown, or superelevate Haskell Ave so that it slopes towards the vegetated side of the road. The installation of roadside ditches is also recommended.

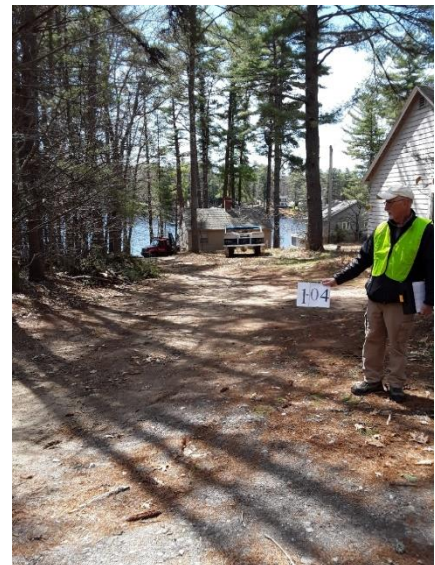
View of the driveway at 13 Haskell Ave, which has signs of rill erosion.

Recommendations: Reshape the driveway using gravel if possible. Runoff diverters such as rubber razors could also be installed as a low-cost solution.

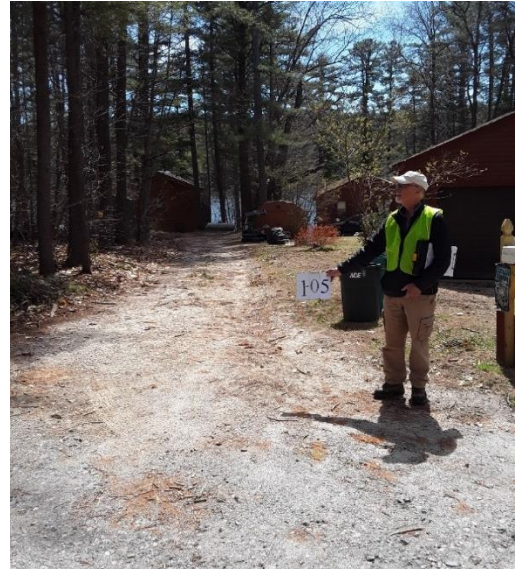
View down the driveway of 17 Haskell Ave, which has experienced erosion in a “W” shape.

Recommendations: Build up and crown the driveway, and/or install runoff diverters such as rubber razors. The team observed the driveway from Haskell Ave, and therefore could not recommend where runoff be diverted.

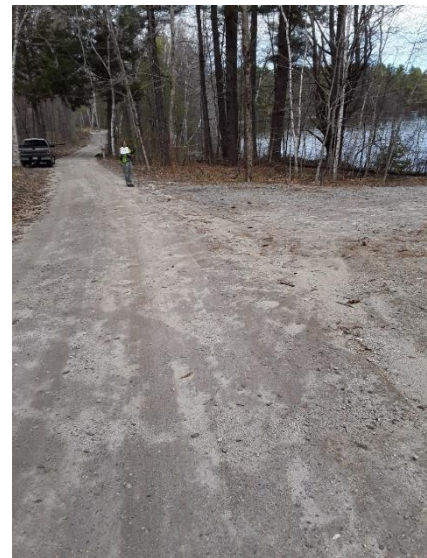
Observations: There is erosion on the shoulder of Kossow Lane. The road is crowned, but its steepness has caused runoff to erode both edges. There are no ditches in place to mitigate erosion impacts. It was noted that the runoff only causes erosion during heavier rainfall events.

View down Kossow Lane. Erosion is occurring on both shoulders of the road.

Recommendations: Installing a road turn-out on the hill is recommended, to reduce the volume of stormwater runoff on the road surface. Alternatively, a ditch on the lakeside of the road would be a potential solution, although this would require a cross-culvert to be built beneath the driveway off this stretch of Kossow Lane. The outlet of the turn-out or ditch could be a plunge pool or apron, which directs water into a vegetated buffer area.

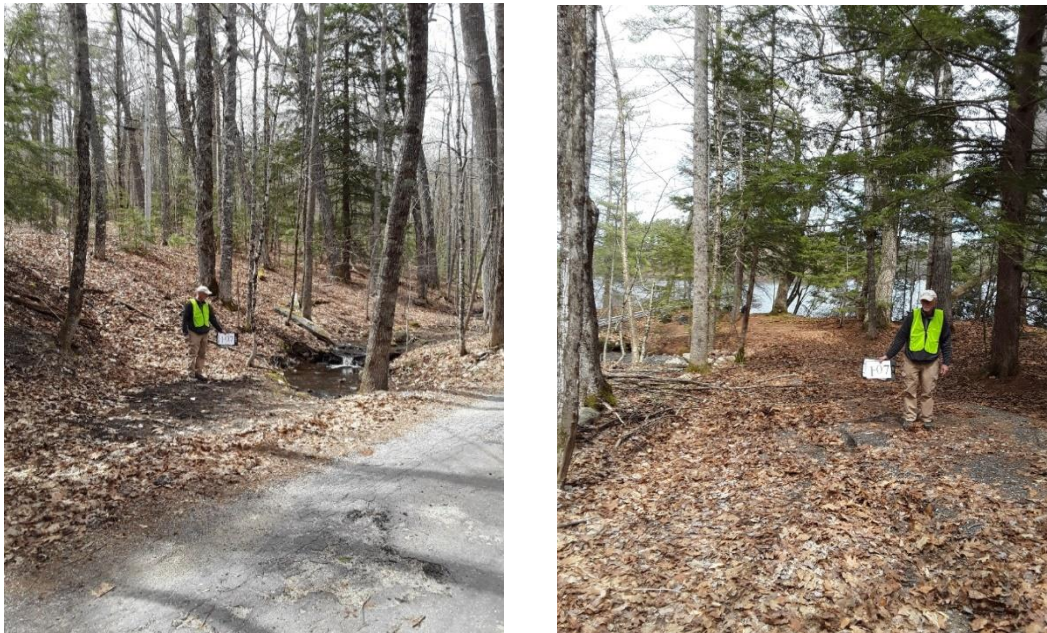
Observations: A stream overtops onto Myron Hall Road during high rainfall events, which has caused the road and driveway opposite the stream to become washed out.

(Left) View of the location where the stream overtops onto Myron Hall Road, causing erosion of the road.

Recommendations: Install a berm on the stream side of Myron Hall Road and install a detention basin next to the stream. Pave the washed-out driveway to prevent future wash outs. Enlarge the culvert with a Stream Smart crossing.

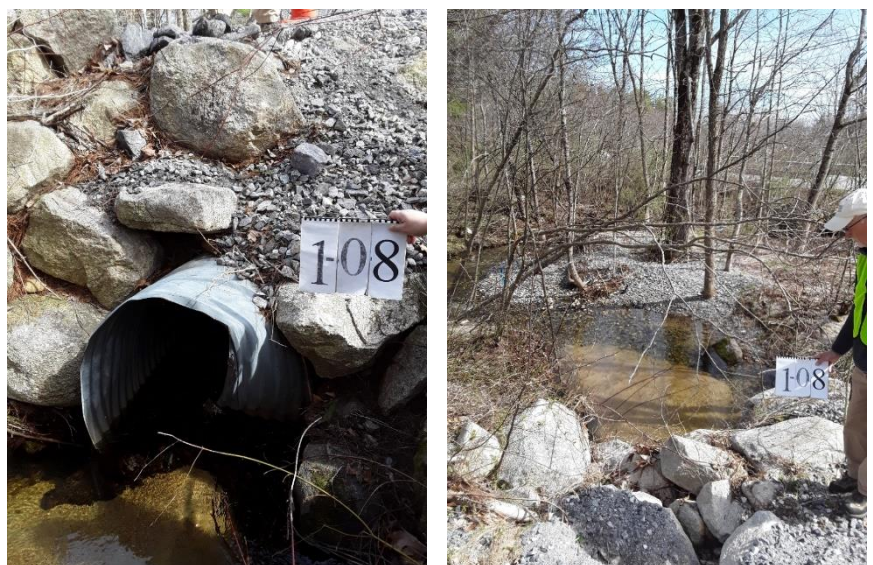
Observations: A crushed, rusting culvert is undercutting the bank below Davis Brook Road. This has caused the road to wash out and has led to significant amounts of sediment deposition in the stream as well as in the lake downstream of the site.

(Left) The culvert beneath Davis Brook Road is rusting and undercutting the bank.

(Right) Erosion has caused the road to wash out, and deposit sediment in the stream.

Recommendations: Replace and enlarge the culvert to align with Stream Smart standards.

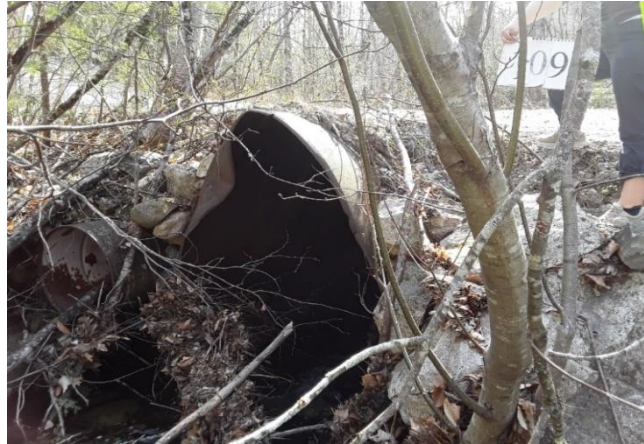
The culvert beneath the driveway, which is crushed.

Recommendations: The culvert should be replaced and possibly lengthened. A more permanent solution would be to construct a bridge for this driveway, which would be costly but would best protect the lake as well as make the driveway safer.

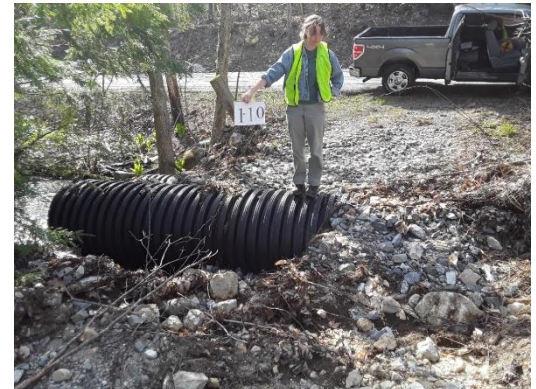
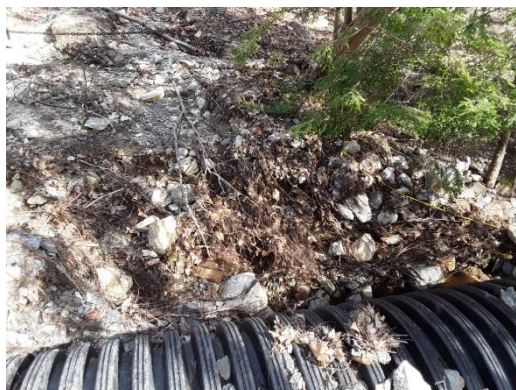
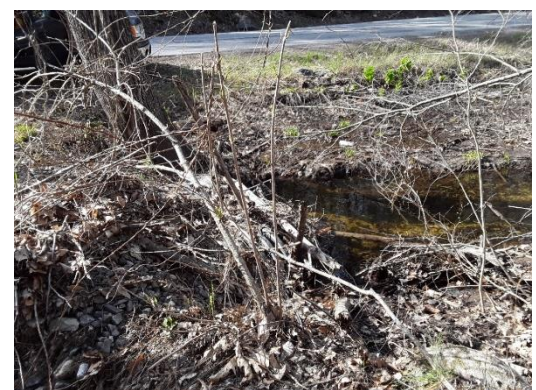
(Top right) The driveway has been washed out, exposing the culverts. (Bottom right) A channel ~1 ft deep has formed around the culverts. (Bottom left) View of erosion around the culverts.

Recommendations: Replaced the twin culverts with a bridge. The driveway should be restabilized and reshaped.

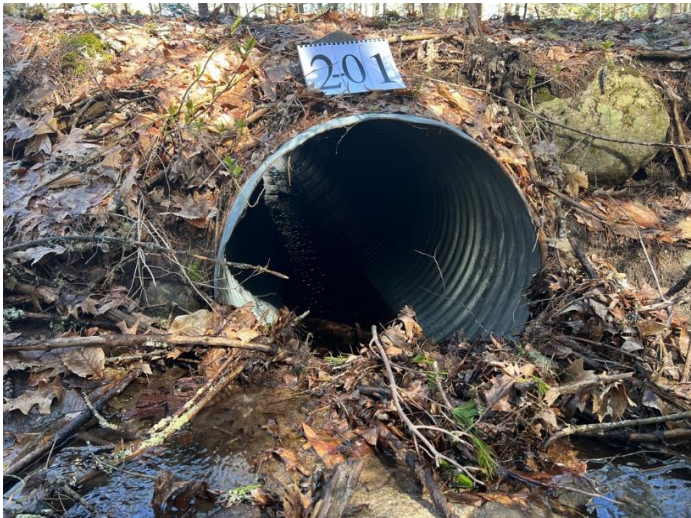
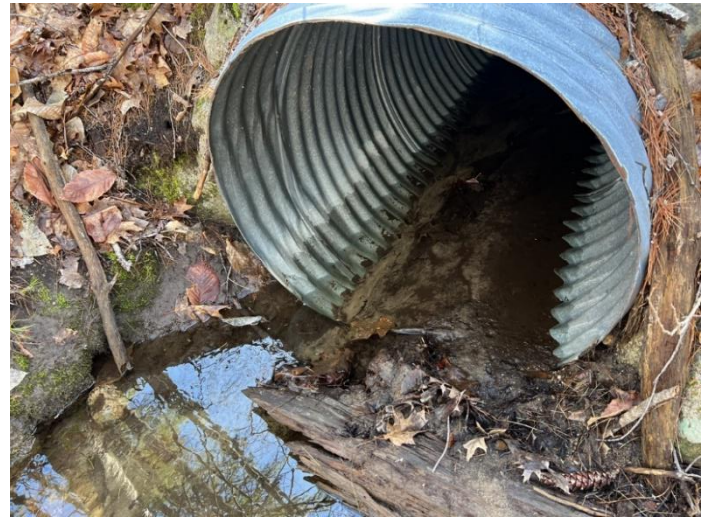
Site 2-01: Culvert #1 under Northern Pines Road

Observations: There is a potentially undersized, 4' corrugated metal culvert with a rusted-out bottom, which contains some blocked debris. The culvert transports water from an unnamed stream below Northern Pines Road.

(Left) Debris blocking the inlet of the culvert. (Right) View of the outlet of the culvert, where sediment and debris have been deposited. The bottom of the culvert is rusted.

Recommendations: The culvert should be cleared regularly, and potentially replaced and enlarged.

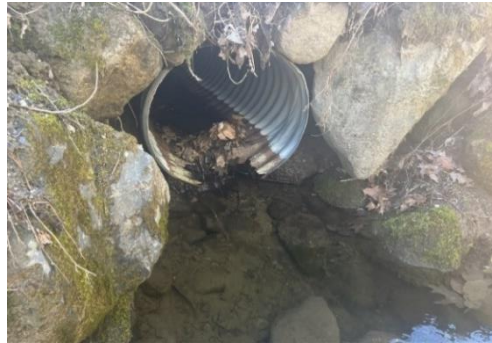
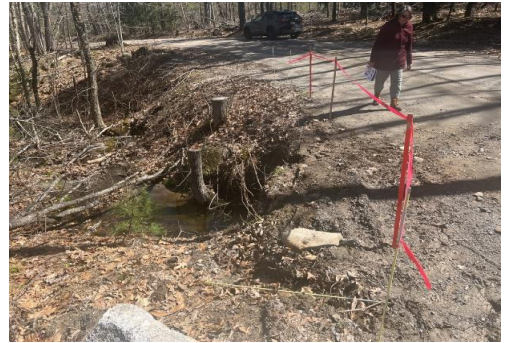
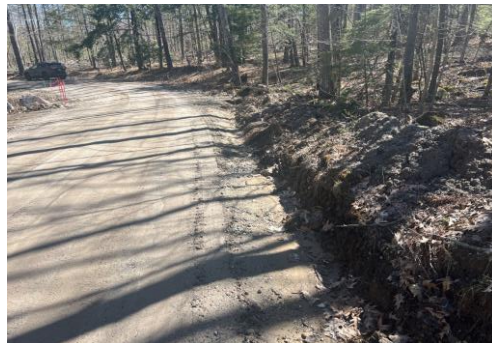
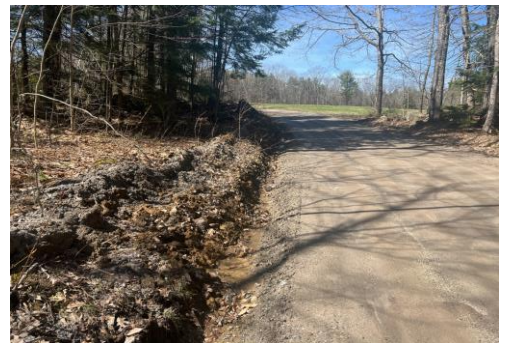
Observations: There is severe road erosion into a stream along Dryad Woods Road. A culvert is also perched, rusting out and clogged with debris. The surrounding area has been logged extensively, and Dryad Woods Road is eroding from the shoulder about 350 feet south of this site. The bank of the road down to the stream is steep.

(Top left) View of the perched, rusted culvert outlet. (Top right) View of the steep bank surrounding the culvert outlet, where road erosion has occurred. (Bottom) Shoulder erosion has occurred on both sides of Dryad Woods Road approximately 350 feet south of the culvert.

Recommendations: Install a ditch along Dryad Woods Road, armored with vegetation and/or riprap and graded to reduce the steep cut of the bank. Revegetate the riparian buffer where it has been thinned. Clear the culvert and eventually replace and enlarge.

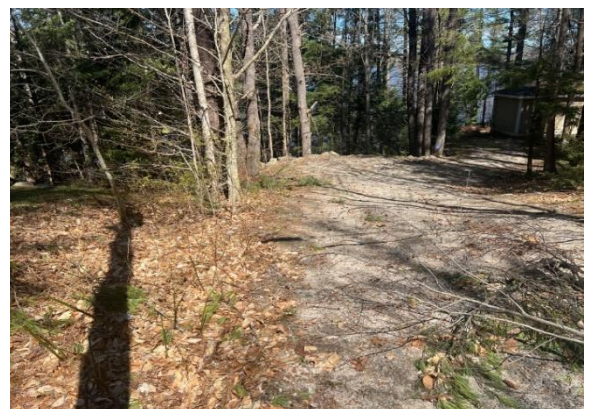
View from the driveway towards the private residence and lake.

Recommendations: Regrade driveway to restore crown or grade away from the lake. Add water diverters (such as rubber razors or turnouts) to the driveway to direct flow into the forested buffer. Add ditching or turnouts along Big Pine Road.

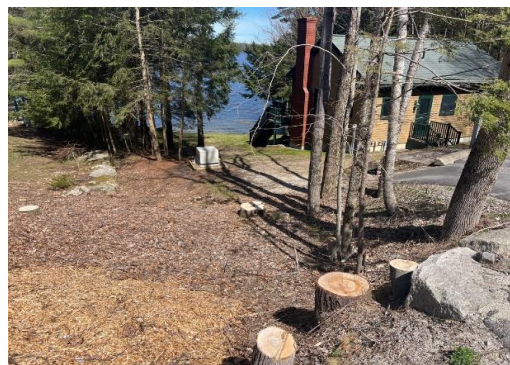
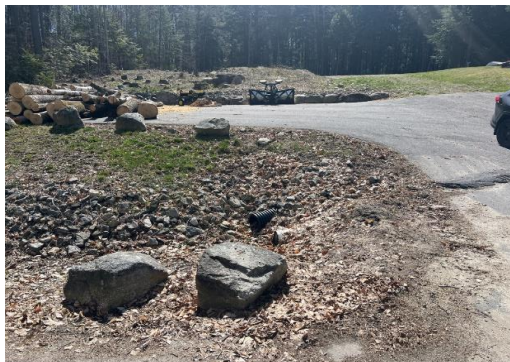
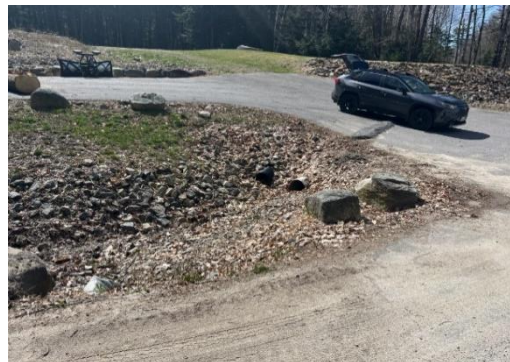
(Bottom) A paved area near the end of Dryad Woods Road, where logged trees are visible in the bottom left photo, slopes steeply towards the road and the lake.

Recommendations: Install a vegetated settling basin beneath the steep paved area. In addition, infiltration steps along the steep private driveway should be installed.

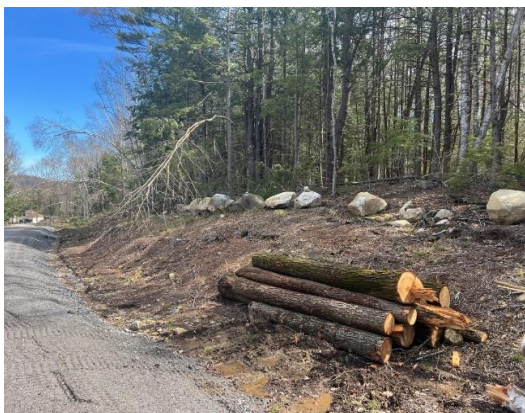
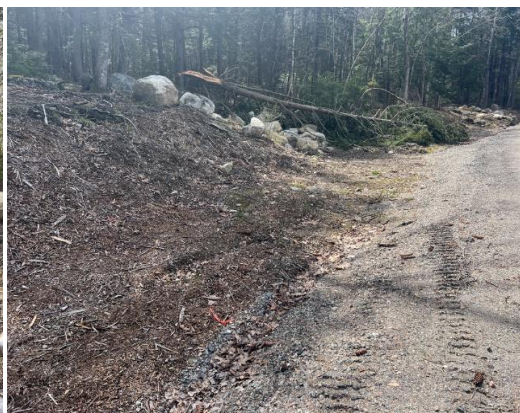
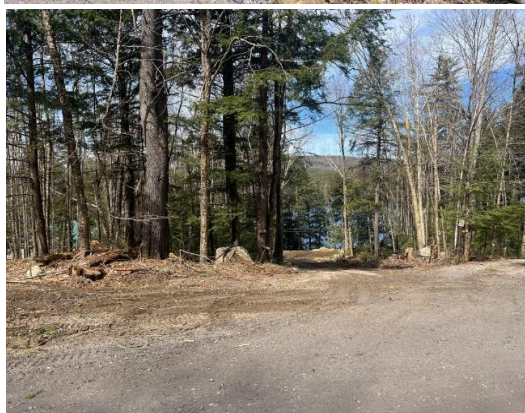
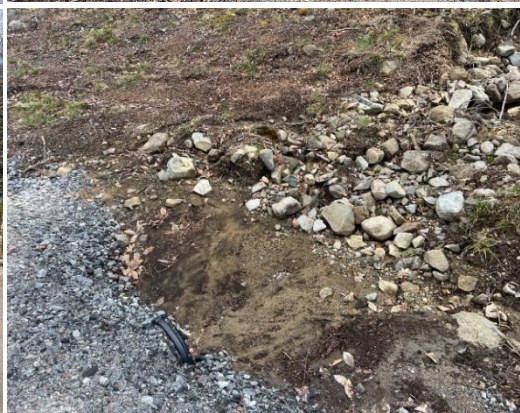
Site 2-06: New road off Dryad Woods Road

(Top) Clearing and logging has taken place along the newly constructed road. (Bottom left) Sediment can easily wash into the lake down the steep roads and driveways. (Bottom right) Sediment deposition around a small plastic culvert.

Recommendations: Ensure proper erosion controls are in place during logging activities to contain sediment on site. Install a vegetated swale along the road. Revegetate road shoulders or cover with erosion control mulch.

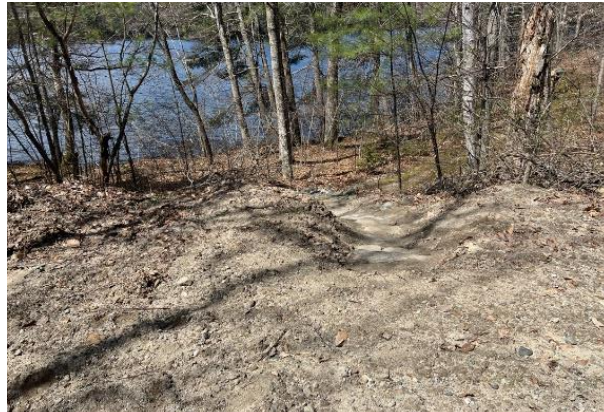
Sediment from Rosewood Drive washed down onto steps providing access to the lake.

Recommendations: Replace existing path and steps with infiltration steps. Add erosion control mulch and plantings to the sides of the steps and paths. Install water diverters on the driveway to direct flow into forested areas and away from the path.

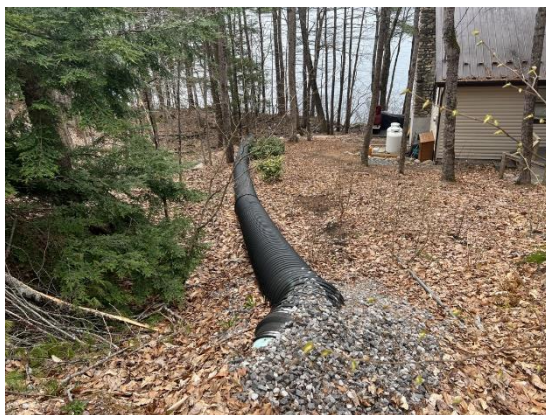
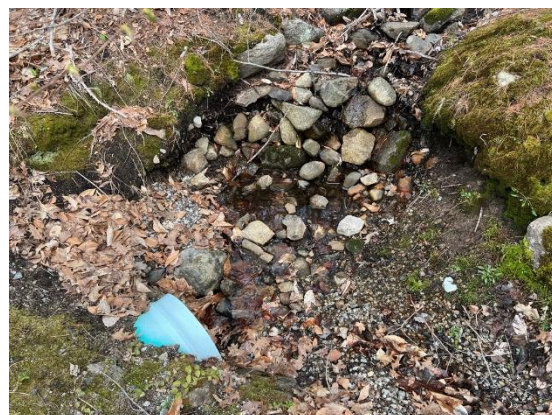
(Left) View looking down the plastic "culvert" towards the lake. (Right) The inlet of the culvert before it passes beneath Mawaga Drive.

Recommendations: The outlet of the pipe should be checked to ensure sediment is not washing into the lake. Install a sediment plunge pool or level lip spreader to a vegetated buffer at the culvert outlet. Consider restoring a more natural stream channel or vegetated swale.

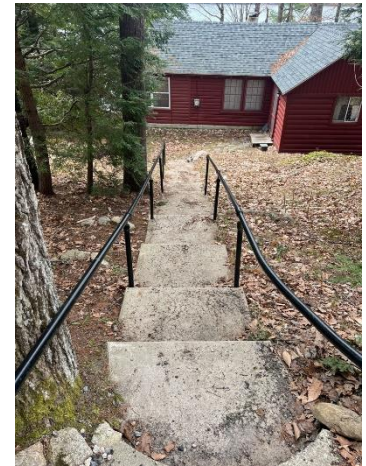
View looking down the top set of stairs from Mawaga Road. Signs of erosion are present at the staircase bottom.

Recommendations: These steps may be a good candidate for the installation of infiltration steps. A settling basin at the bottom would reduce sediment transported by sheet runoff from entering the lake. Add erosion control mulch and native plants to the sides of the stairs.

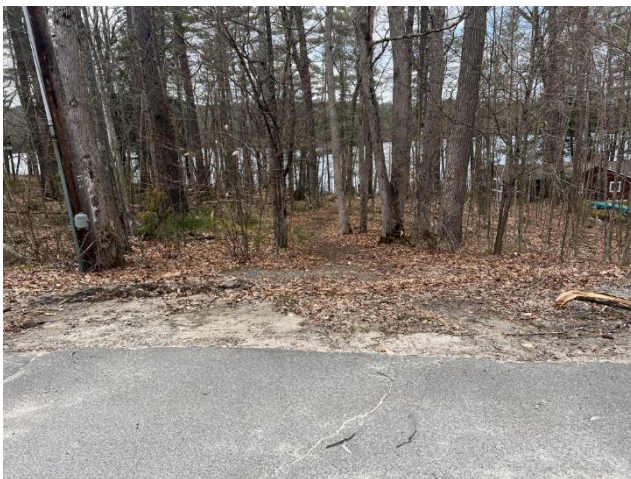
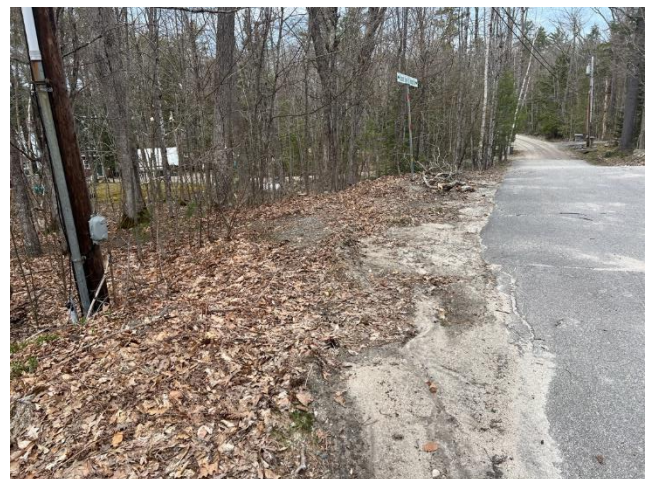
(Left) View from the end of Hancock Road, looking down the access trail which is in the center of the photo. No mulch is present, and signs of erosion are visible. (Right) View north up Crescent Shore Road from the end of Hancock Road, showing signs of erosion.

Recommendations: A small infiltration basin or sediment forebay is recommended to be installed at the end of Hancock Road, where the access trail begins. Add new erosion control mulch and/or water diverters to the access path. Regrade the road to direct road runoff into the existing swale.

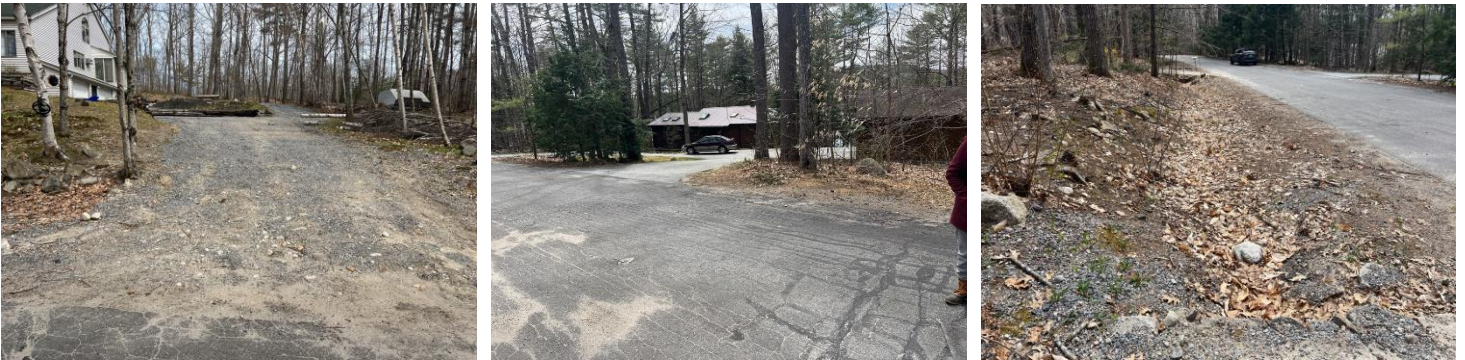
(Left) View up the steep driveway where runoff occurs. (Center) One of the lakeside neighbor's driveways downslope of the steep driveway. (Right) View of a ditch along Crescent Shore Road that needs clearing.

Recommendations: Install water diverters across the gravel driveway. Alternately, crown driveway and add ditches with turnouts to direct flow into existing road ditches. Clear ditches and culverts regularly.

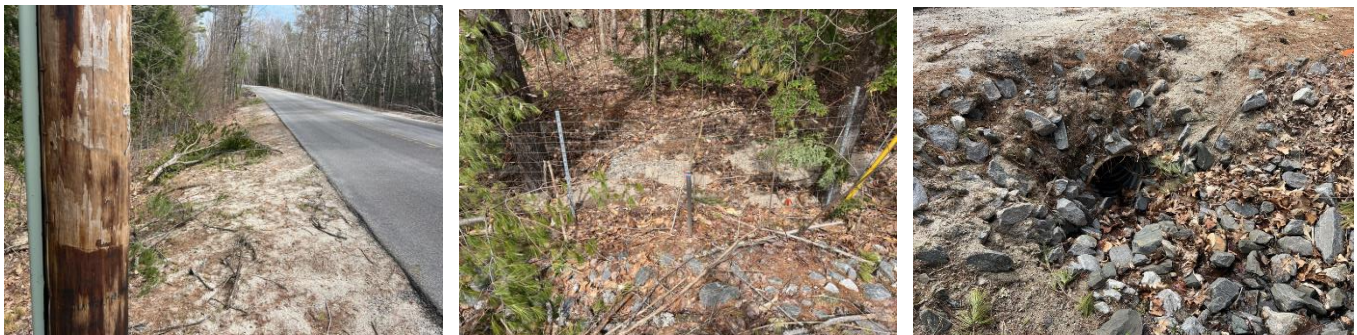
(Left) View of the roadside, where sediment washes. (Center) View of the land downslope of the roadside, where sediment deposition is evident. (Right) View of the small culvert downslope of the road.

Recommendations: Revisit to verify that runoff from this site reaches the lake. If so, install ditches along the side of Conesca Road and turnouts to infiltration basins. Unclog the culvert and stabilize the inlet and outlet.

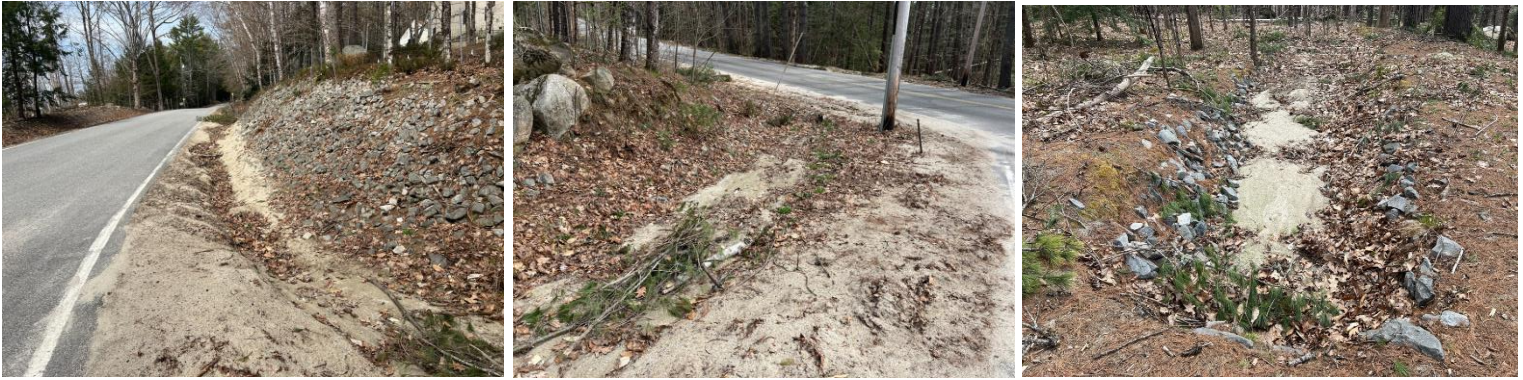
(Left) View up Mountain Road where roadside erosion is evident. (Center) View down Mountain Road towards the intersection with Conesca Road. (Right) View downslope of the intersection of Mountain Road and Conesca Road, where runoff has deposited sediment.

Recommendations: Re-evaluate the site to verify if the runoff is making its way into the lake. If so, clean out the existing ditches and install stone check dams. Where possible, add turnouts into forested buffer areas or install an infiltration basin.

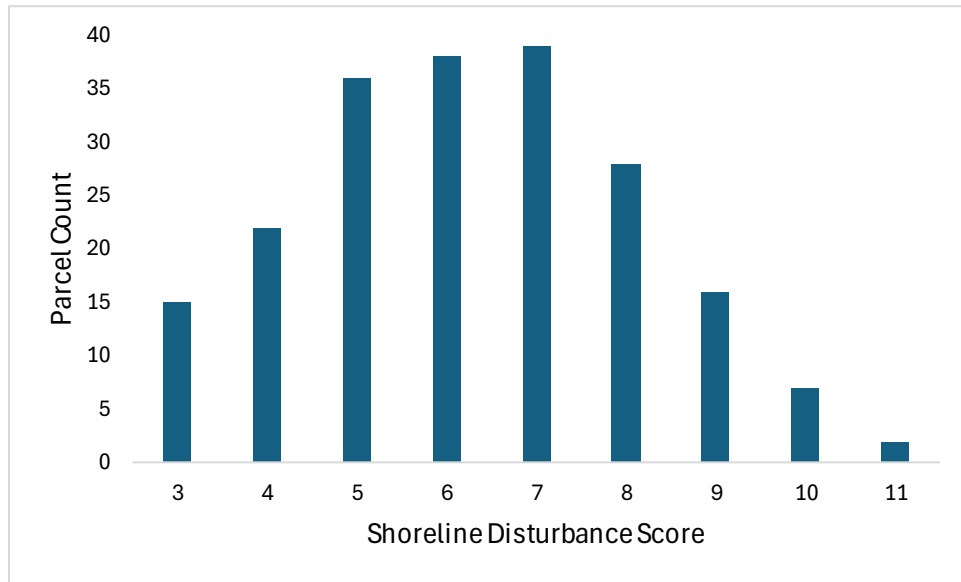
Figure 2. Histogram showing the number of parcels falling into each shoreline disturbance score category. The possible range of Shoreline Disturbance Scores is 3-12.

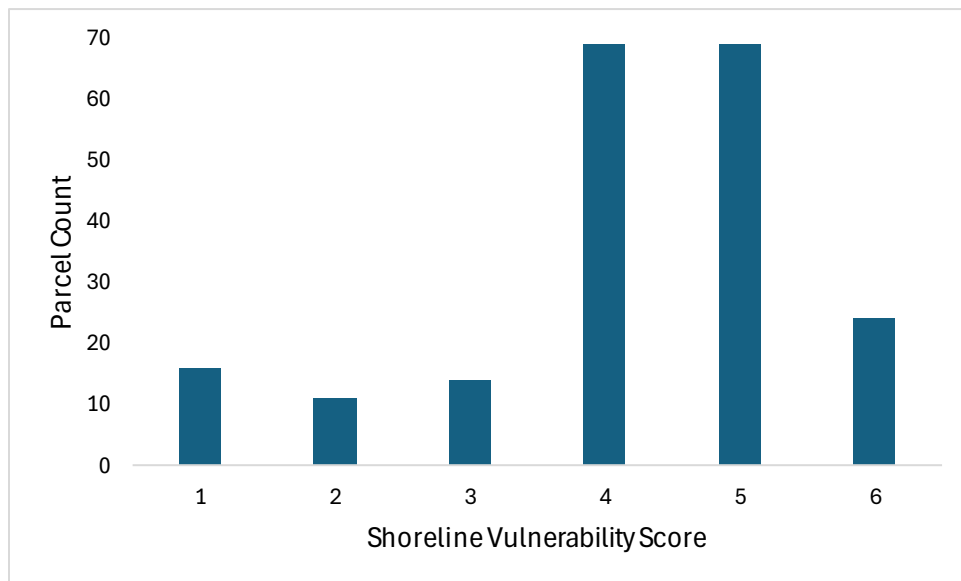
Figure 3. Histogram showing the number of parcels falling into each shoreline vulnerability score category. The possible range of Shoreline Vulnerability Scores is 1-6.

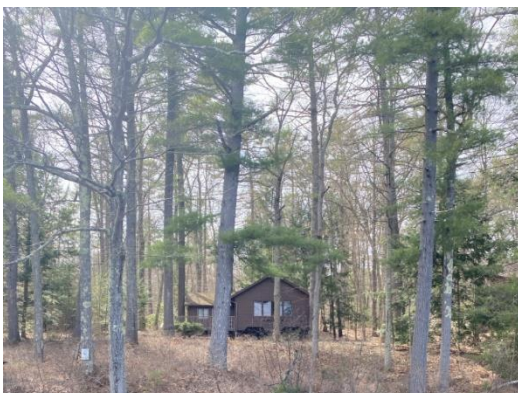
Crescent Lake parcel 15-62 receiving a final score of 3 due to a thickly vegetated buffer, which is comprised of natural vegetation of both trees and shrubs along the shore. It also has very little exposed soil present. This is a LakeSmart property.

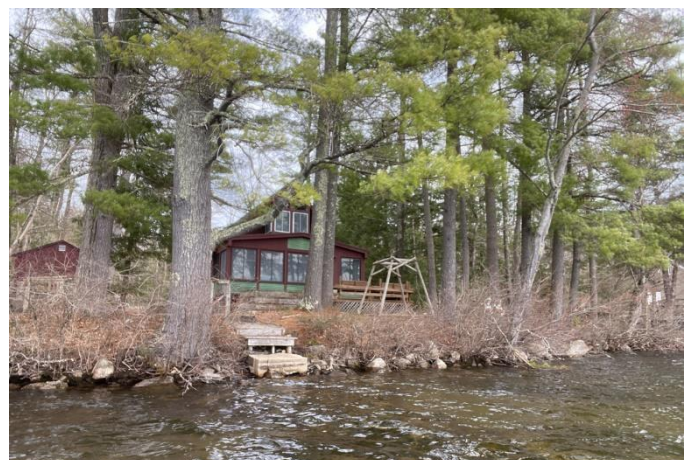
Crescent Lake parcel 15-28 receiving a final score of 5 due to a vegetated buffer consisting of multi-story canopy (trees and shrubs), minimal exposed soil, and a defined access point.
