INSPECTION REPORT

PANTHER POND DAM
MEMA No. 122

**Department of Inland Fisheries and Wildlife
Augusta, Maine**

March 2020

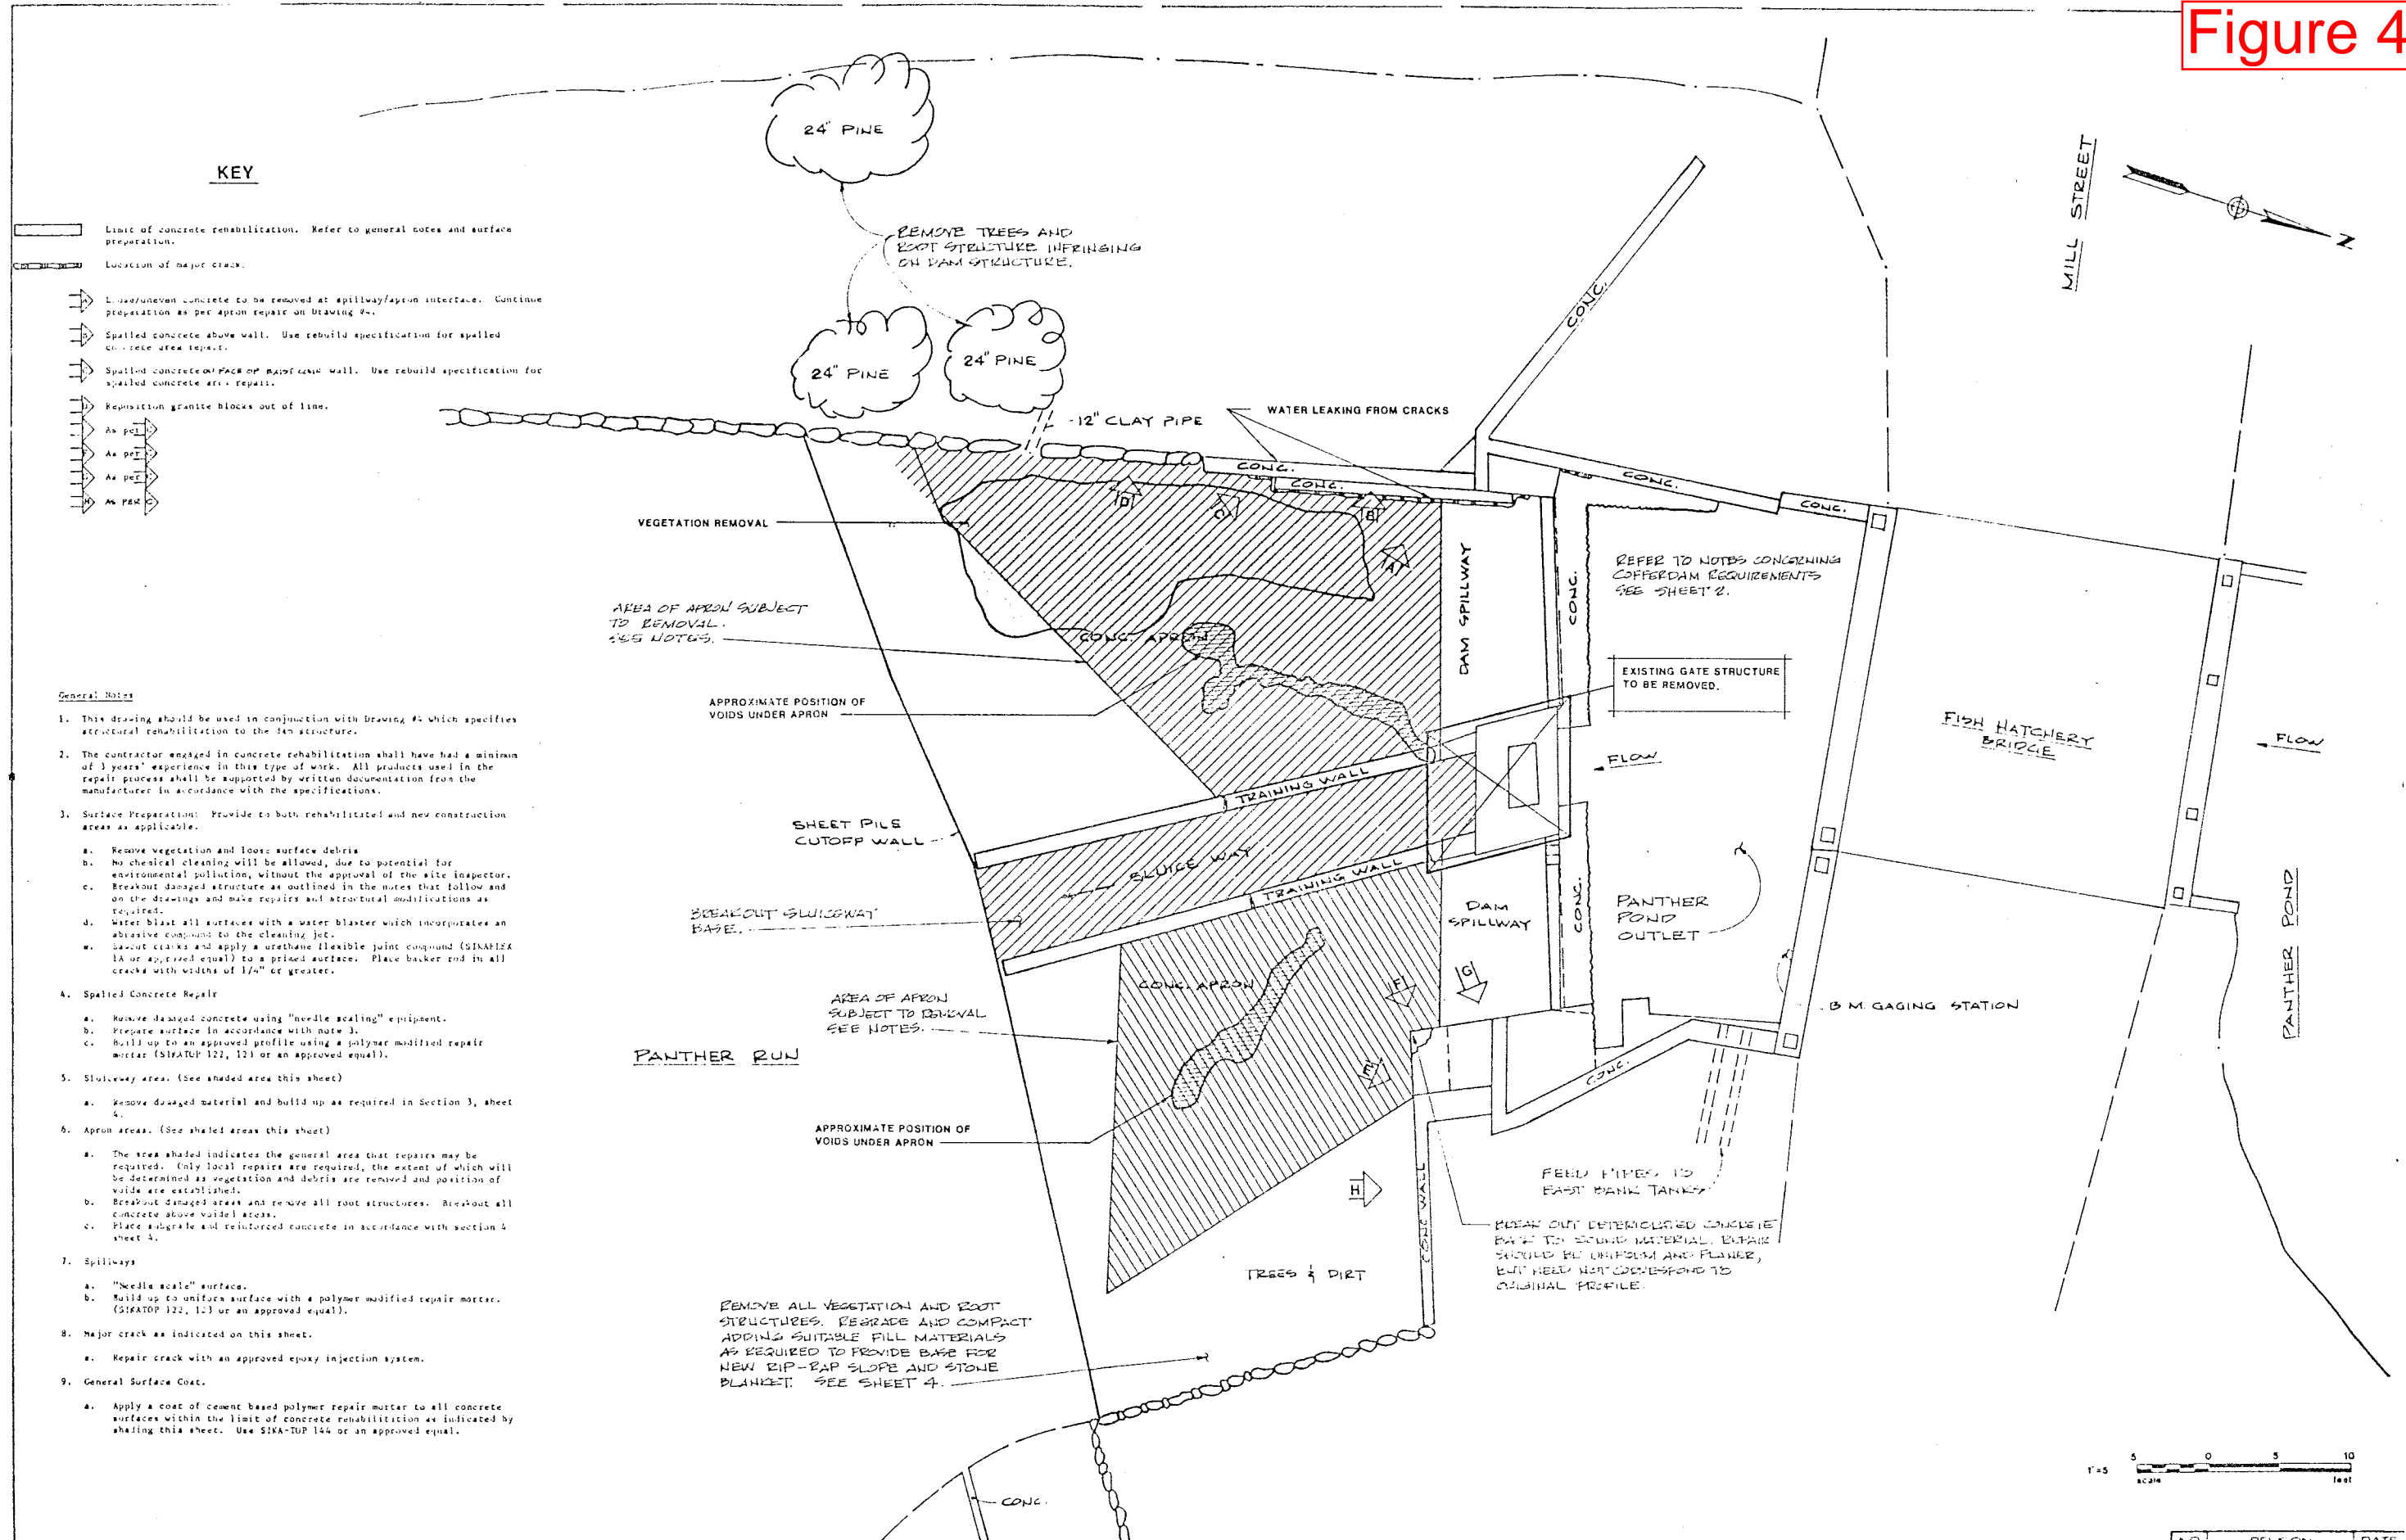
Figure 4

- Limit of concrete rehabilitation. Refer to general notes and surface preparation.
- Location of major crack.
- Loose/uniform concrete to be removed at spillway/apron interface. Continue preparation as per Apron repair on Drawing #4.
- Spalled concrete above wall. Use rebuild specification for spalled concrete area repair.
- Spalled concrete on FACE of major concrete wall. Use rebuild specification for spalled concrete area repair.
- Reposition granite blocks out of line.
- As per →
- As per →
- As per →
- As per →

4. Spalled Concrete Repair
 - a. Remove damaged concrete using "needle scaling" equipment.
 - b. Prepare surface in accordance with note 3.
 - c. Build up to an approved profile using a polymer modified repair mortar (SIFATOP 122, 123 or an approved equal).

5. Sluiceway area. (See shaded area this sheet)
 - a. Remove damaged material and build up as required in Section 3, sheet 4.
6. Apron areas. (See shaded areas this sheet)

- a. The area shaded indicates the general area that repairs may be required. Only local repairs are required, the extent of which will be determined as vegetation and debris are removed and position of voids are established.

- b. Breakout damaged areas and remove all root structures. Breakout all concrete above voided areas.
 - c. Place subgrade and reinforced concrete in accordance with section 4 sheet 4.

7. Spillways
 - a. "Needle scale" surface.
 - b. Build up to uniform surface with a polymer modified repair mortar. (SIFATOP 122, 123 or an approved equal).

8. Major crack as indicated on this sheet.
 - a. Repair crack with an approved epoxy injection system.
9. General Surface Coat.
 - a. Apply a coat of cement based polymer repair mortar to all concrete surfaces within the limit of concrete rehabilitation as indicated by shading this sheet. Use SIFATOP 144 or an approved equal.
